Analysis of Field Performance of Landslide Repair Using a Pile Wall

A historically slow moving embankment fill landslide on Secondary Highway 682:02 accelerated to failure in the spring of 2007. The landslide was translational with the failure plane located between 4.5 and 6.5 m depth within native lacustrine clay. The stabilization repair method selected was a pile wall that consisted of 67 cast-in-place reinforced concrete piles spaced at 1.5 m on centre.

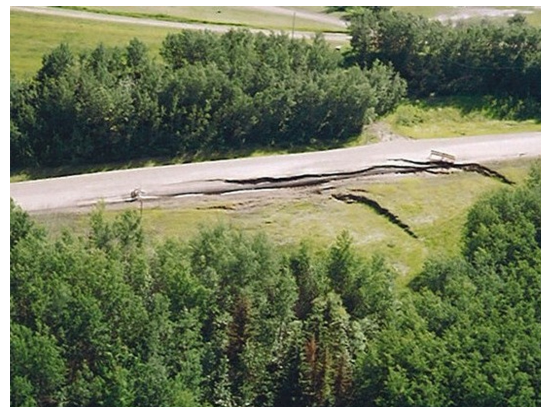
The landslide site encompassed an 11 m high embankment that spans a small ephemeral creek valley. Part of the highway grade line was constructed using cut and fill methods. The landslide was approximately 90 m wide at the head and extended to the centerline of the highway as shown in Photo 1. A pronounced toe push feature was evident near the toe of the embankment

Photo 1. Aerial view of Hines Creek (PH4) Landslide

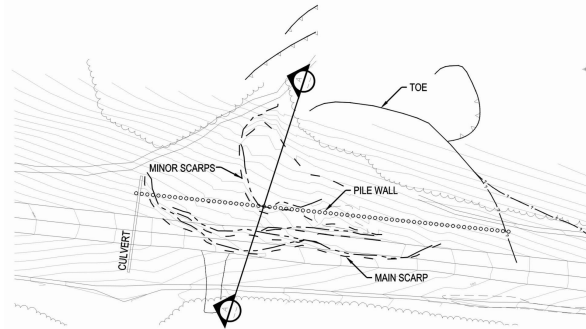
Figure 1. Site Plan

slope, which indicated day-lighting of the failure plane. The embankment fill slopes varied from 11° to 17°. A site plan showing the extent of the landslide and borehole/instrument locations is presented on Figure 1.

The final design of the pile wall included 67 cast-in-place reinforced concrete piles, 14 m in length, 1.0 m in diameter and spaced at 1.5 m on centre. The area of the steel within the piles was 2.2% of the total pile cross-sectional area. The layout of the pile wall is presented in Figure 1. A contingency plan is in place in the event that embankment fill and asphalt road surface deformations exceed AT tolerances. This contingency includes installation of tie-back anchors to further restrain the wall movements.

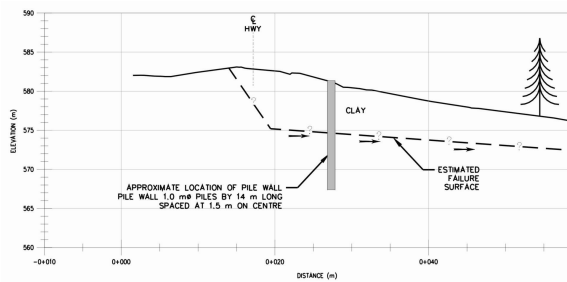
Figure 2. Landslide Cross Section

The cause of the landslide was determined to be due to the destabilizing influence of the embankment fill at the site and moderately adverse groundwater conditions. Seepage was present at various locations on the embankment slope, including approximately 2.0 m below the highway grade line. The drainage ditch immediately south of the landslide area was poorly graded with ponded water present after rainfall events. A section of the embankment slope and estimated failure plane is presented in Figure 2.

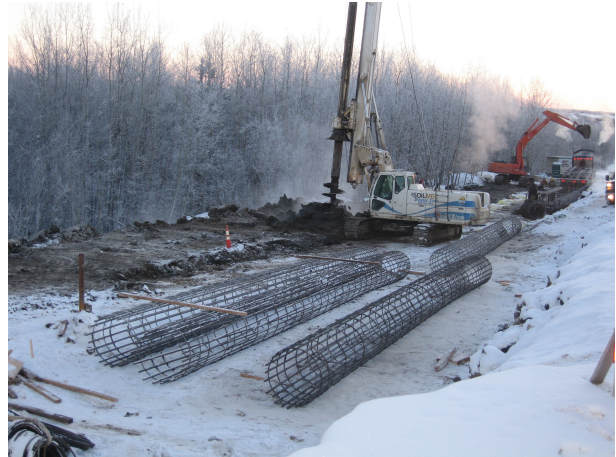
Photo 2. Pile Wall Construction (late January 2008)

Construction started in December 2007. An access road and level pad area were built across the embankment at the pile wall location. The timing of construction was primarily dictated by the urgency associated with completing the repair work. There was some benefit to cold weather conditions as it allowed for ground freezing to improve equipment trafficability on site. Pile installation was started in mid-January and was completed in 10 days. A photograph of the pile wall construction is presented in Photo 2. The ambient air temperature varied between -25 and -40° C throughout piling construction. Pile drilling near the formerly wet area near the zone of initial movement encountered a buried drainage pipe, indicative of historic drainage efforts.

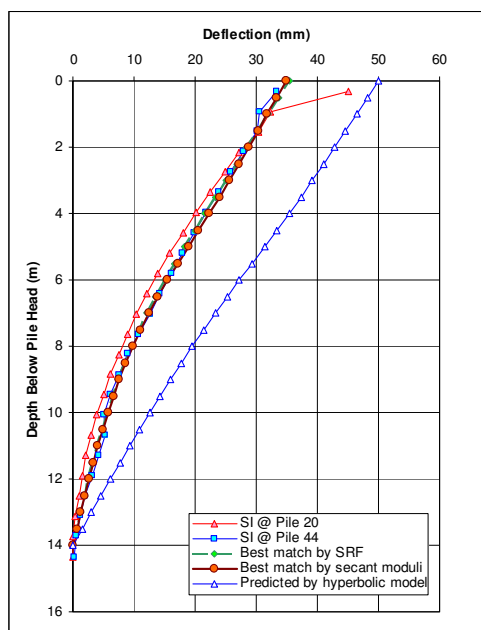
Figure 3. Comparison between pile wall SI readings (April 29, 2009) and back analyzed deformations

Slope inclinometer readings (on April 29, 2009) indicating the deflection observed in the pile wall since completion of construction are illustrated in Figure 3. The observed deflections were within the bracketed range of 7 to 93 mm predicted during the design phase. The majority of the deflections occurred prior to early summer 2008 when the final grading and paving was complete. There has been limited post-construction deformation or cracking of the embankment slope and repaired road surface above the pile wall.

The model parameters and results of the back analysis are presented in Table 2. Figure 3 shows a comparison between pile wall SI readings (April 29, 2009) and deformations back analyzed predicted by various methods described above.
