## **BIM Advisory Bulletin #6 – May, 2017**

In 2012, Alberta Transportation was informed of 6 SC girder bridges that were showing signs of accelerated freeze thaw deterioration on exterior girders. Further investigations revealed that the deterioration was due to the use of substandard aggregates in the concrete mixes used in some girders fabricated between 2003 and 2007.

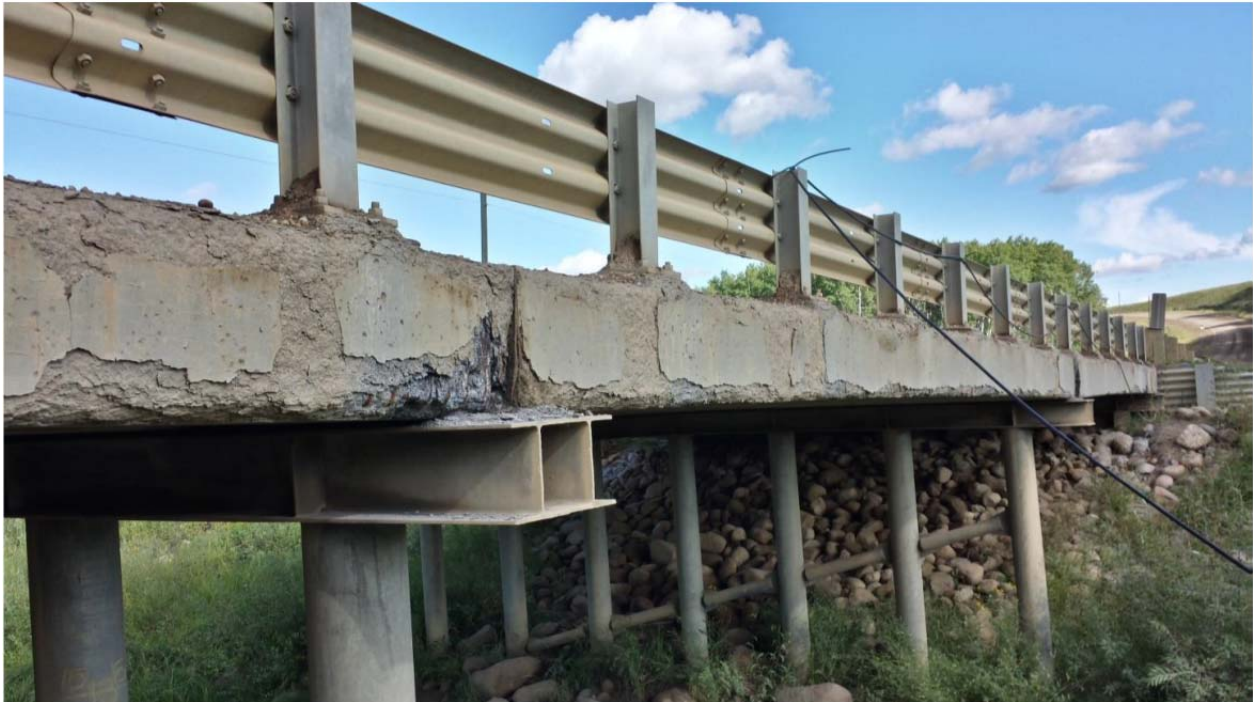
**Example 1:** Extensive scaling of exterior girder surfaces with concrete section loss extending more than 50 mm from top, bottom, and end edges of the girder. Exposed strand and stirrups. Concrete section loss of girder top that extends up to the edge of the bridge rail base plate. Girders rated 2. Bridge rail posts rated 2.

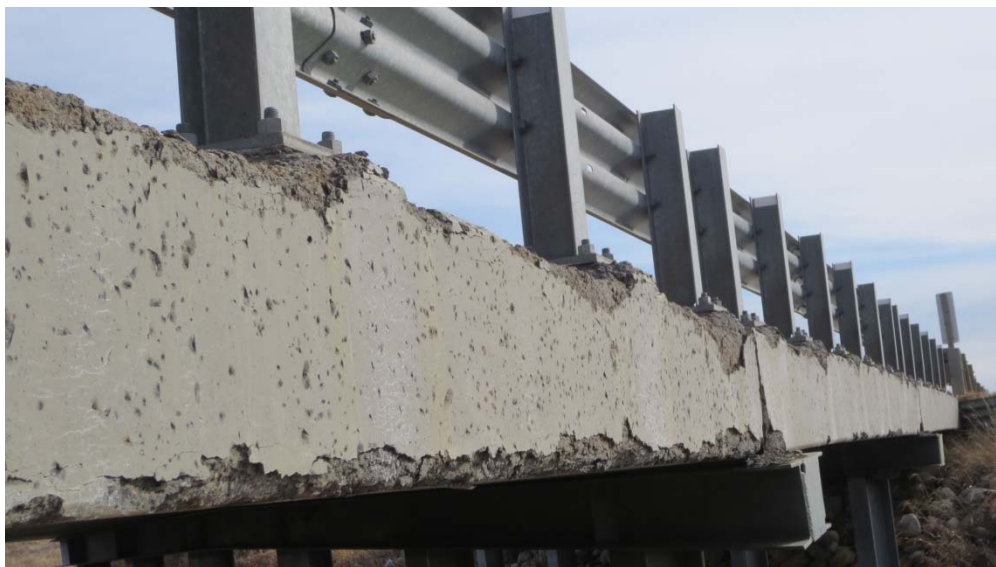
**Example 2:** Concrete section loss extending more than 50 mm from top and bottom edges of the girder with no exposed stirrups or strands. Concrete section loss of plinths, extending to bridge rail post base plates. Girder rated 2. Bridge rail posts rated 2.

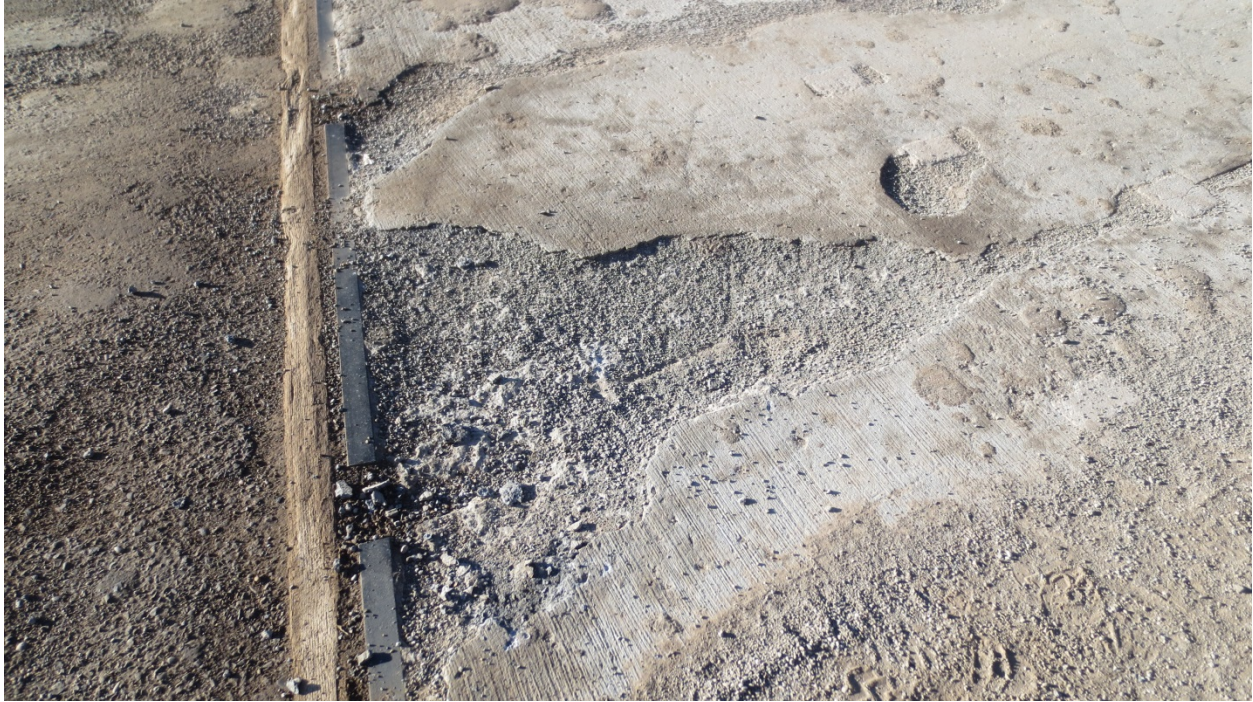
**Example 3:** Concrete section loss less than 35 mm in depth along top surfaces of interior girders. Interior girders rated 3.

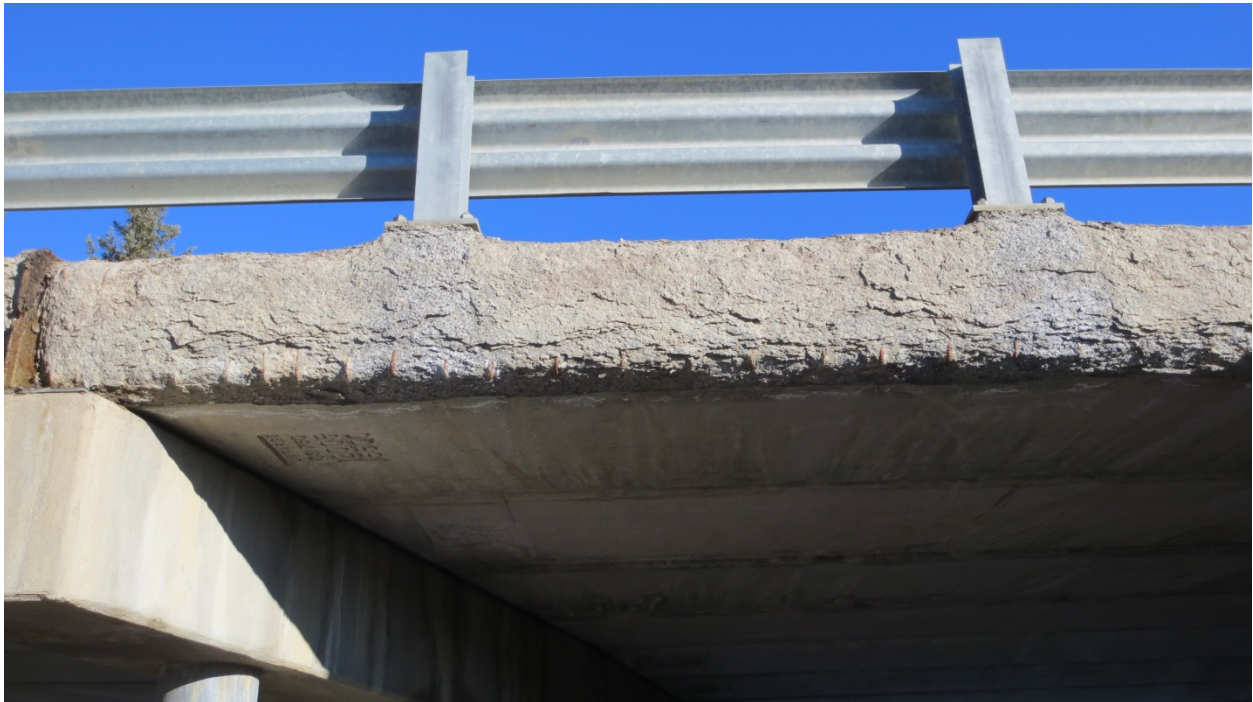
**Example 4:** Significant concrete section loss with exposed steel stirrups. Exterior girder rated 2. Concrete section loss extending below bridgerail post baseplate. Bridgerail posts rated 2.

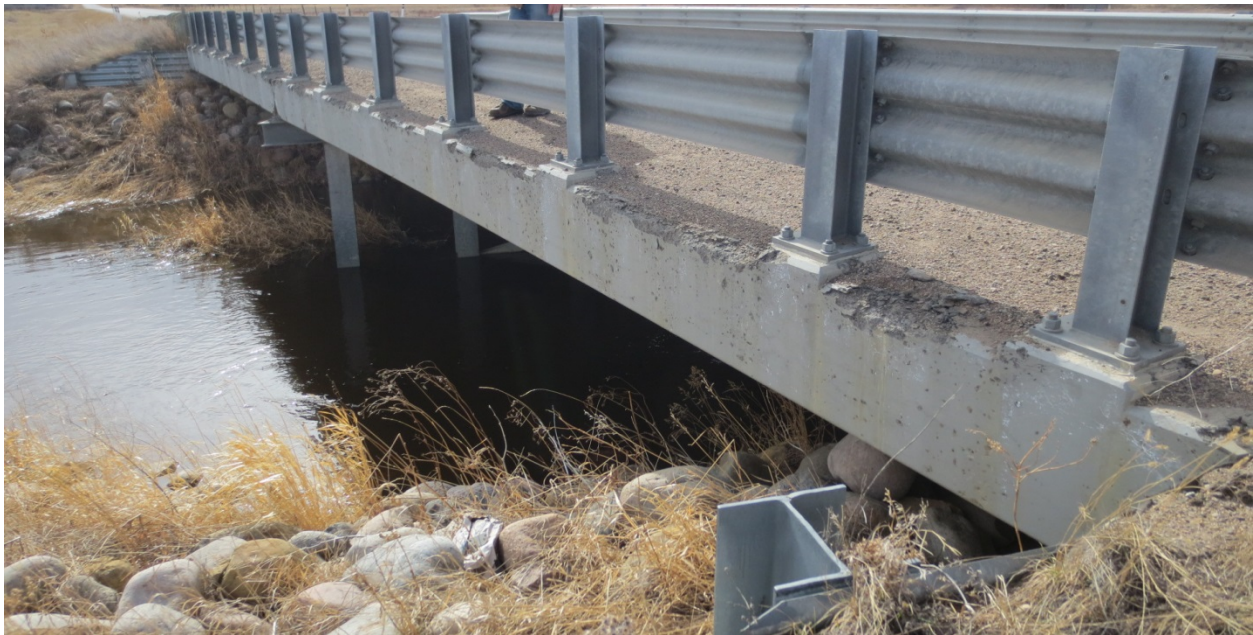
**Example 5:** Concrete section loss of exterior girder extending less than 50 mm from the top edge of the girder. Girder rated 3. Concrete section loss of bridgerail post plinth not extending to bridgerail post baseplate. Bridgerail post rated 3.

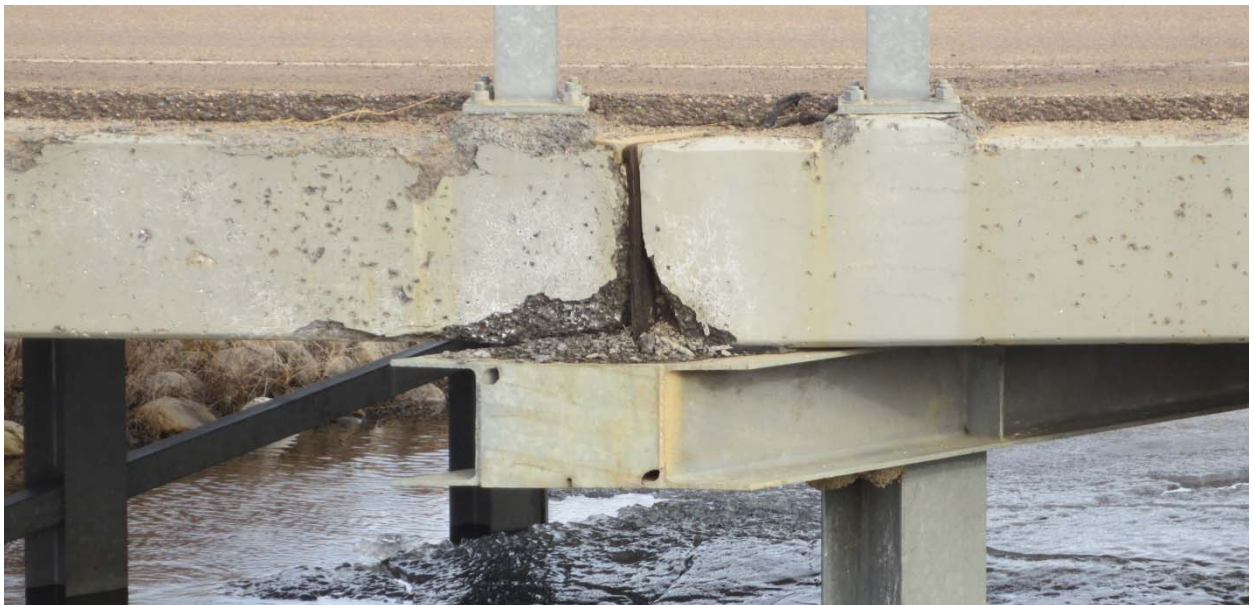
**Example 6:** Concrete section loss of exterior girder extending more than 50 mm from the vertical edge of the girder end. Girder rated 2. Concrete section loss of bridgerail post plinth extending to bridgerail post baseplate. Bridgerail post rated 2.

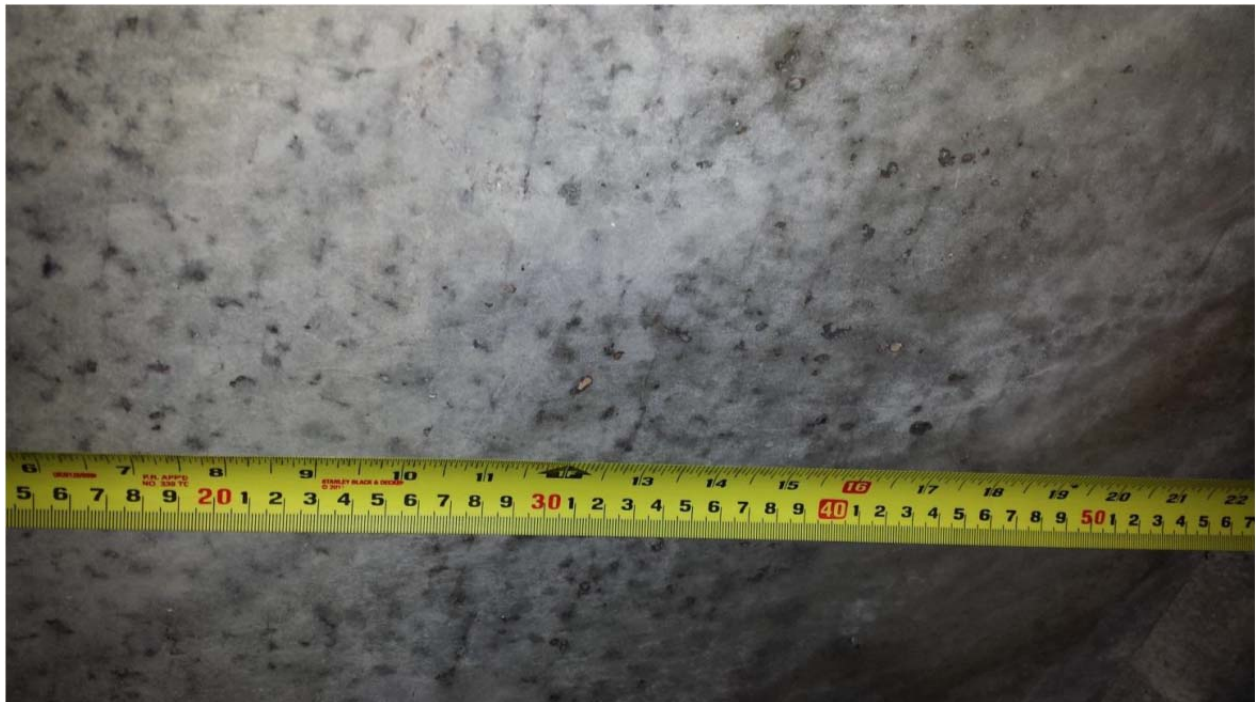
**Example 7:** Isolated aggregate popouts along interior girder. Girder rated 4.

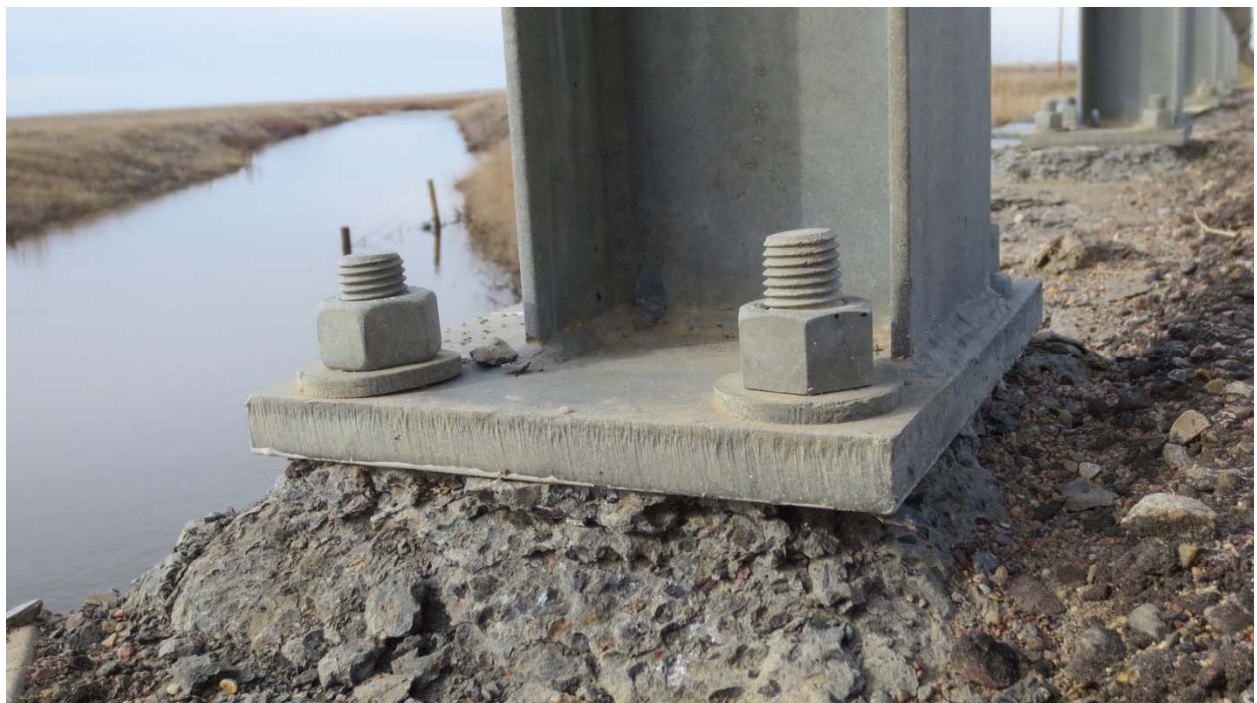
**Example 8:** Concrete plinth section loss extending below bridge rail base plate. Bridge rail post rated 2.
