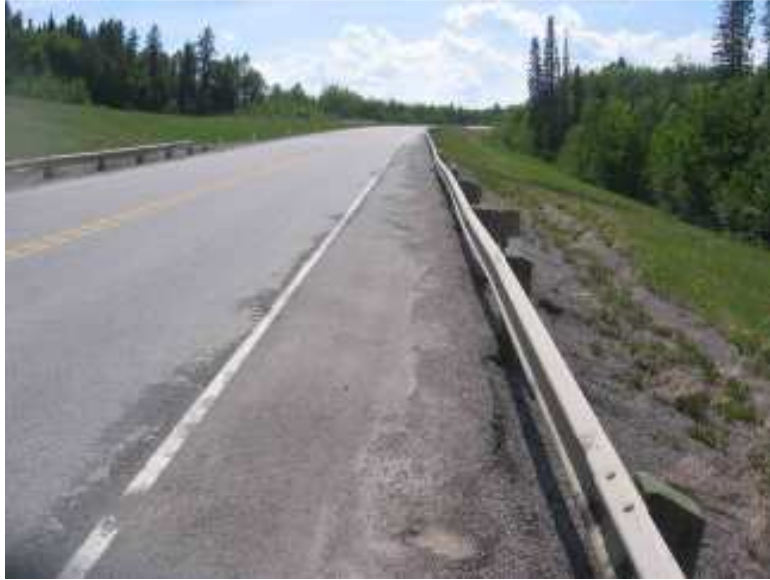
**Photo S2-1** – Looking west along the downslope edge of the road along the pile wall area. Cracking in the road surface along the guardrail is present but covered with gravel and road debris. The road surface was in similar condition as was observed in 2009 and previous years with the cracking appearing to define the shape and extent of the existing pile wall.

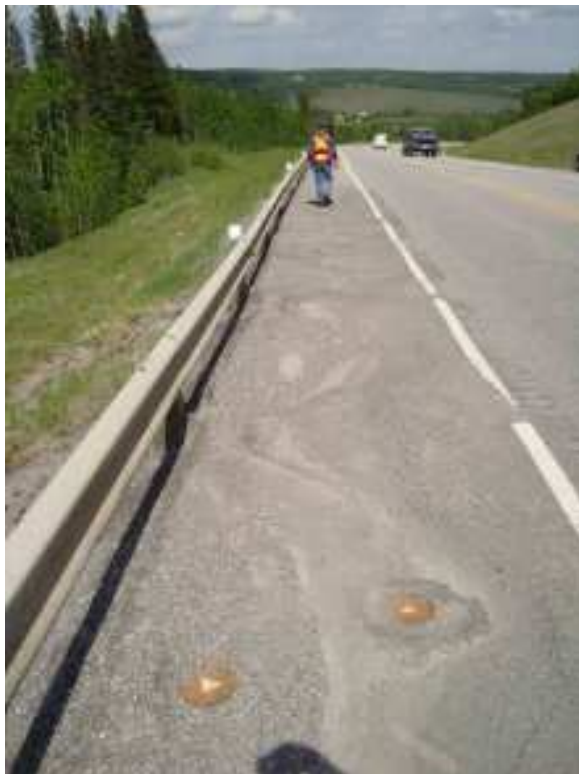
**Photo S2-2** – Looking east along the pile wall area. SI#10 and AMEC BH#1 are visible in the foreground.

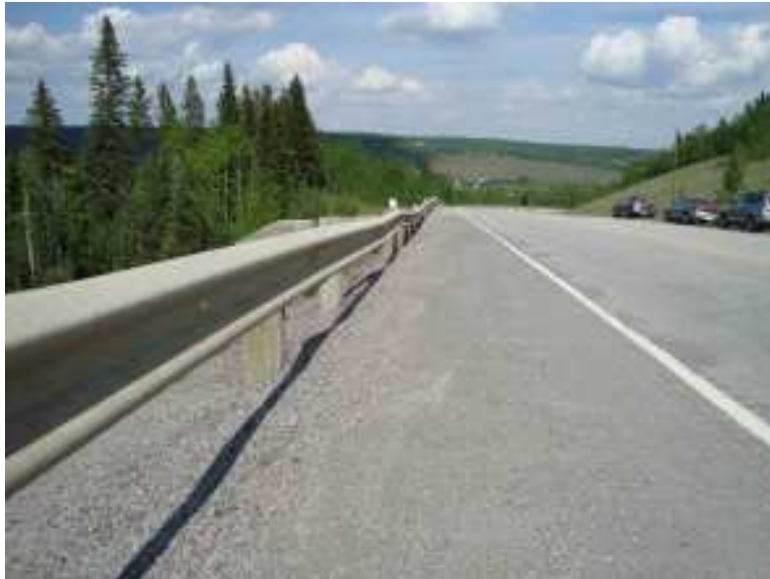
**Photo S2-3** – Facing eastbound along the downslope shoulder of the highway from the west end of the landslide area. Settlement of the guardrail is visible in the area of the pile wall.

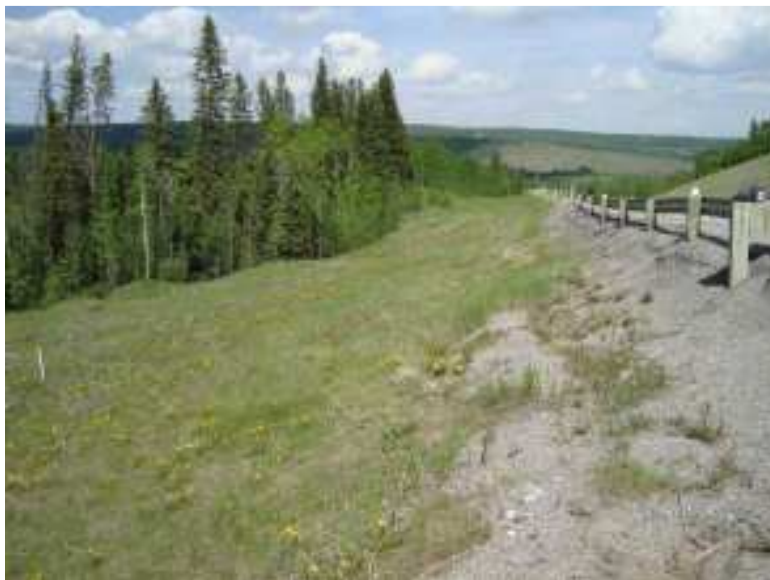
**Photo S2-4** – Looking east at the slope below the highway in the landslide area. The slope appears to be in similar condition as was observed in 2009.
