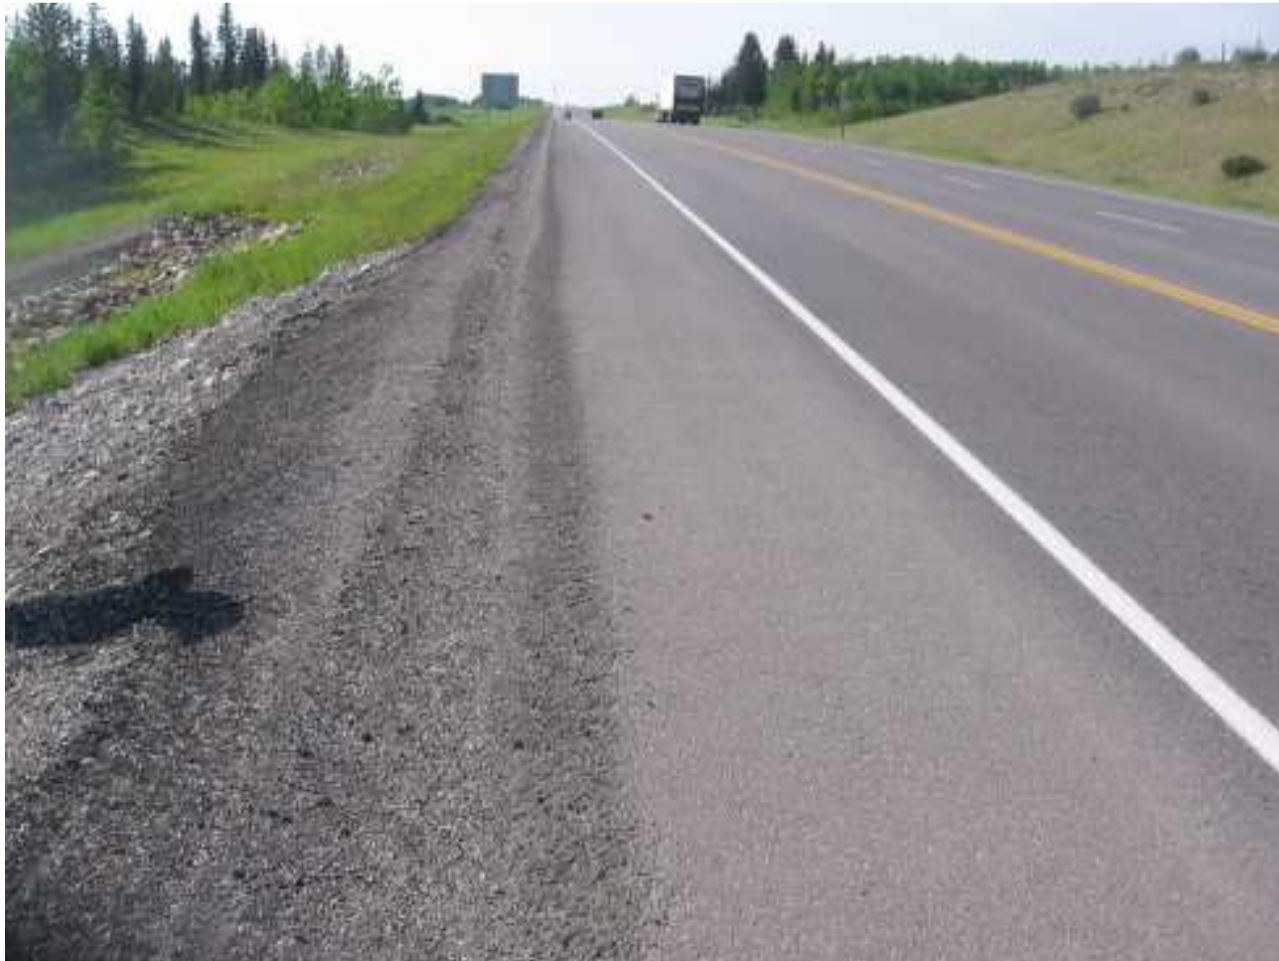
**Photograph S3-1 – Facing southbound along the downslope shoulder of the highway, above the landslide area. An overlay was placed in this area in the summer of 2009 to repair past cracking and settlement of the road surface.**

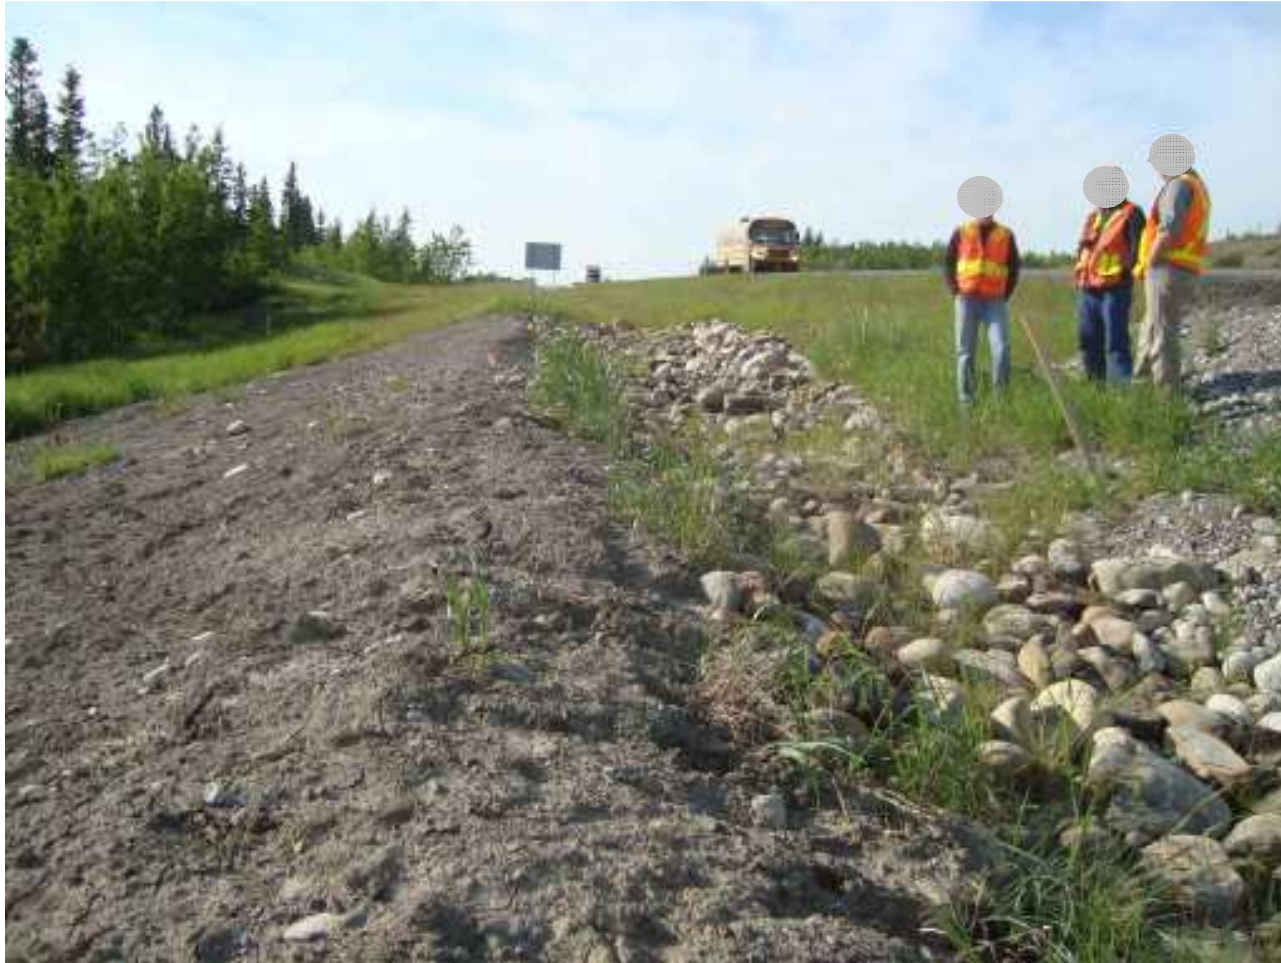
**Photograph S3-2 - Looking southbound along the 2009 repairs to the ditch berm. Vegetation has not become established on the areas regraded in 2009.**

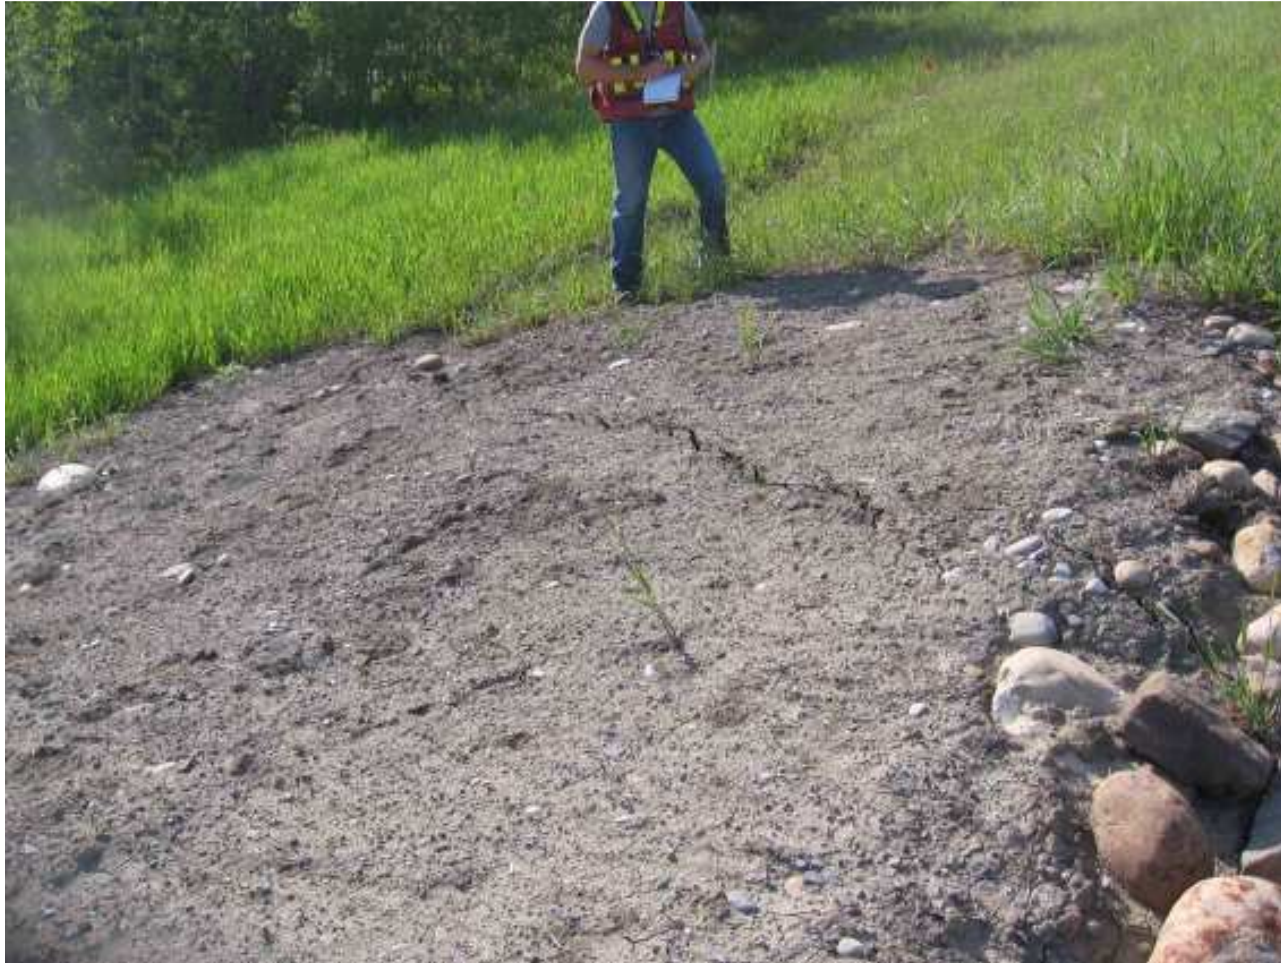
**Photograph S3-3 - Crack formed at south end of the segment of the ditch berm that was regraded in 2009. The crack follows the same pattern as past damage, and likely indicates the south flank of the slide that remains active since the 2009 regrading.**

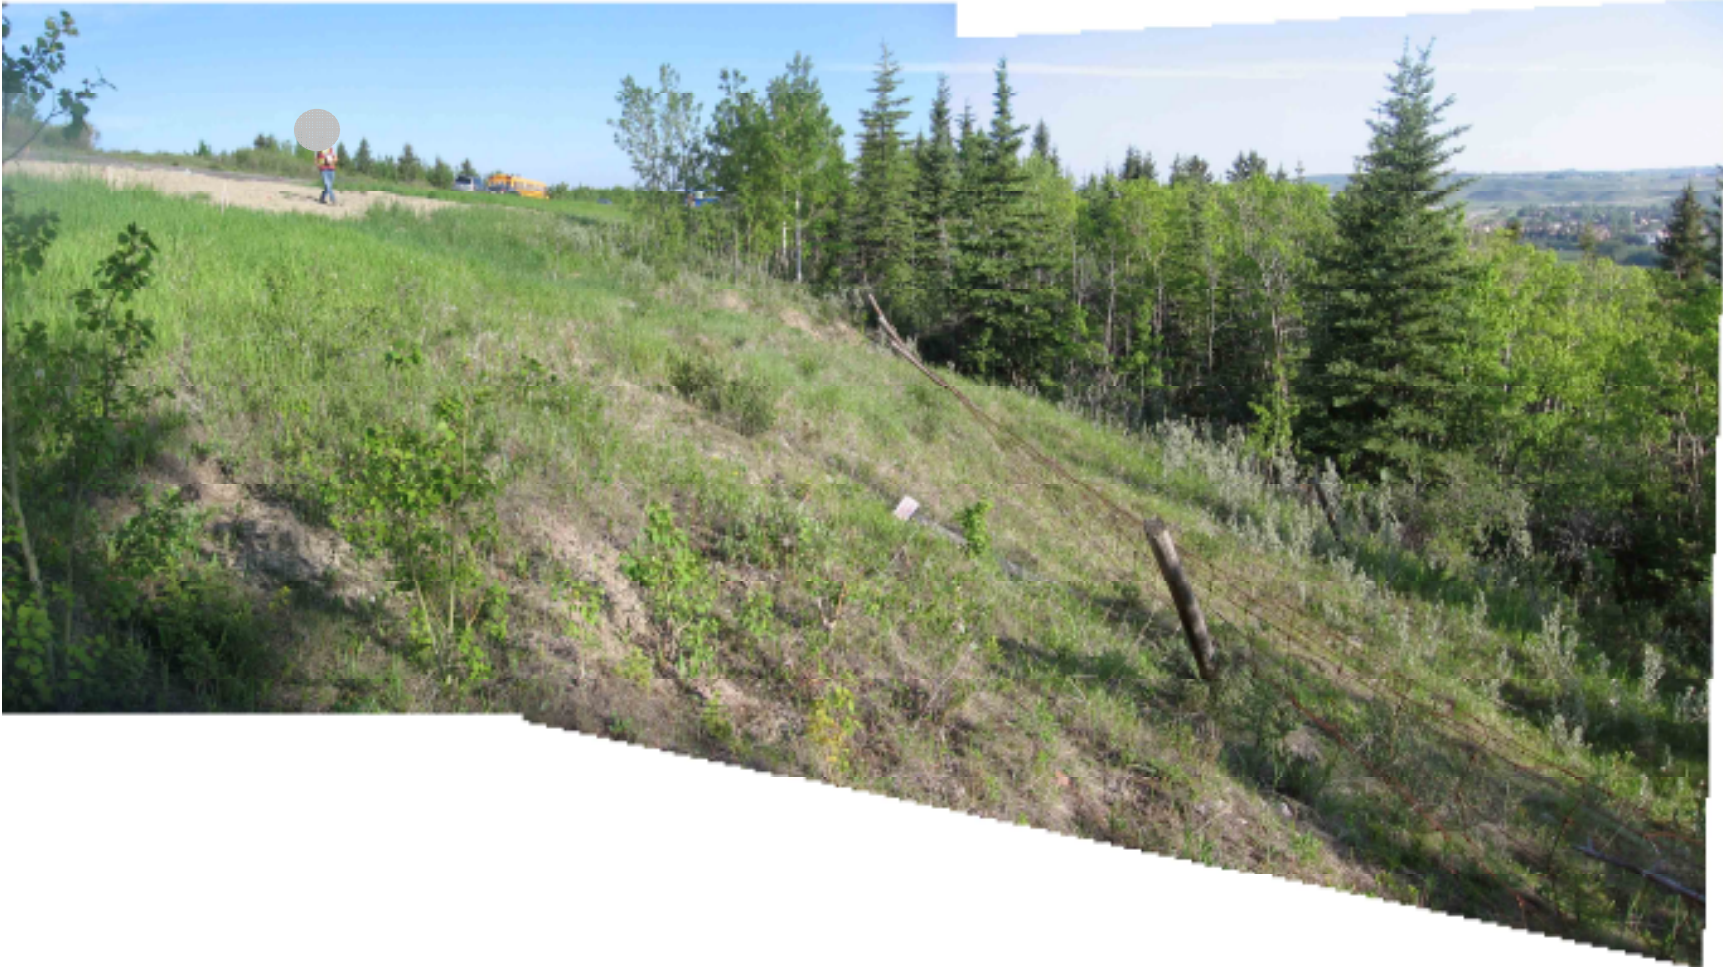
**Photograph S3-4 – Looking northwest at the slope below the instrumented area. The condition of the tension cracks, slumps and fenceline damage have not changed significantly since the 2009 inspection.**

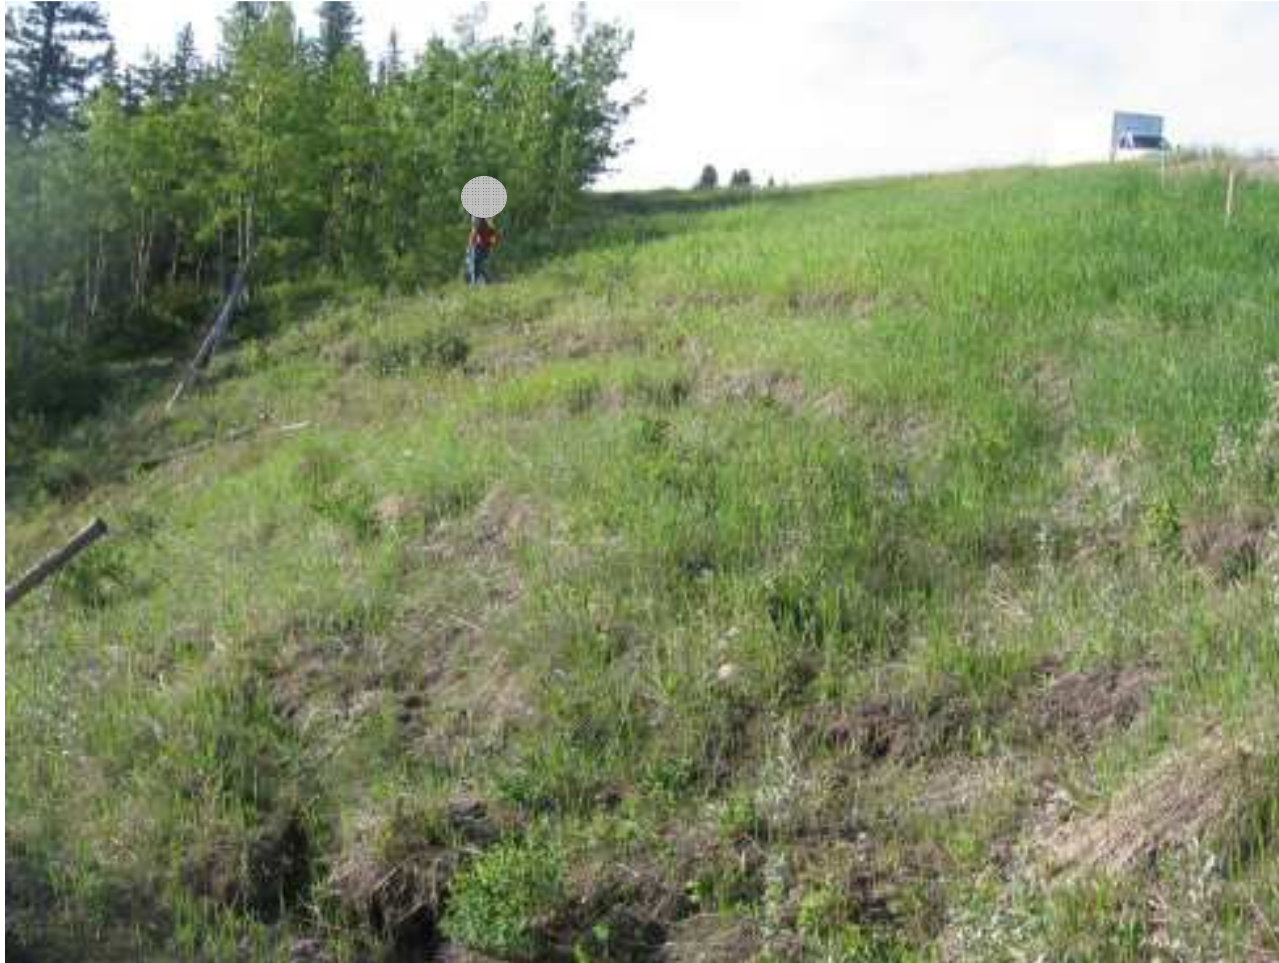
**Photograph S3-5 - Looking south at the slide area below the instrumented area.**
