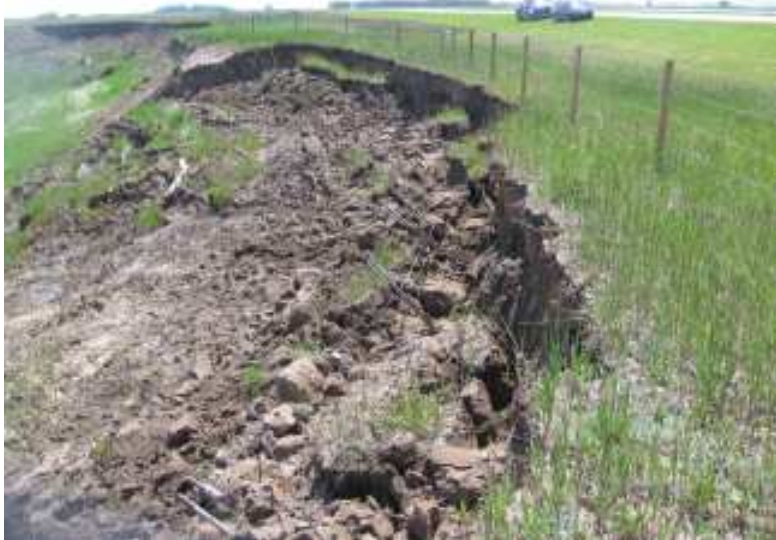
Photo S4-1 (Top) – June 2010

Looking south at the headscarp in the soil nailed area. The headscarp has retrogressed to the fenceline due to blocks toppling from the face. Shallow earth flows have also occurred on the slide mass. Soil nails are protruding up to 2 m.

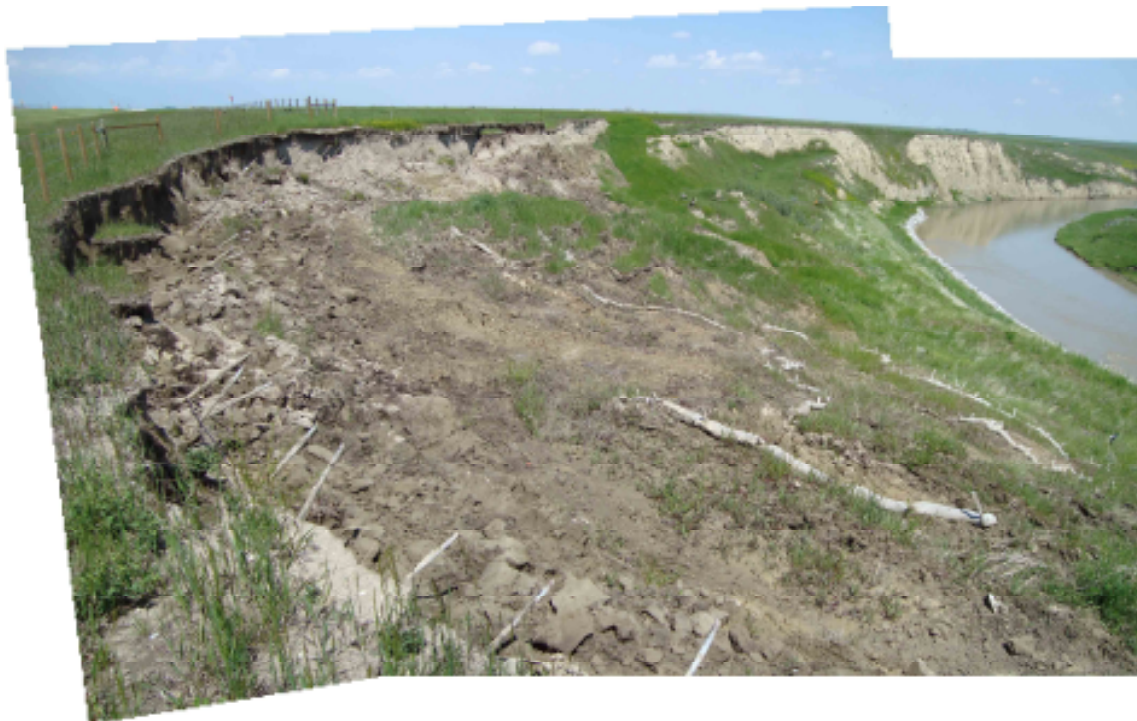
Photo S4-2 (Bottom) – June 2010

Looking north at the soil nailed area. The vegetative cover is poor in the areas disturbed by earth flows. The slopes in the background are dry and are more stable than the repaired site area. Compare to Photo S4-11 which shows the site area shortly after the repair work.

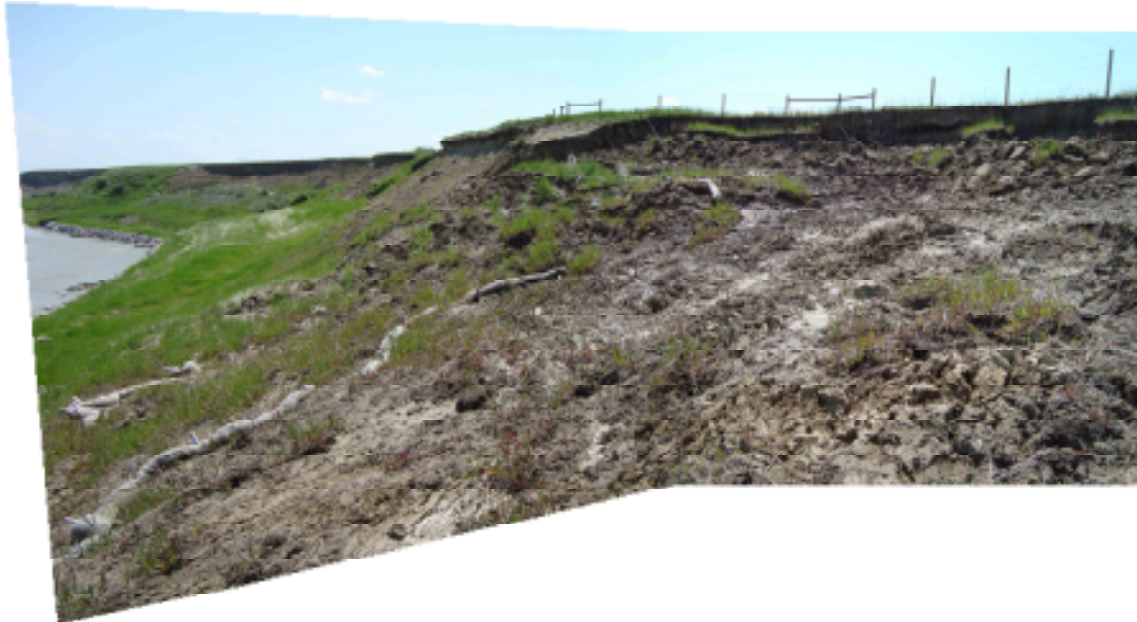
Photo S4-3 (Top) – June 2010

Looking southwest at the soil nailed area. The earth flows are apparent. The upper slopes have poor vegetative cover, while the more gentle angled lower slopes and benches have good cover.

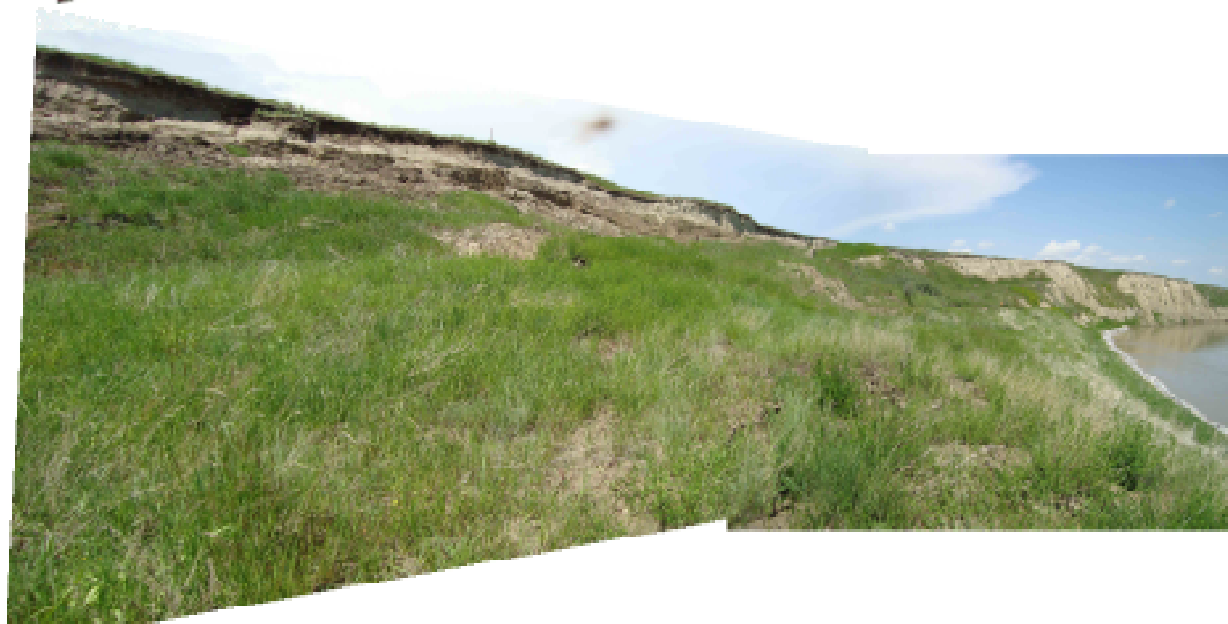
Photo S4-4 (Bottom) – June 2010

Looking north along the lower slopes from near the middle of the site.

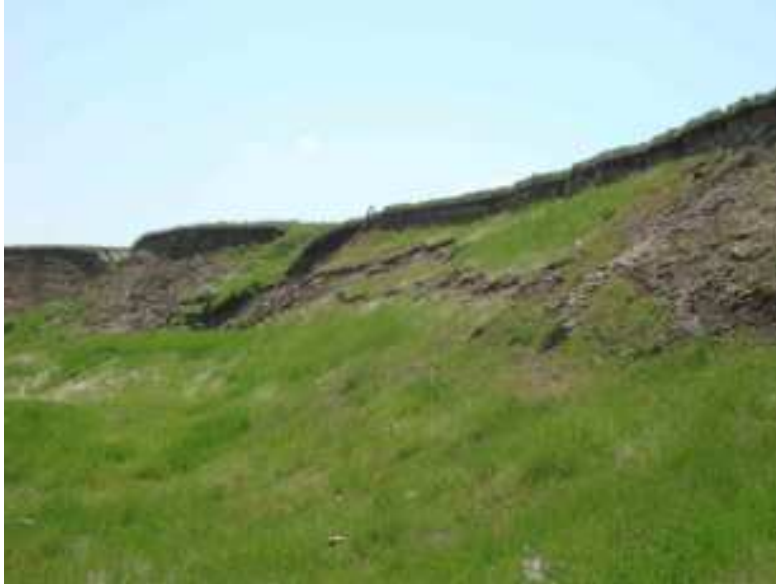
Photo S4-5 – June 2010

Looking south at the upper slope near the south end of the site. This area was treated with flexible growth medium, and aside from some shallow earth flows, has performed well.

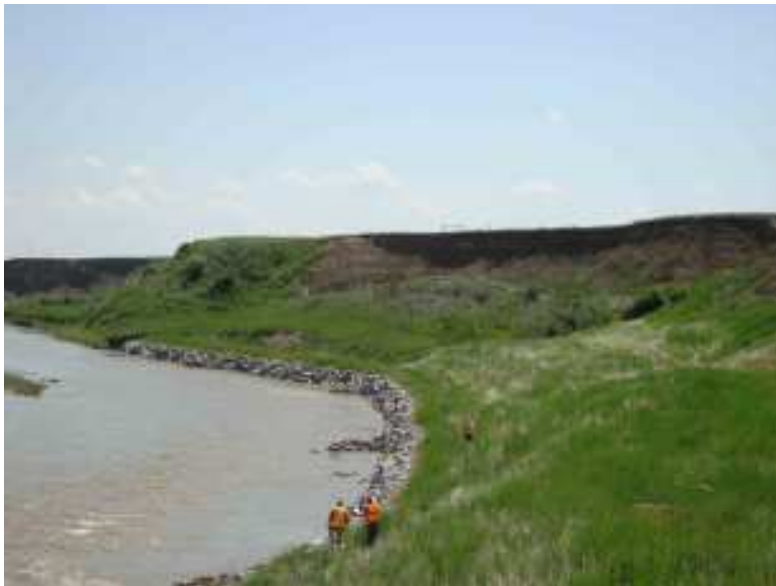
Photo S4-6 – June 2010

Looking south at the general site area. Several of the rock vanes are below the water level. Note that the turbulent flow has been directed away from the bank.

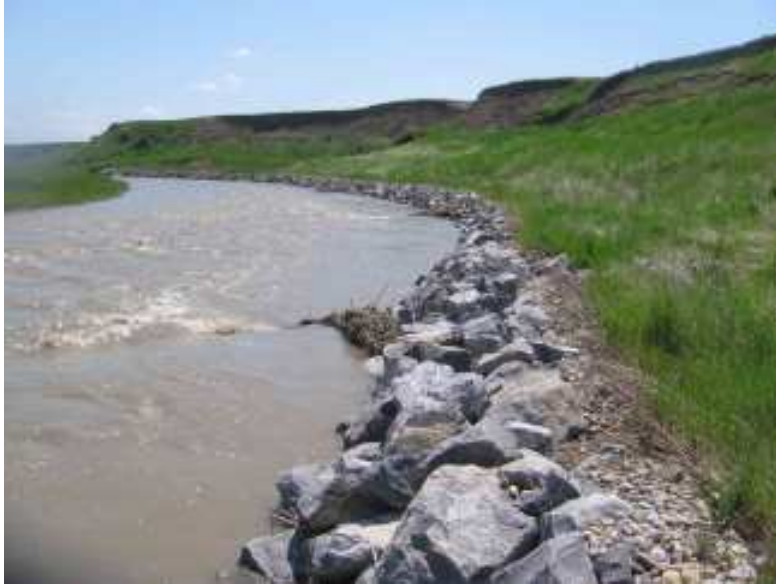
Photo S4-7 – June 2010

Looking south along the LPSTP. The vanes in this area are below the water level.

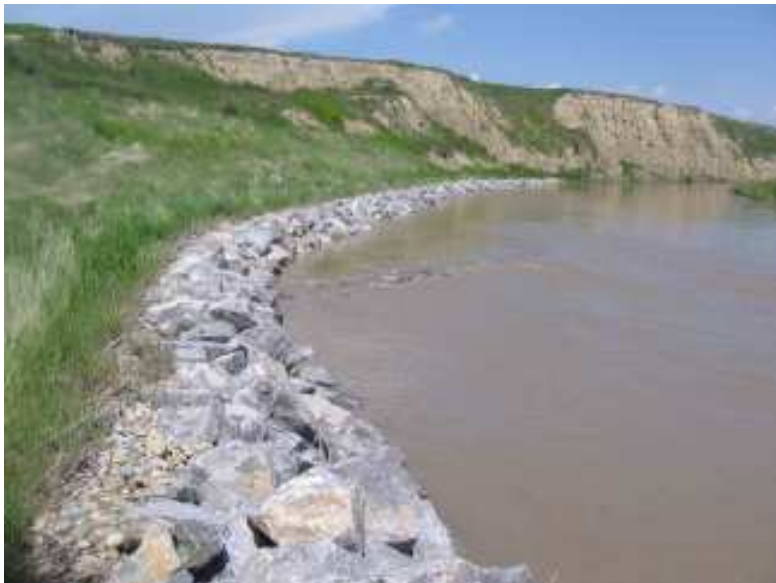
Photo S4-8 – June 2010

Looking north along the LPSTP.

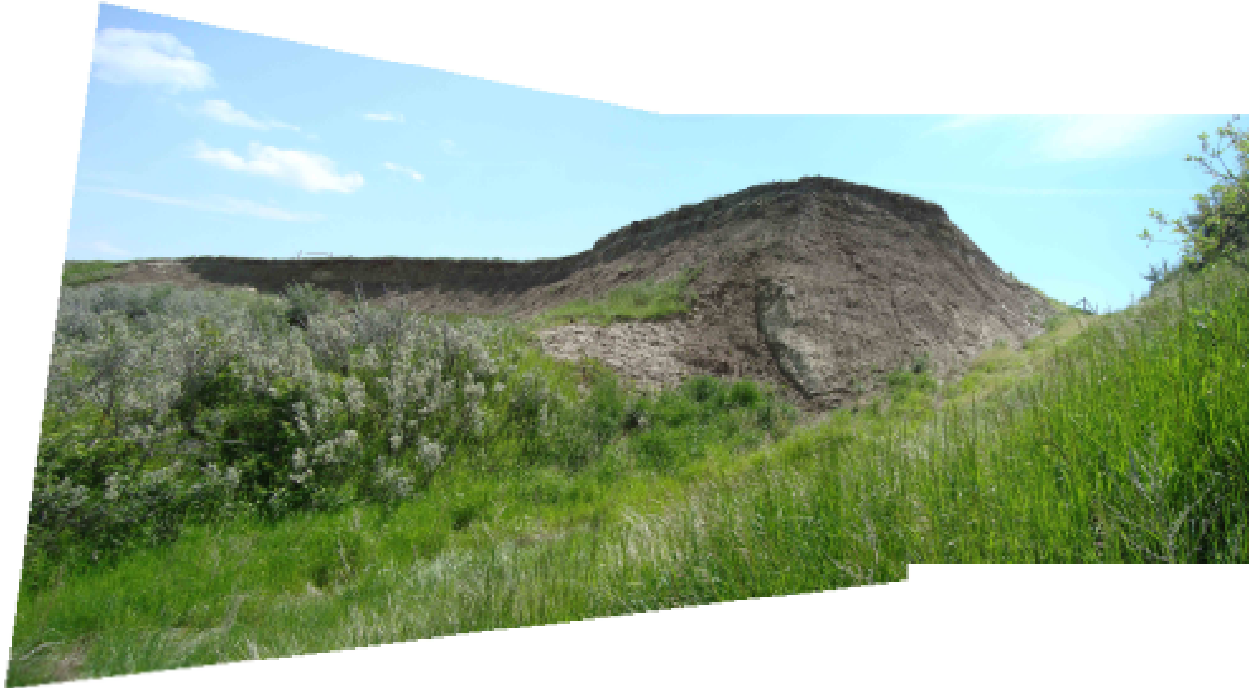
Photo S4-9 – June 2010
Looking southwest at the gully at the south end of the site.

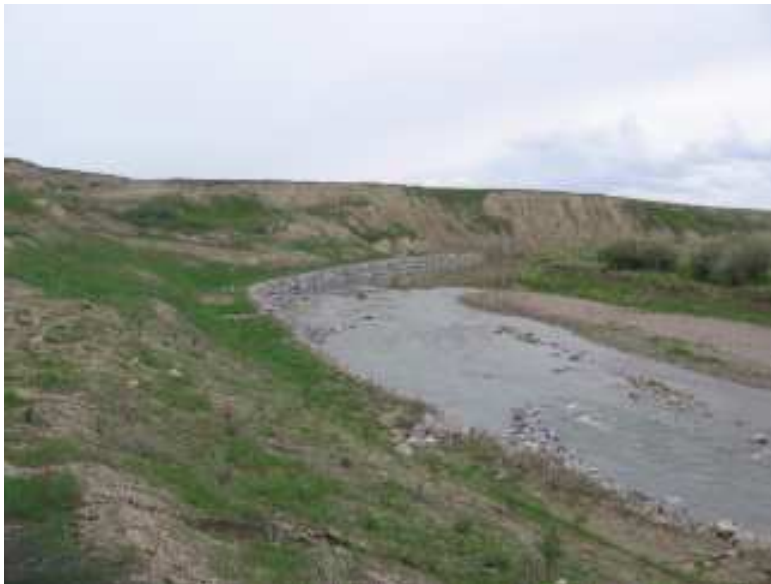
Photo S4-10 – June 2009
A view of the site area from 2009 for comparison. Note the greatly improved vegetative cover in 2010.

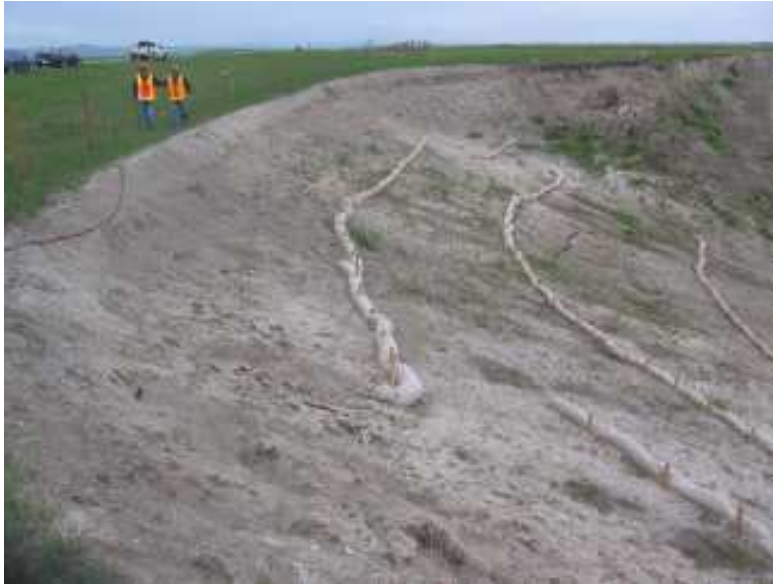
Photo S4-11 – June 2009

The soil nailed area in 2009 for comparison.
