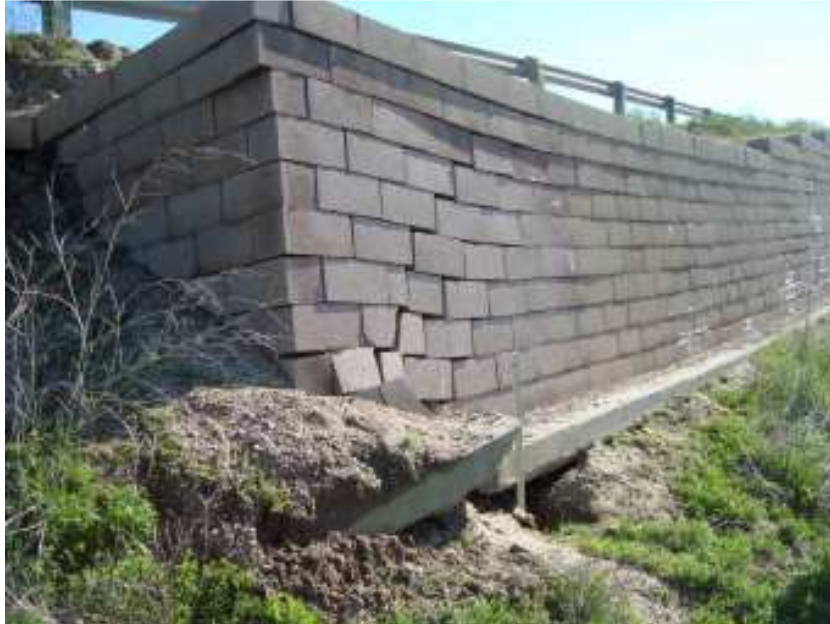
Photo S5-1 (top)

The footing at the west end of the May 2008 retaining wall has become undermined around the drainage pipe and cracking of the footing has occurred. This damage has worsened considerably since the 2009 inspection.

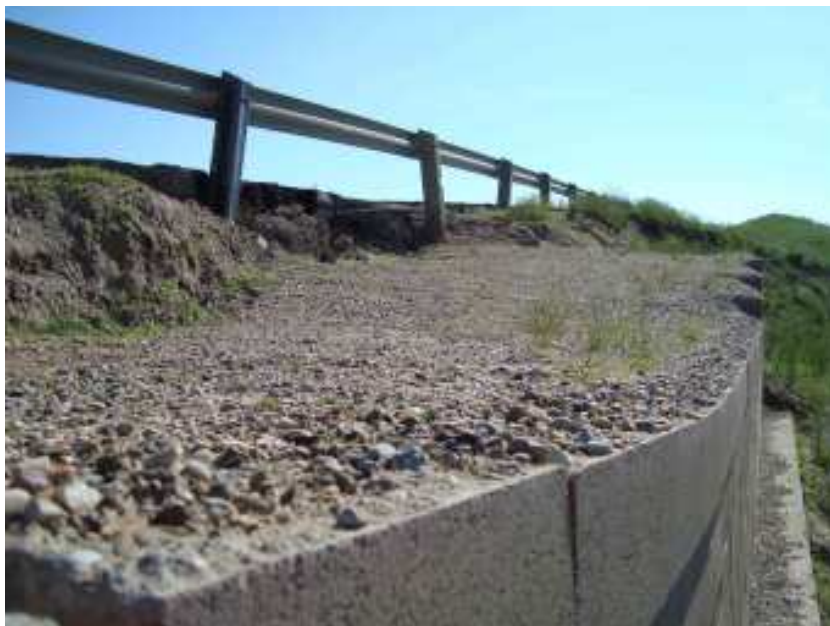
Photo S5-2 (bottom)

Looking along the top of the wall, differential settlement of about 300 mm is noted. Settlement of about 500 mm has occurred along the guardrail leaving two of the posts unsupported.

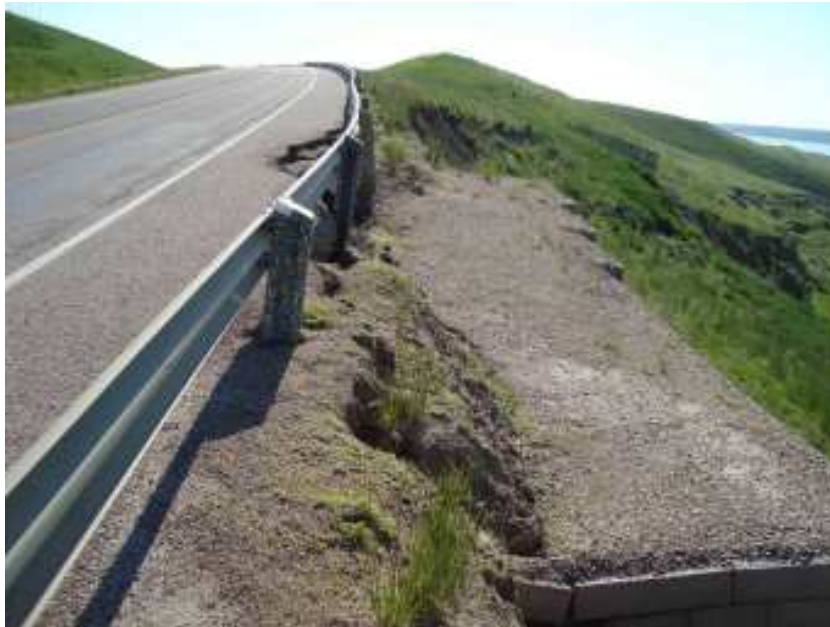
Photo S5-3 (top)

Slumping of the road surface has formed since 2009, likely due to the lack of support of the road edge due to the settled wall. Similar cracking and settlement was observed in this area prior to the construction of the wall in May 2008.

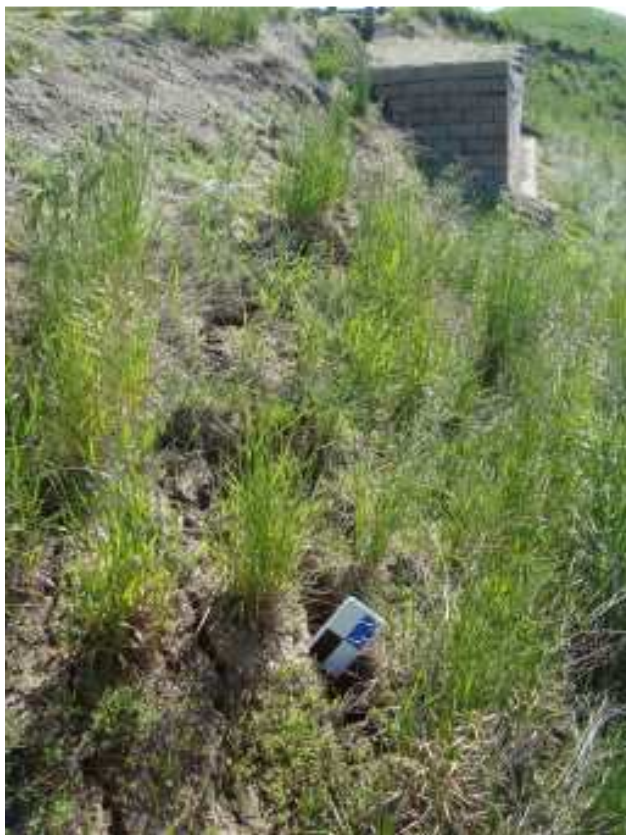
Photo S5-4 (bottom)

Tension cracks have formed in the area adjacent to the retaining wall. This area was regraded during the 2008 wall construction, and the cracks have formed since the 2009 site inspection. The crack is marked with the survey book in the foreground. The cracking indicates continued movement of the colluvium in the old landslide area.

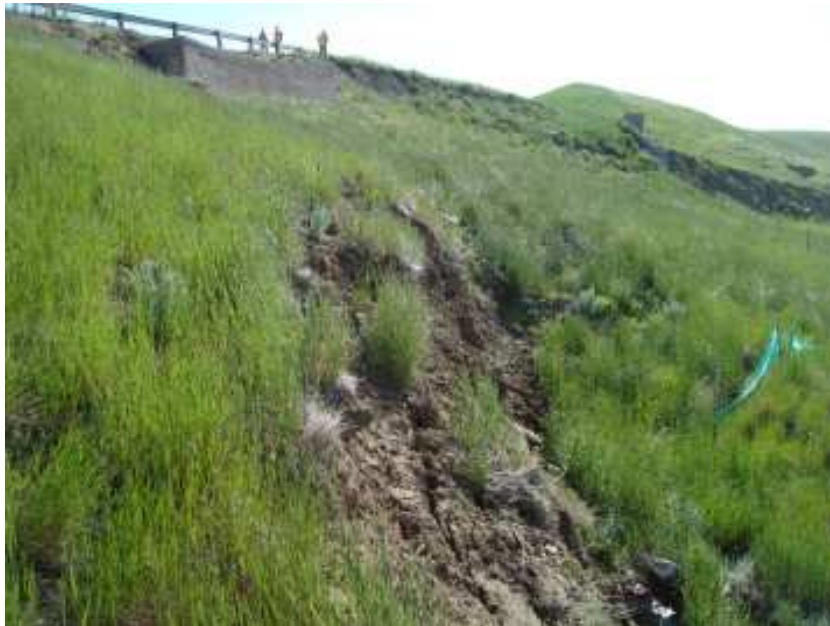
Photo S5-5 (top)
Scarp recently formed on the colluvium slide mass below the retaining wall indicates continued movement of the slide mass.

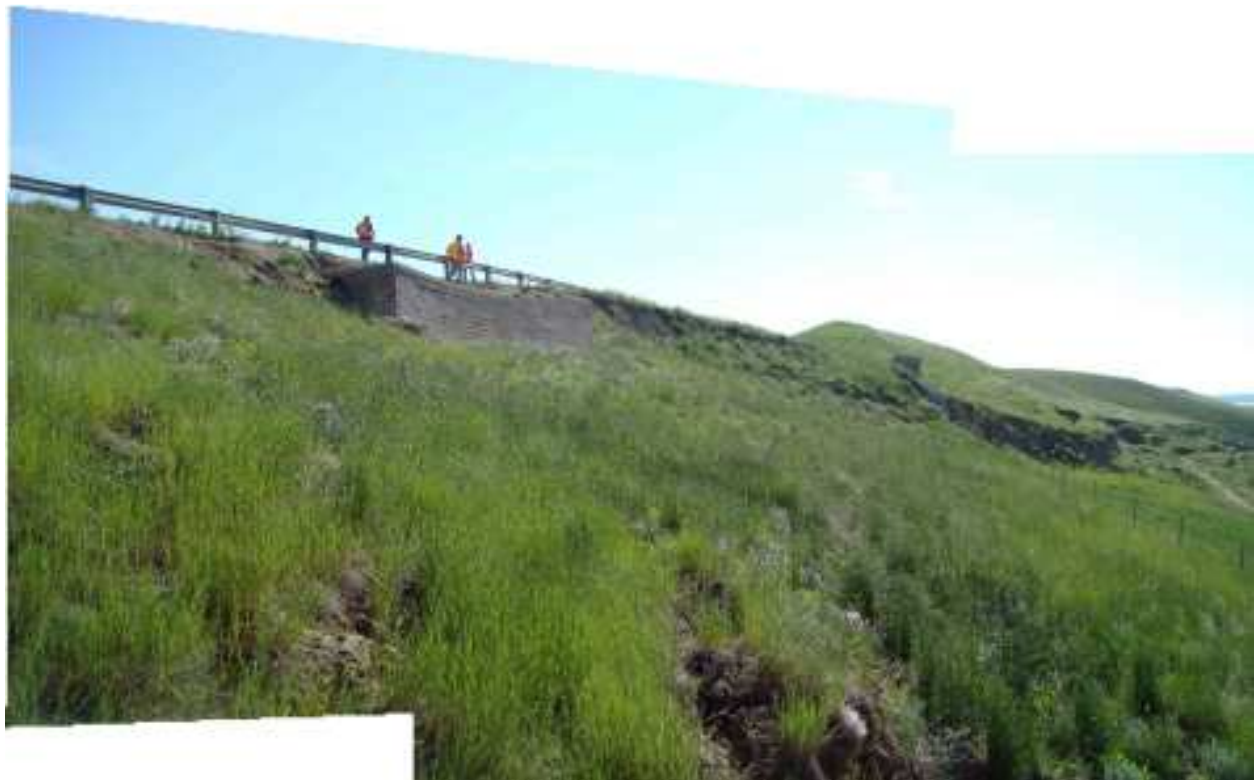
Photo S5-6 (bottom)
General view of the site area from below the retaining wall.
