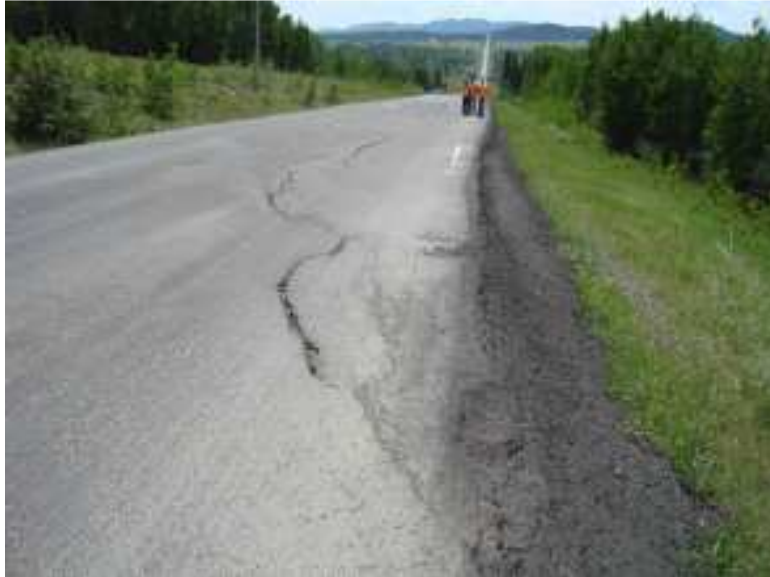
**Photo S8-1** – Looking southbound along the west edge of the road at the north end of the site area. The cracking in this area follows the same pattern as has been observed in past inspections. The continued settlement and successive overlays has resulted in the asphalt becoming very thick, with a steep drop at the edge of the road. This area may require a guardrail. These cracks are likely old and have been uncovered by the recent milling, however some settlement has continued since the milling.

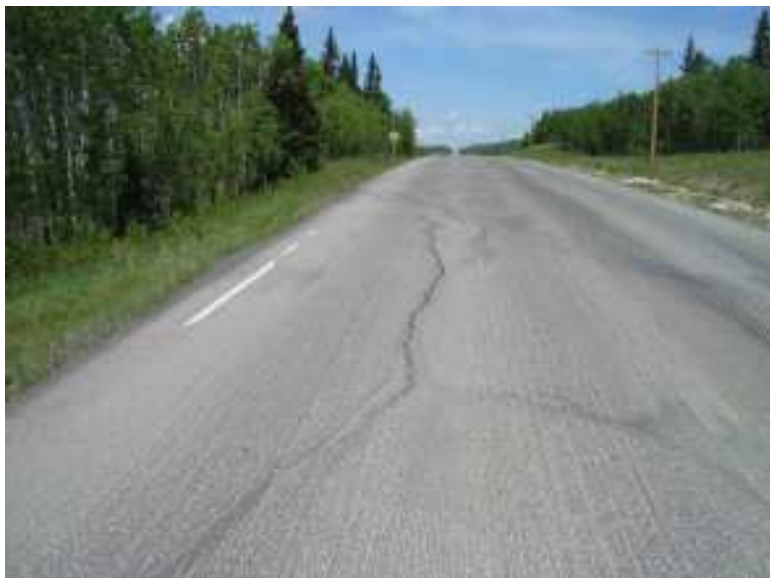
**Photo S8-2**– Looking northbound along the west edge of the road surface at the north end of the site. The road surface has been milled and this has revealed old cracks.

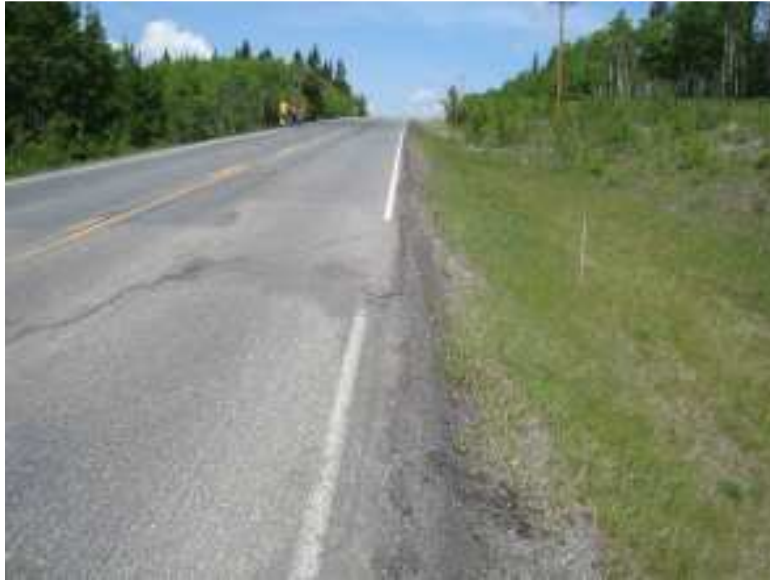
**Photo S8-3**– Looking northbound along the east edge of the road near the centre of the site. No significant change to the road condition since the 2009 inspection. The road surface has been milled and this has revealed old cracks.

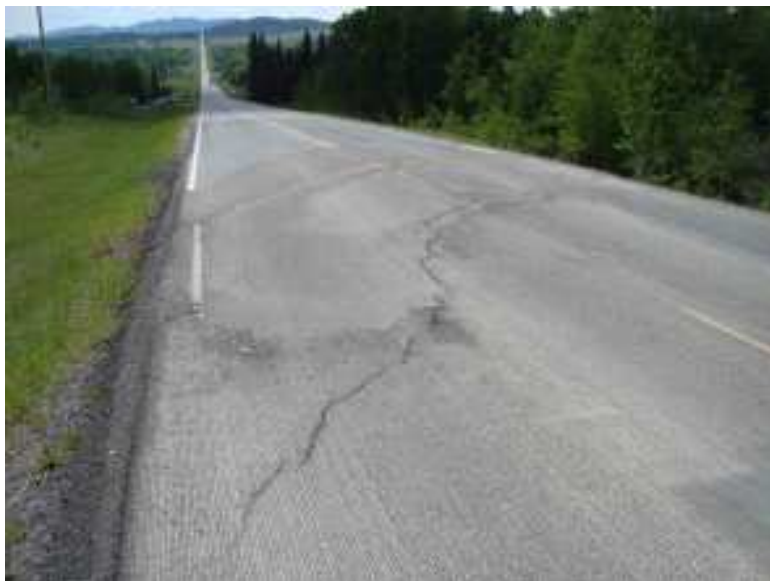
**Photo S8-4**– Looking southbound along the east edge of the road at the south end of the site. No change to the condition of the road since the 2009 inspection. The road surface has been milled and this has revealed old cracks.
