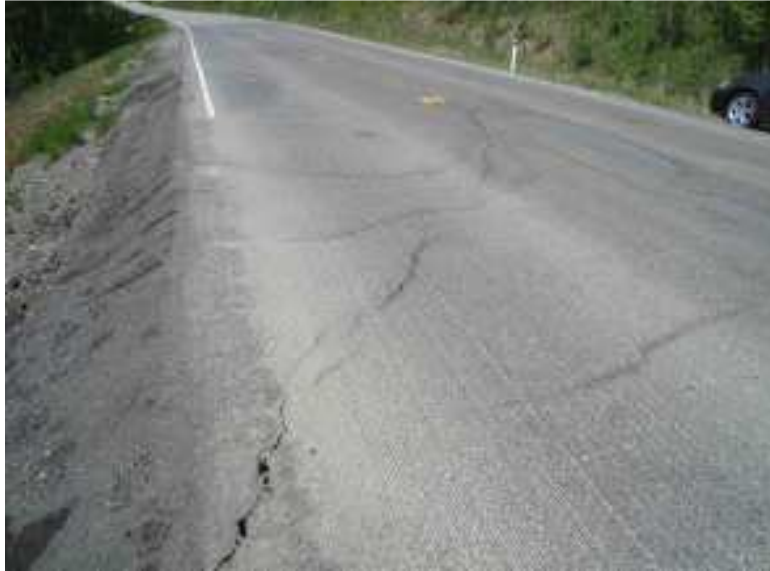
Photo S10A - 1 – Looking northbound from the south end of the site. The pattern and extent of the cracking in the road surface is similar to the conditions observed in 2009.

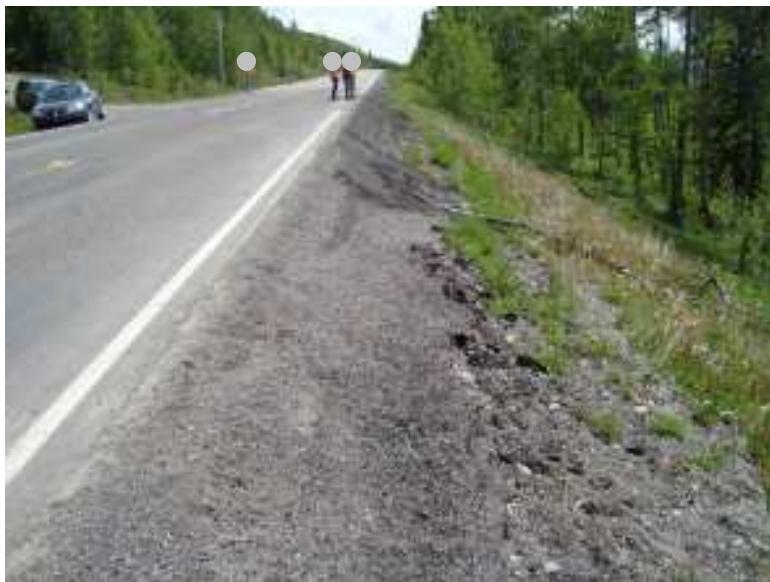
Photo S10A - 2 – Looking southbound from the north end of the site. Successive overlays have caused a steep drop to form at the edge of the road surface and have reduced the shoulder width. A guardrail may be required.
