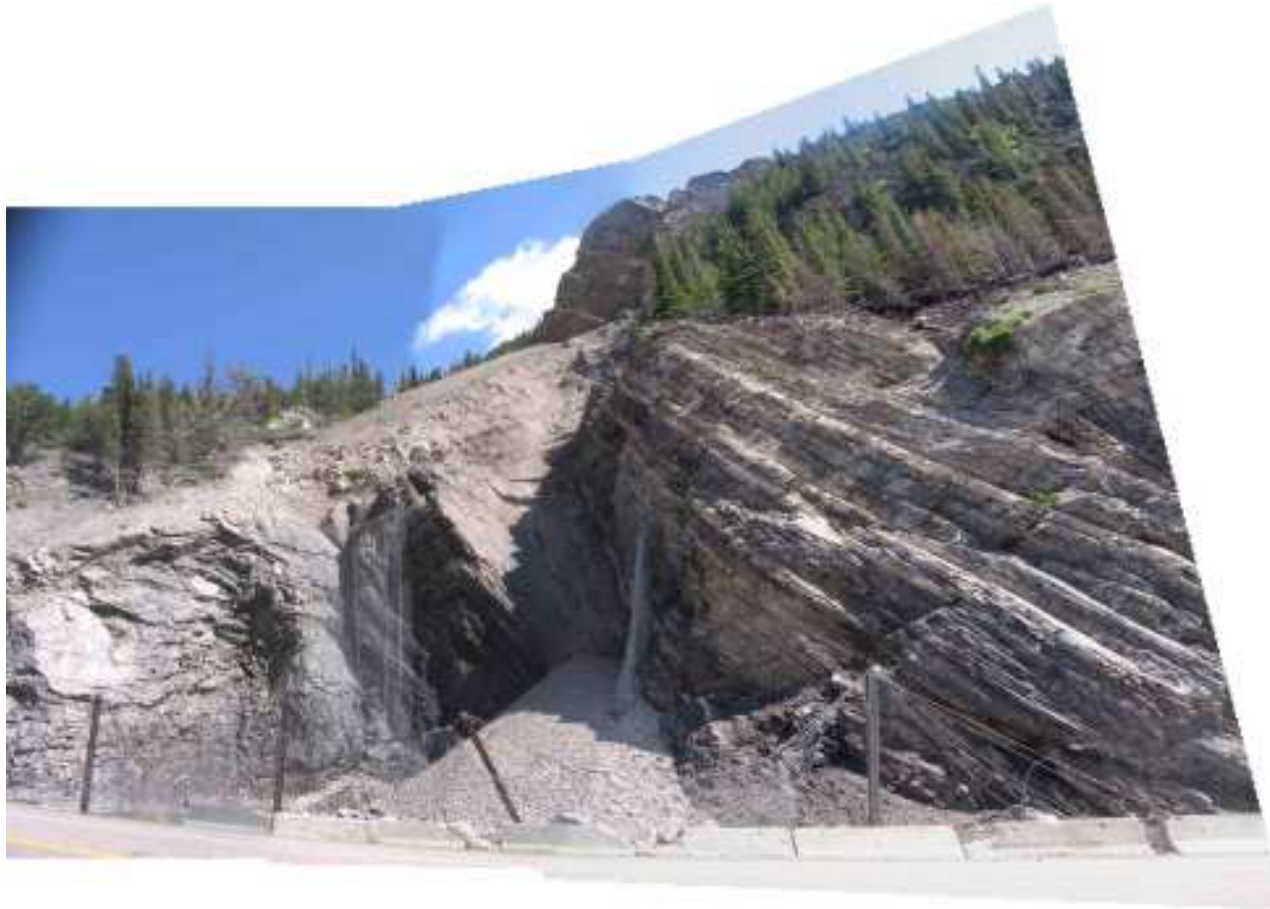
Photo S15-1 – June 2010

Looking south towards the barrier net and talus slope. The debris cone was large at the time of the inspection. The barrier net has been extensively damaged with several of the braking elements activated, and some of the post supports broken. The net is repairable, but is nearly ineffective in its current state.

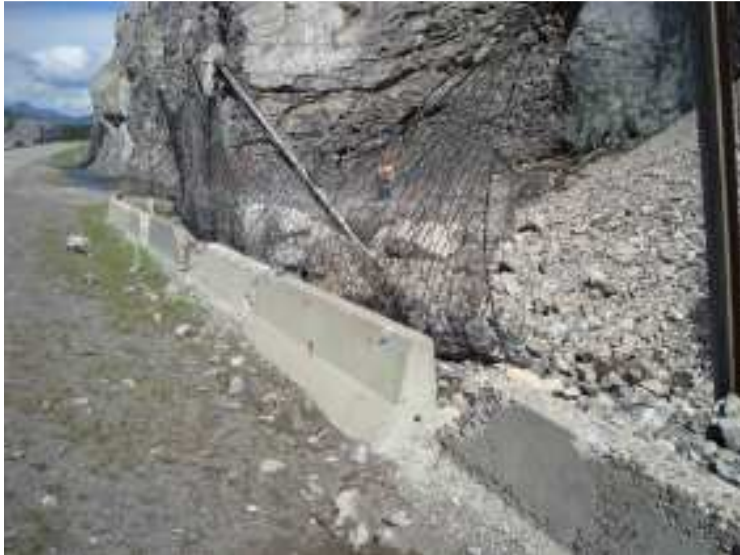
Photo S15-2 – June 2010

Looking east along the barrier net and jersey barriers. The large rocks that have come to rest behind the net have pushed the net outwards towards the road. The increased damage to the jersey barriers indicate that large rocks continue to strike the net and barriers. The rocks on the road shoulder indicate that gravel to cobble sized rocks are passing through or over the net, and possibly also landing on the road as well.

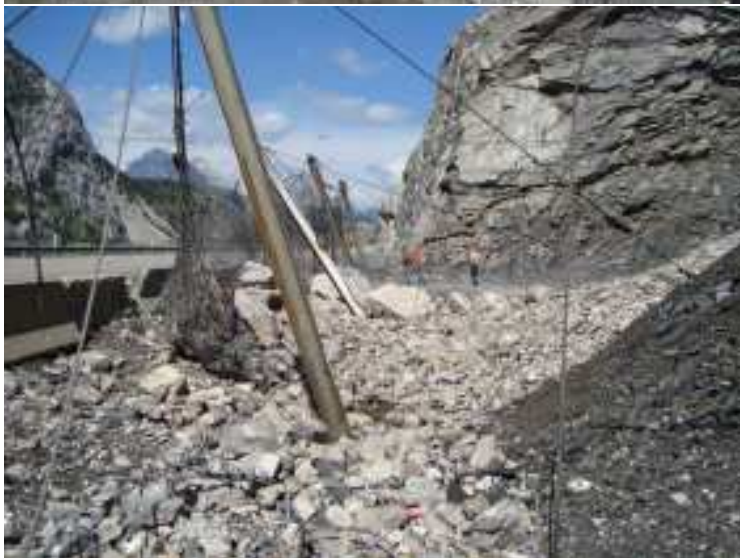
Photo S15-3 – June 2010

Looking east along the barrier net. Large rocks remain caught in the net and are pulling the net down reducing the effective height of the barrier.

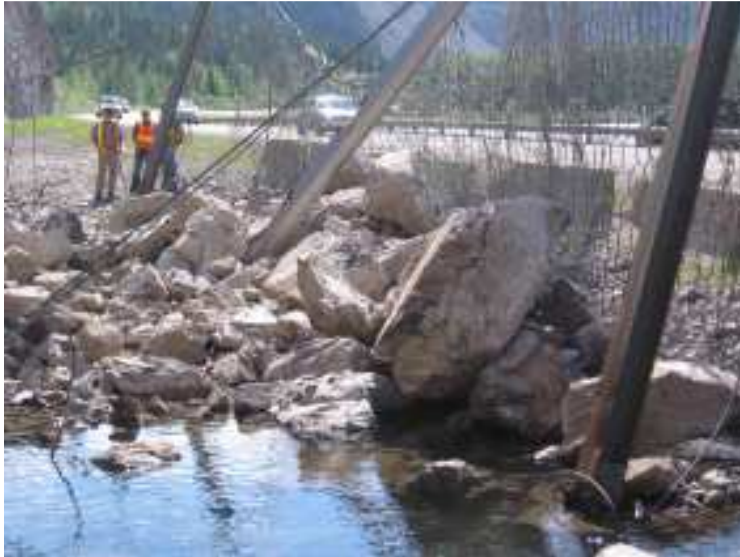
Photo S15-4 – June 2010

Looking west along the barrier net. The large rocks are up to 2.5 m³.

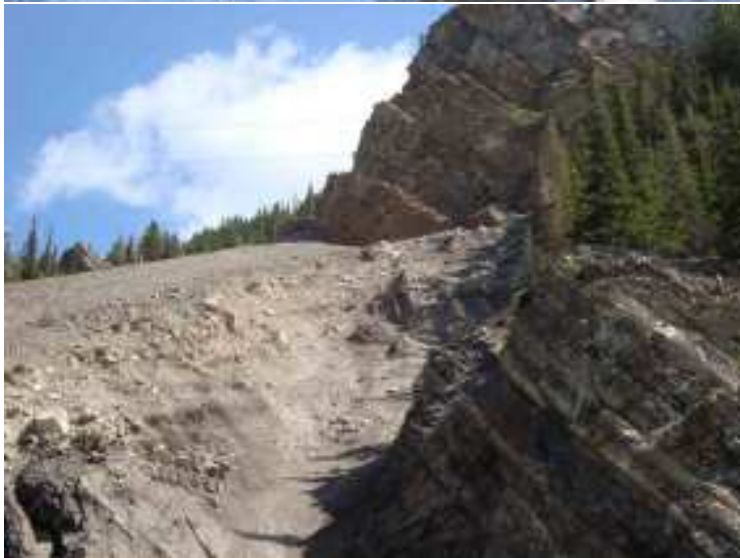
Photo S15-5 – June 2010

The upper gully in the talus slope has expanded towards the cliff face. The gully appears to have retrogressed slightly since the June 2009 inspection. Compare with Photo S15-6 from June 2009.

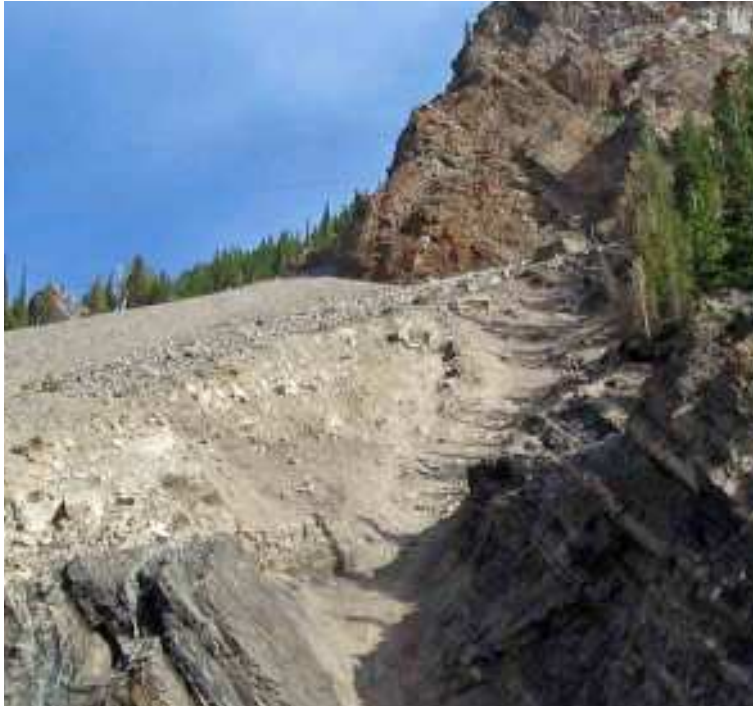
Photo S15-6 – June 2009

The upper gully as observed in June 2009.
Compare with Photos S15-5 from June 2010.
