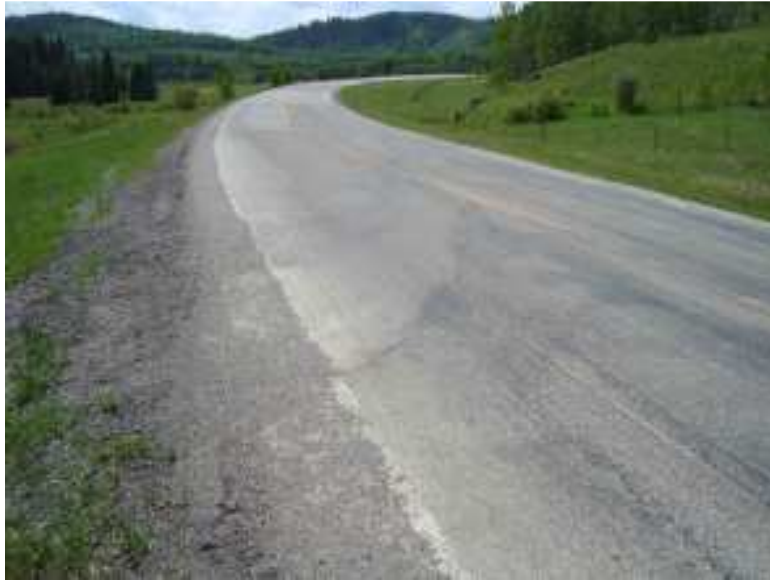
**Photo S22-1** – Looking northbound from the east end of the site. The road surface has recently been milled which makes it difficult to compare the condition at the time of the inspection to past observations. The pattern and extent of the cracks in the road surface are similar to what was noted in 2009.

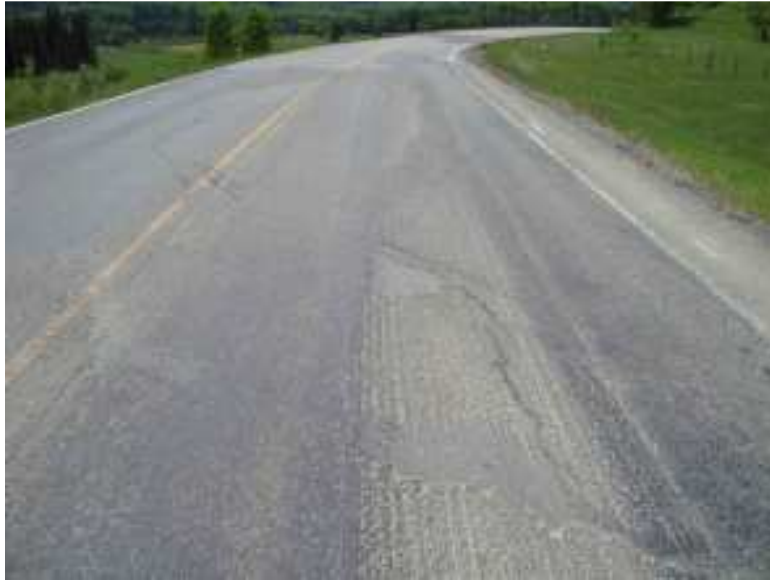
**Photo S22-3** – Looking northbound from near the west end of the site. The cracking that has formed since the milling (or was exposed by the milling), follows the same pattern as past observation .s
