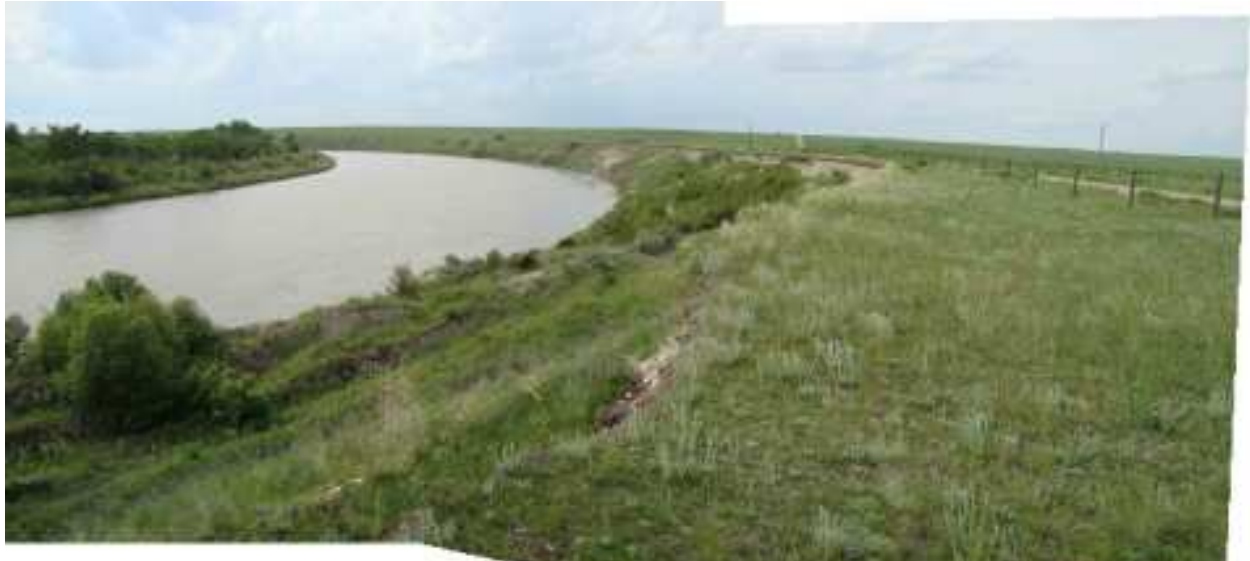
Photo S32-1 (top) – June 2010

Facing north towards the landslide area from the east slope crest. The site appears mostly unchanged from the 2009 inspection. The fenceline and highway are visible on the right hand side of the photo.

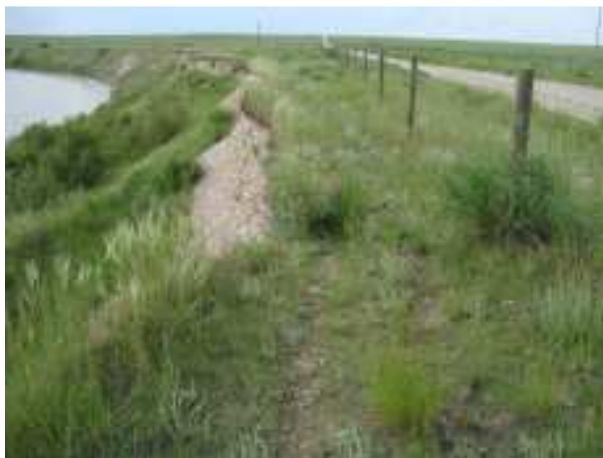
Photo S32-2 (bottom left) – June 2010

Facing north at the headscarp area where the slide is closest to the road. The scarp was approximately 1.7 m from the fenceline at the time of the inspection.

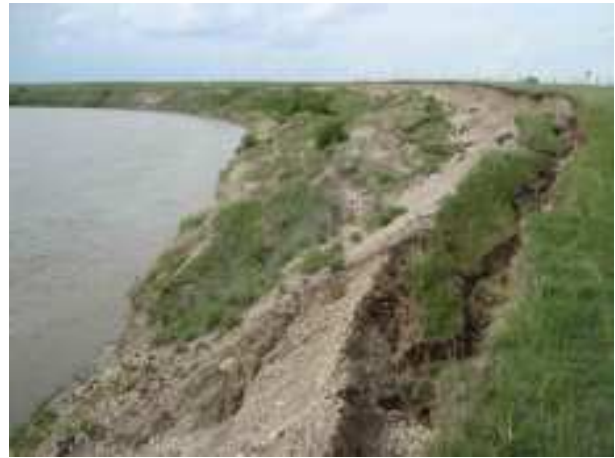
Photo S32-3 (bottom right) – June 2010

The scarp is continuing to retrogress, as indicated by the freshly slumped strip of soil with turf intact. This area is south from Photo S32-2 and further offset from the highway.
