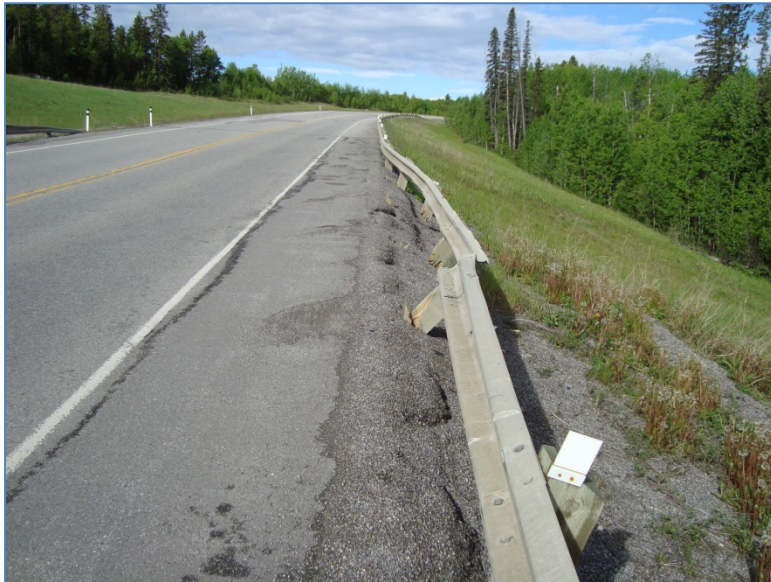
Photo S2-1 (June 2011) – Facing westwards along the downslope edge of the road along the pile wall area. Cracking in the road surface along the guardrail is present but covered with gravel and road debris. The road surface was in similar condition as was observed in 2010 and previous years. The guardrail was damaged due to a recent vehicle impact.

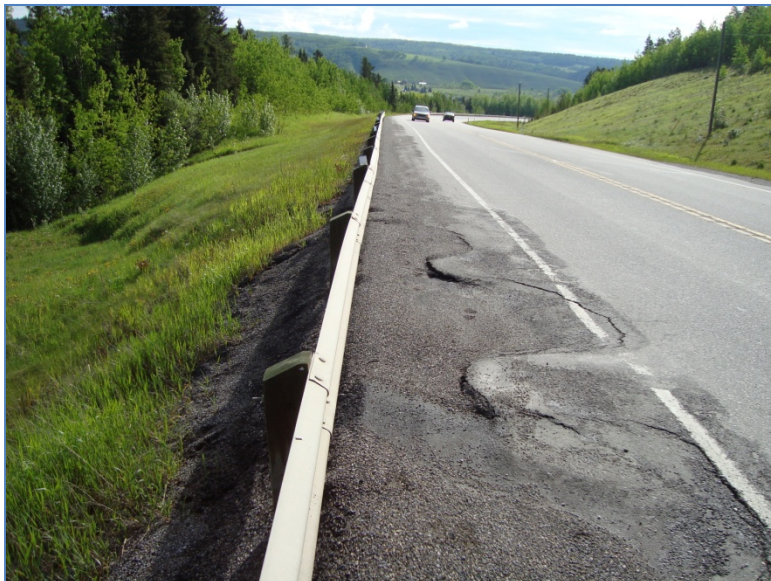
Photo S2-2 (June 2011) –Facing eastwards along the pile wall area. Cracking/settlement is visible up to the white line and the pattern of the cracking appears to delineate the existing pile wall.

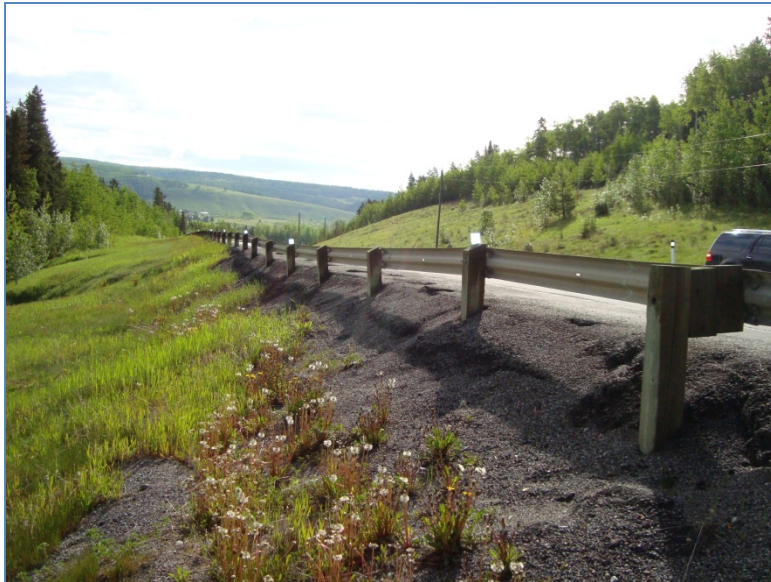
Photo S2-3 (June 2011) – Facing eastbound along the downslope shoulder of the highway from the west end of the landslide area. Settlement of the guardrail is visible in the area of the pile wall.

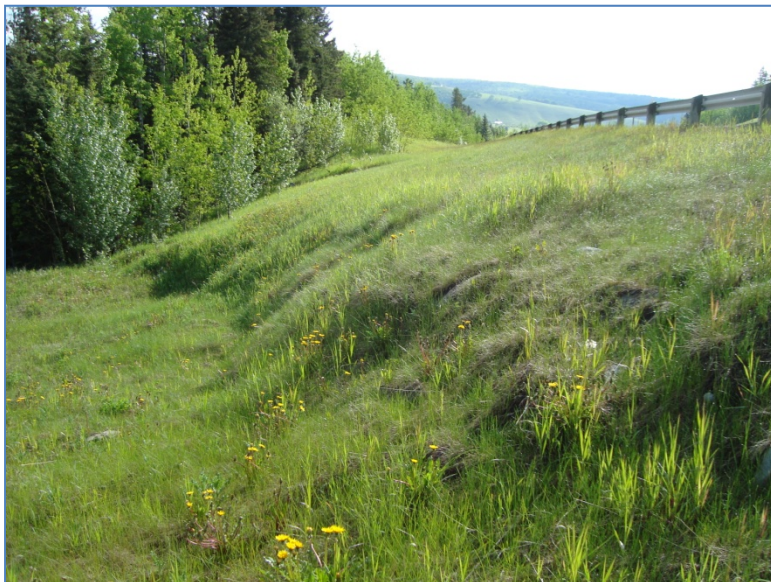
Photo S2-4 (June 2011) – Looking east at the slope below the highway in the landslide area. The slope appears to be in similar condition as was observed in 2010.
