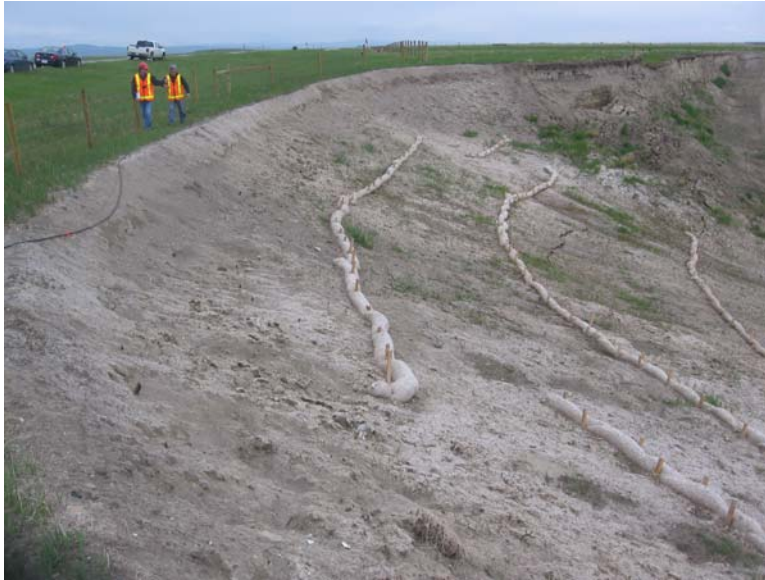
Photo S4-1 (June 2009) –
Facing north across the soil
nail repair area in 2009, for
comparison with 2011
conditions (refer to Photo S4-
2).

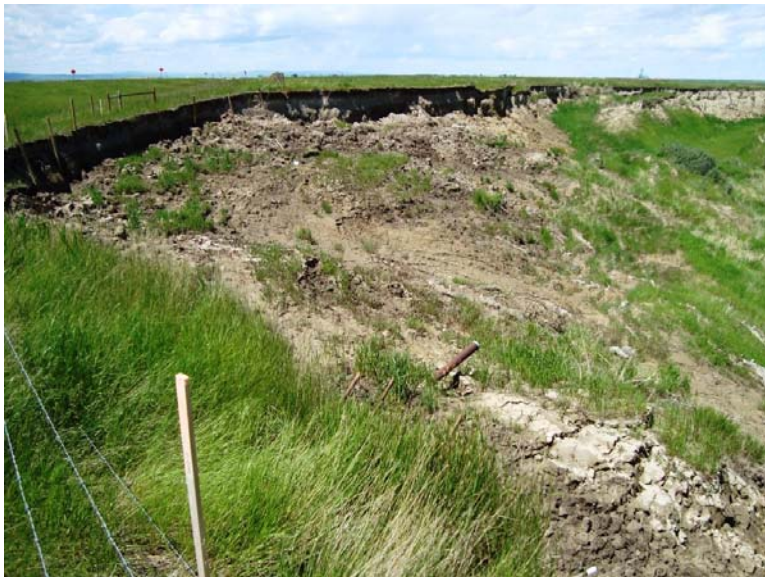
Photo S4-2 (June 2011) –
Taken from the same location
as Photo S4-1. Landslide
movement has been ongoing,
with continued retrogression
at the slope crest and
disturbance of the erosion
control and bioremediation
techniques by soil flows.

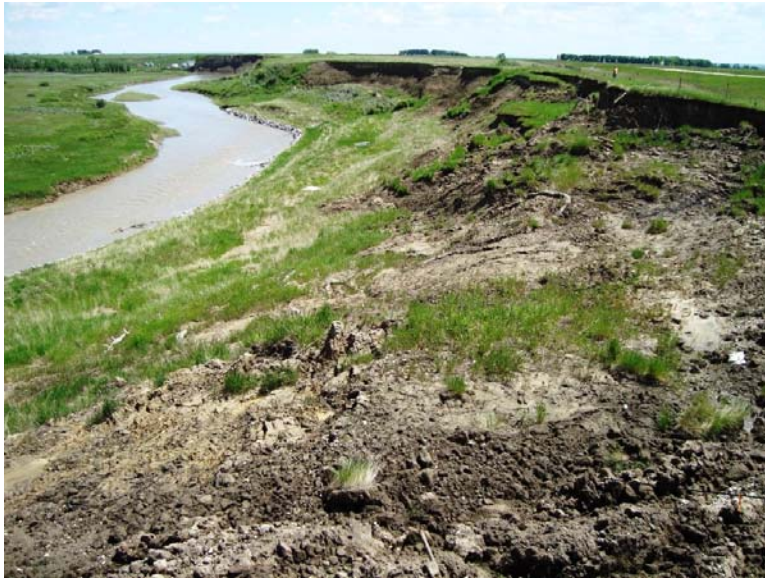
Photo S4-3 (June 2011) –
Facing south at the slide area.
Note the instability in the upper,
steeper portions of the slope.
Retrogression of the slide
continues to occur with large
blocks sliding down and adding
to the slide mass.

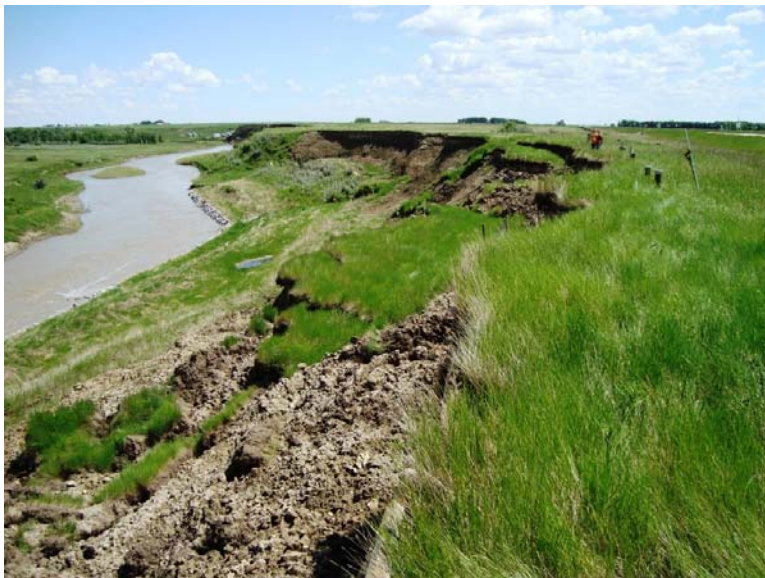
Photo S4-4 (June 2011) –
Facing south at recent
retrogressions of the slide scarp
where large blocks have
detached from scarp face. The
blocks detached in late 2010 to
early 2011.

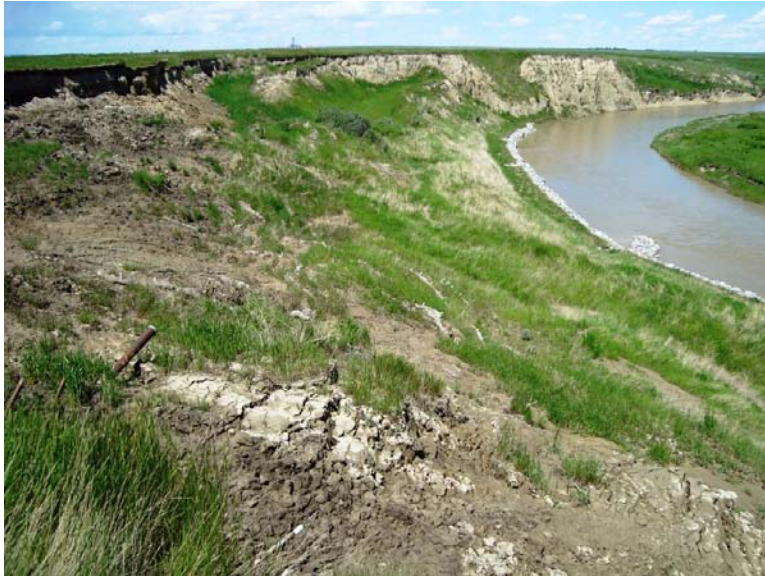
Photo S4-5 (June 2011) –
Taken from near the same location as Photo S4-6. Slide movement has continued in the upper slope. The vegetation cover has become well established on the lower slope. The bank protection remains in good condition.

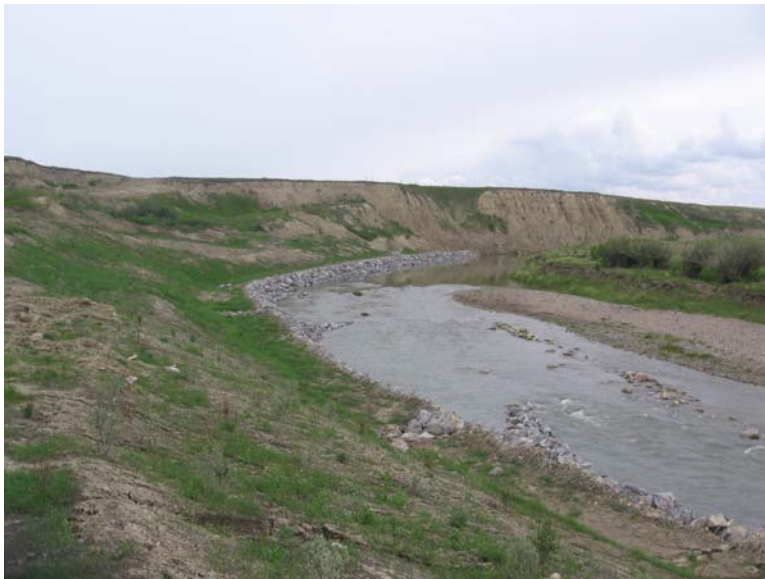
Photo S4-6 June 2009 –
A view of the site area from 2009, for comparison with Photo S4-5.
