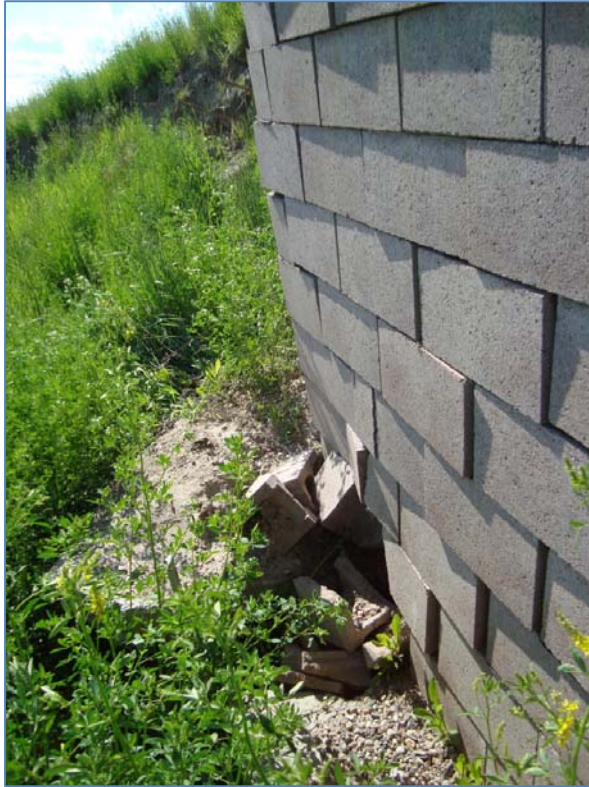
**Photo S5-1 – top – (June 2011)**  
The footing at the west end of the retaining wall has become undermined around the drainage pipe and cracking of the footing has occurred. The condition of the damage in this part of the wall has not changed significantly since the 2010 inspection.

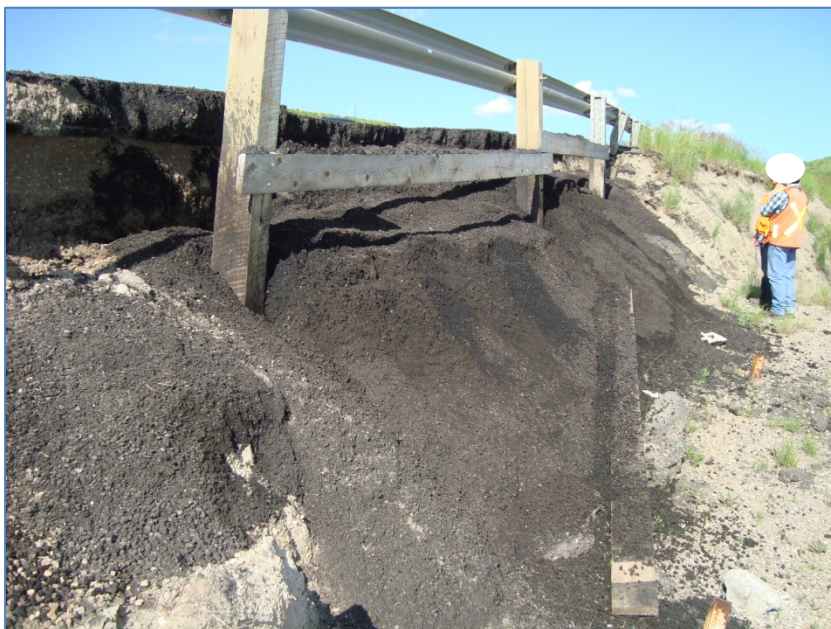
**Photo S5-2 – bottom – (June 2011)**  
Facing northeast along the top of the wall. The wall has settled approximately 2 m since construction due to ongoing slide movement. The guardrail posts are no longer properly supported.

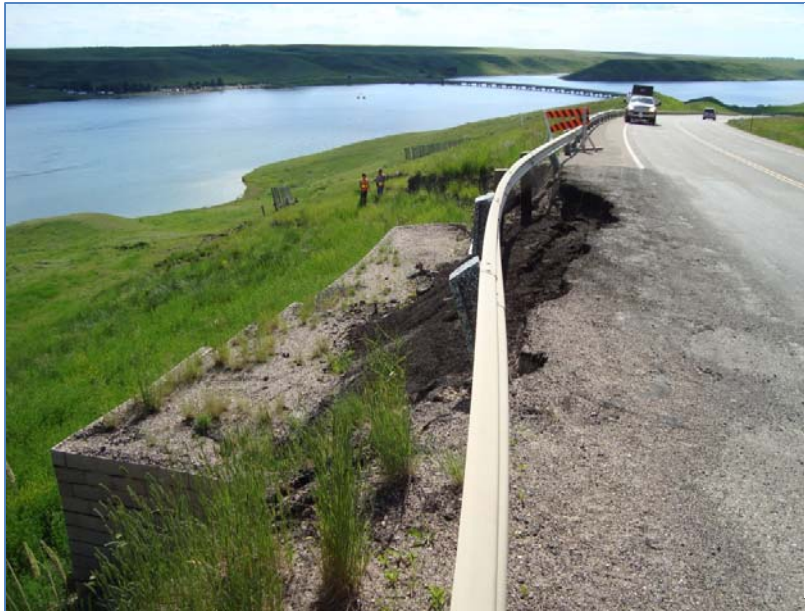
**Photo S5-3 – top - (June 2011)**  
Facing southwest at the retaining wall. The guardrail is visibly deflected, and the headscarp has retrogressed 1.3 m into the road surface.

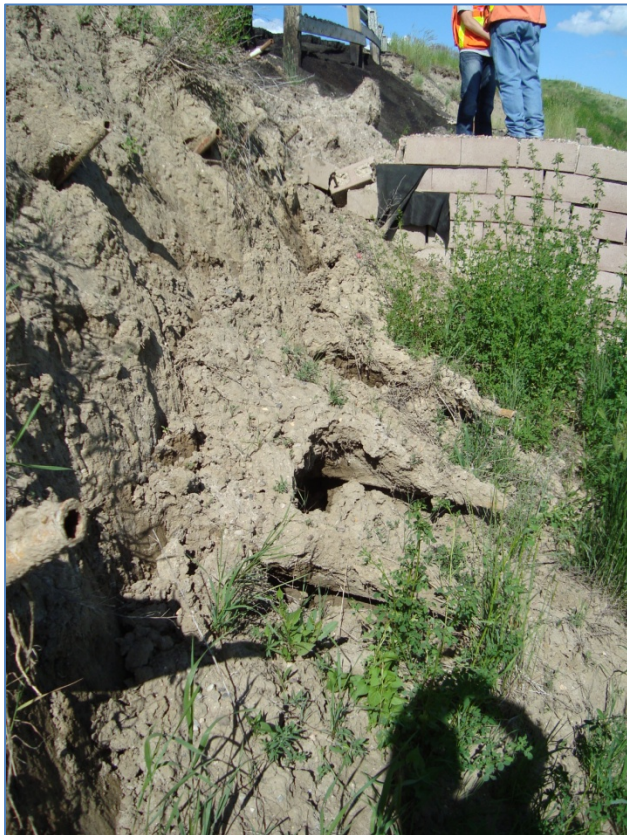
**Photo S5-4 – bottom – (June 2011)**  
Soil nails have become exposed at the headscarp.

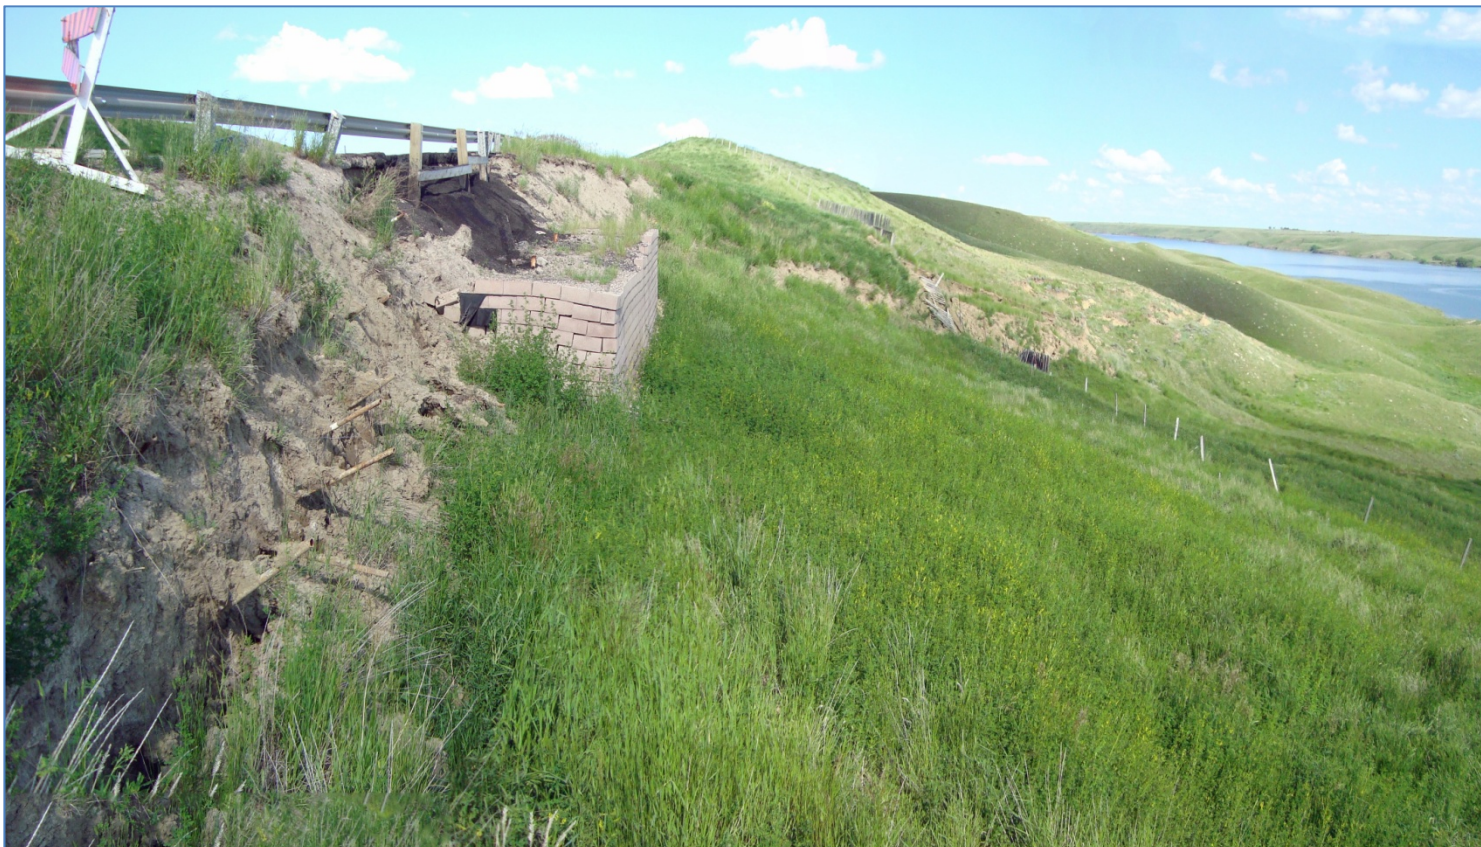
**Photo S5-5 (June 2011)**

A general view of the site area facing towards the east, illustrating the extent of the wall settlement and the exposed soil nails.

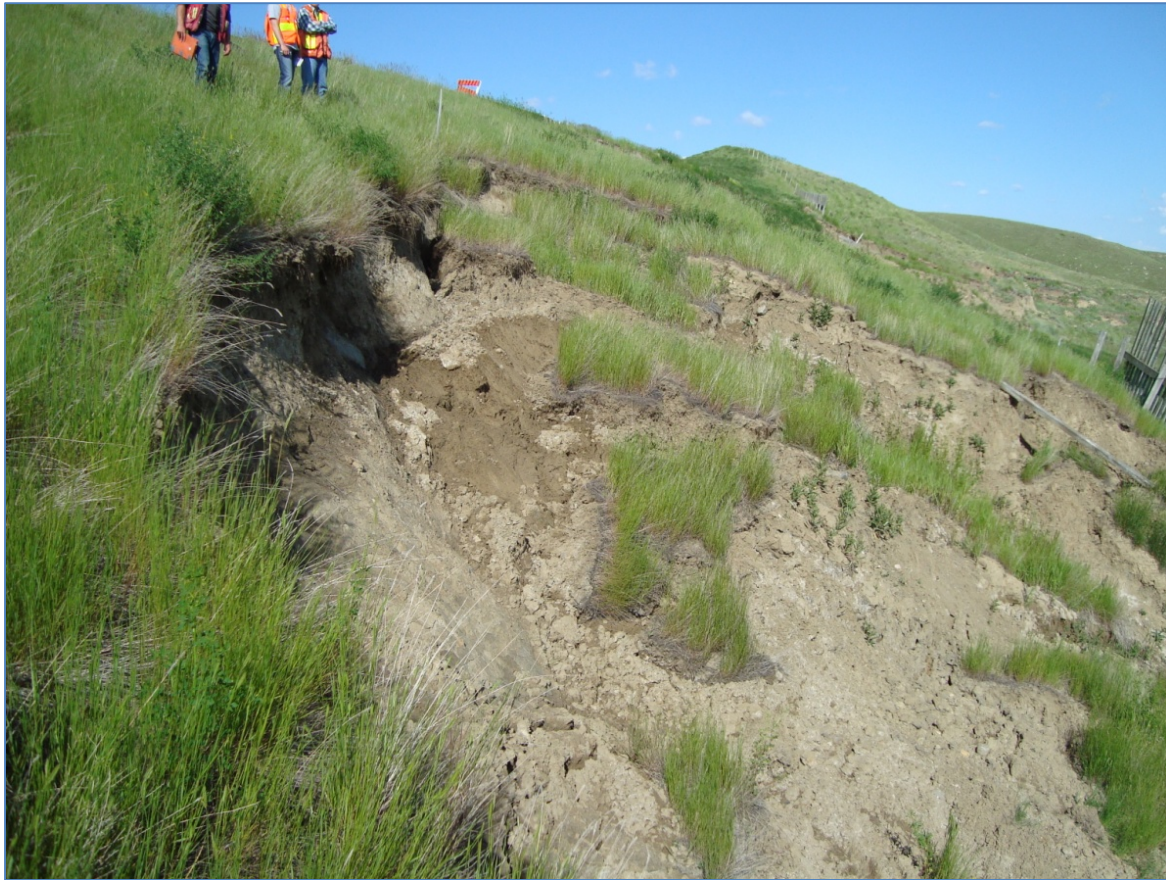
**Photo S5-6 (June 2011)**

A recently formed scarp noted on the slide mass to the west of the retaining wall. The scarp was not present during the 2010 inspection, and indicates that slide movement is ongoing.
