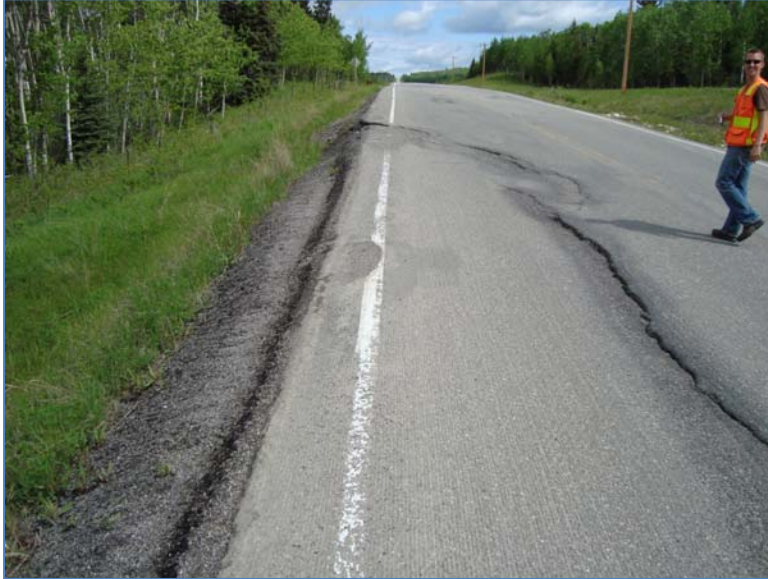
**Photo S8-1 (June 2011)** - Facing north along the west edge of the road surface at the north end of the site. This area had the most significant cracking at the site following a similar pattern as has been observed during previous inspections. The other areas of the site remained mostly unchanged since the previous inspection in June 2011.

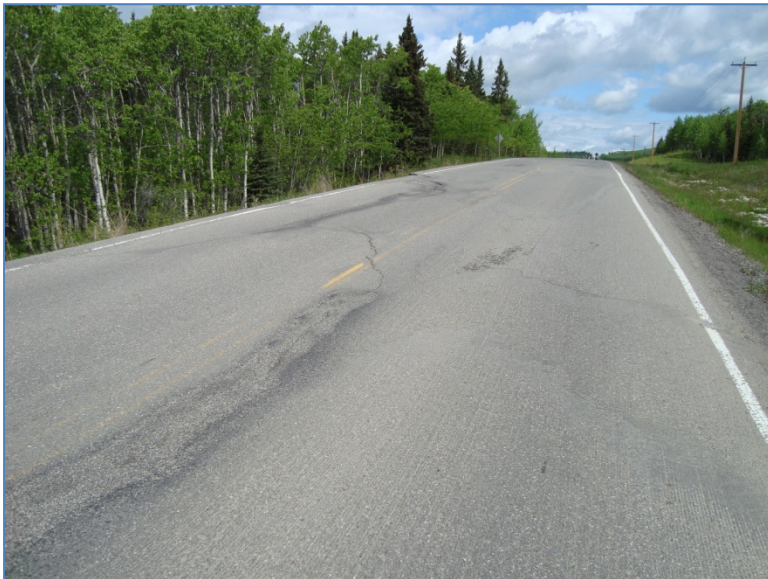
**Photo S8-2 (June 2011)** – Facing north from the middle of the site. The cracks in the road surface are relatively minor, and follow a similar pattern as has been observed during past inspections.
