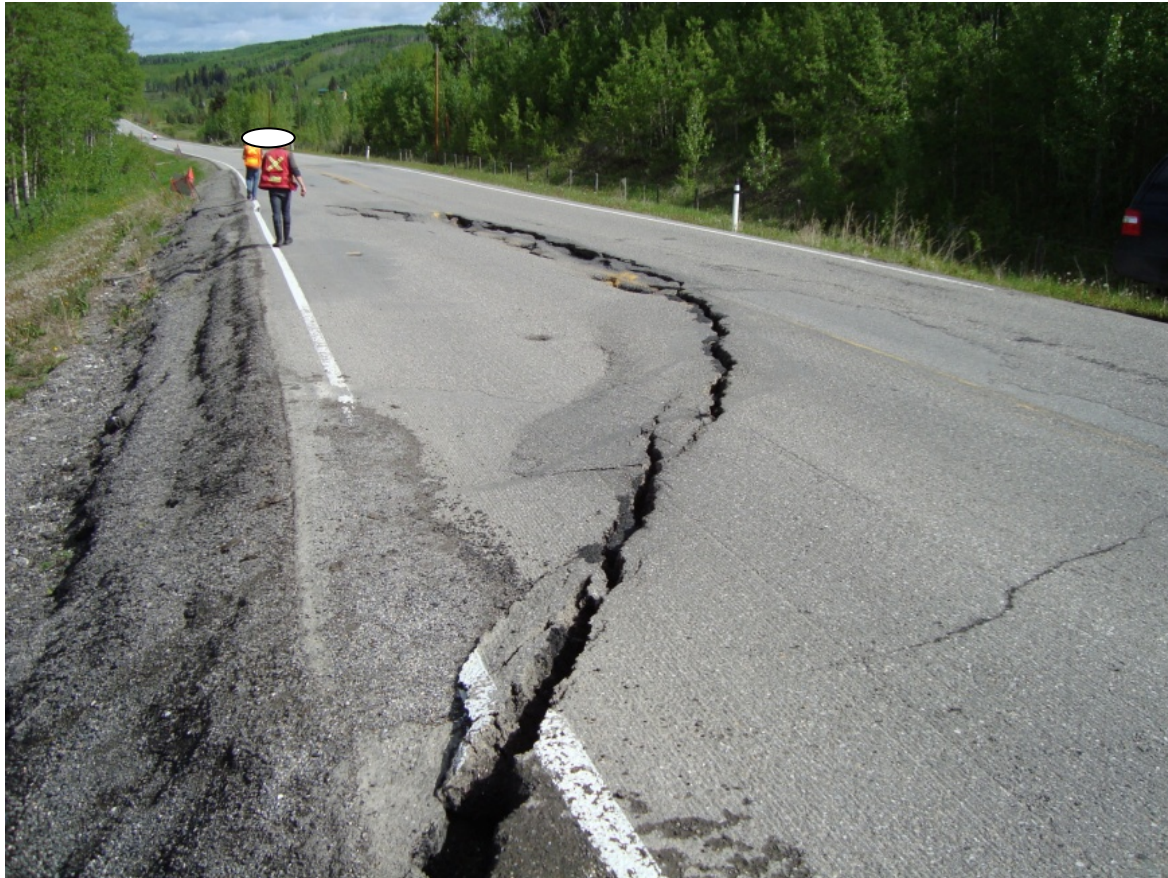
Photo S10A - 1 (June 2011) - Facing north from the south end of the site. The pattern of the cracking in the road surface is similar to the conditions observed in 2010; however, the magnitude of the vertical settlement and crack aperture has increased in comparison to the conditions during previous inspections.
