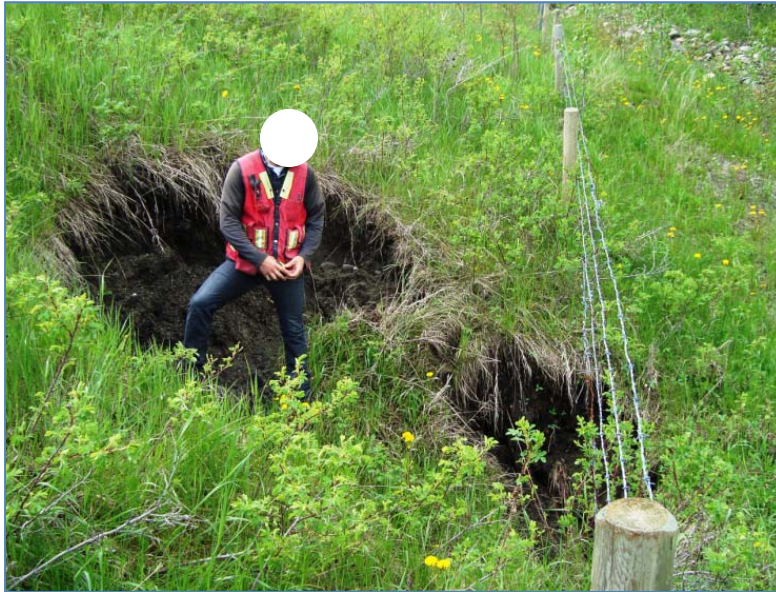
**Photo S10(C)-1 (June 2011)**

Facing south at the sinkhole formed over the culvert in the west ditch. The sinkhole has expanded in size since it was first identified in 2007.

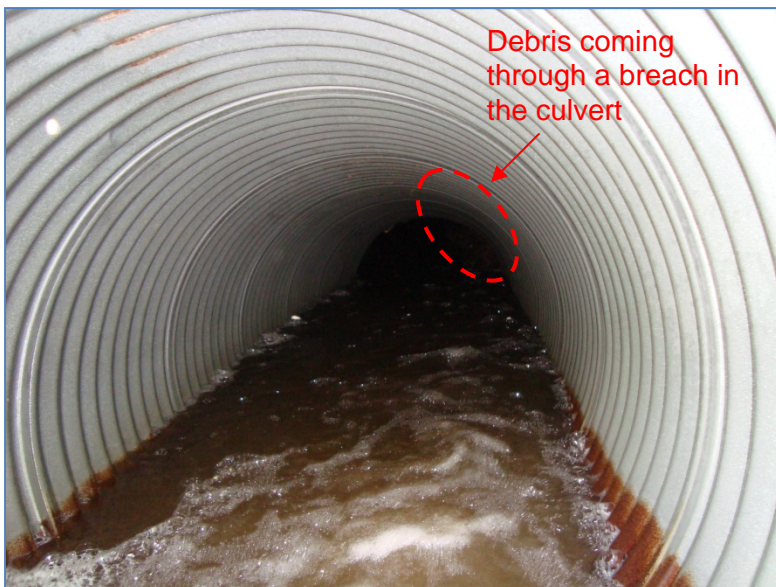
**Photo S10(C)-2 (June 2009)**

Facing downstream from the culvert inlet, with soil debris from the sinkhole coming through a breach in the top of the culvert faintly visible in the right background.

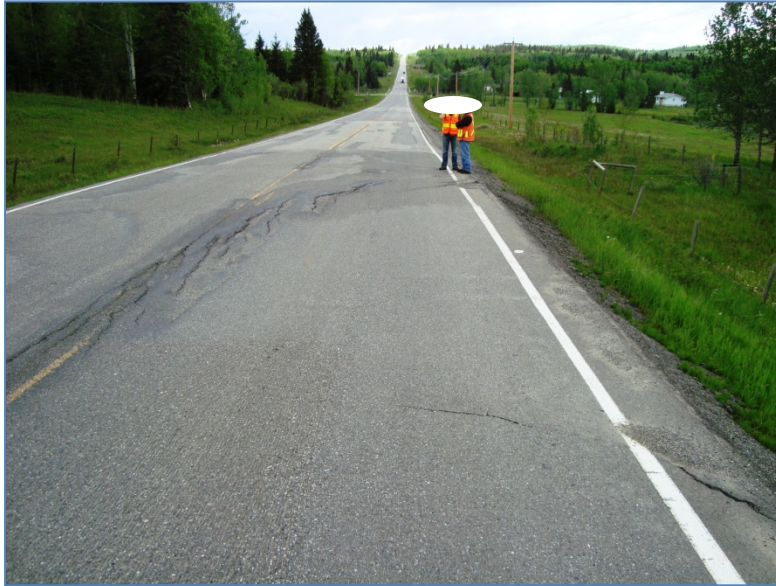
**Photo S10(C)-3 (June 2011)**

Facing north across the cracking and settlement area of the northbound lane that has formed through repeated overlays since 2003.

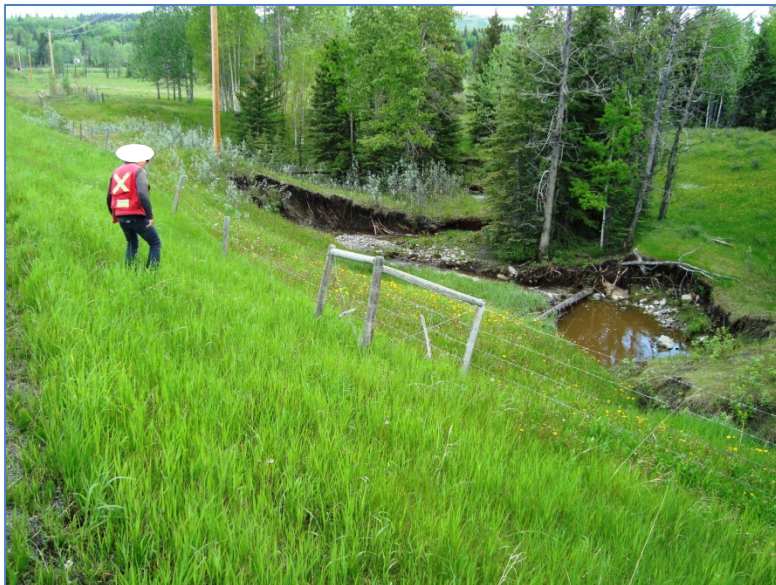
**Photo S10(C)-4 (June 2009)**

Facing towards the creek channel downstream of the road culvert (northeast). The creek channel and bank are in approximately the same condition as was observed during the 2008 and 2009 inspections.

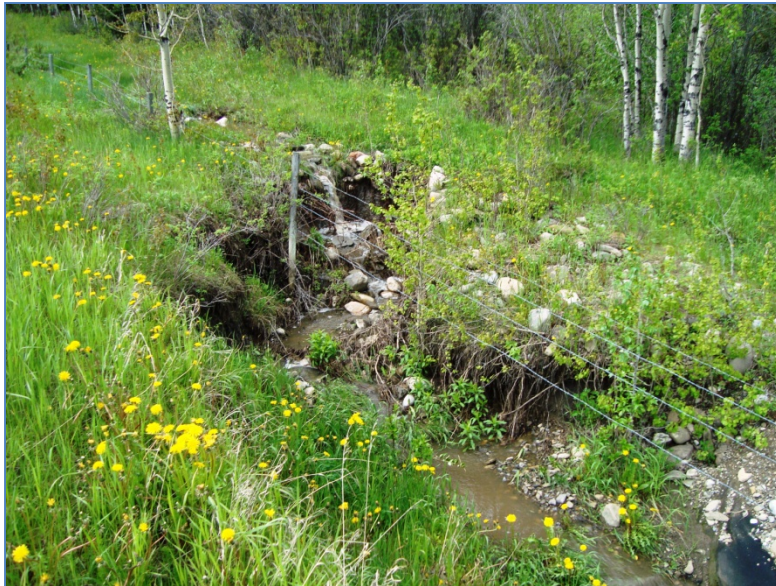
**Photo S10(C)-5 (June 2011)**

Facing upstream (southwest) at the west ditch. Note the erosion damage that has apparently worsened in recent years.
