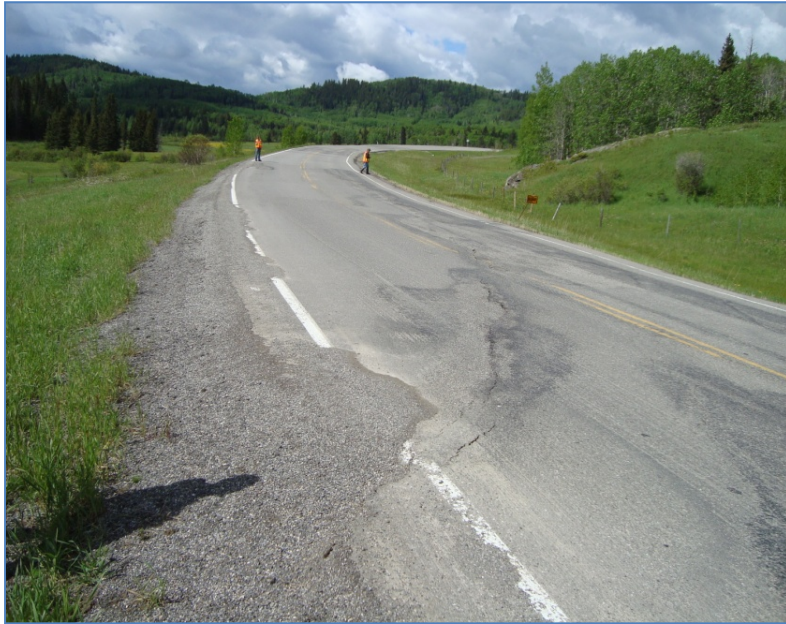
**Photo S22-1 (June 2011)** - Facing west (along the southbound lane) from the east end of the site. The pattern and extent of the cracks in the road surface are similar to what has been noted during past inspections.

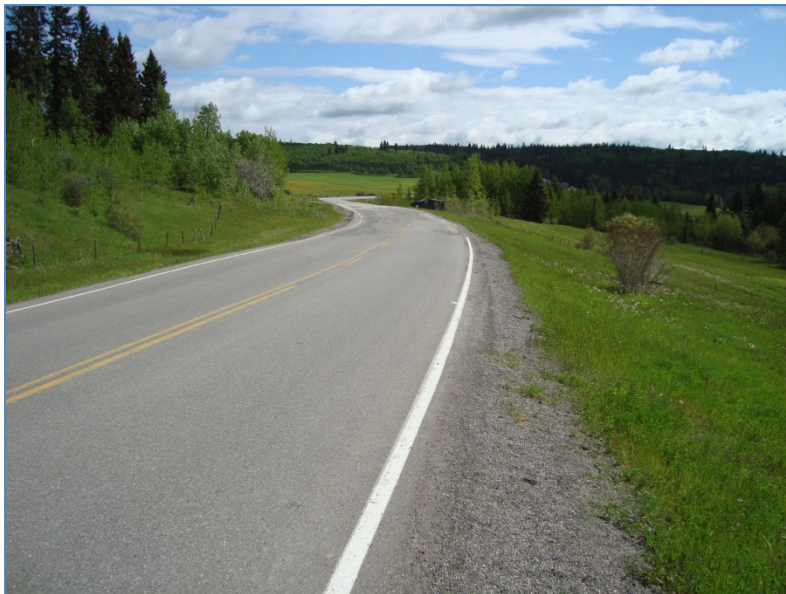
**Photo S22-2 (June 2011)** - Facing east (along the southbound lane) from the west edge of the site. The damage to the road surface is similar to that noted in past inspections.
