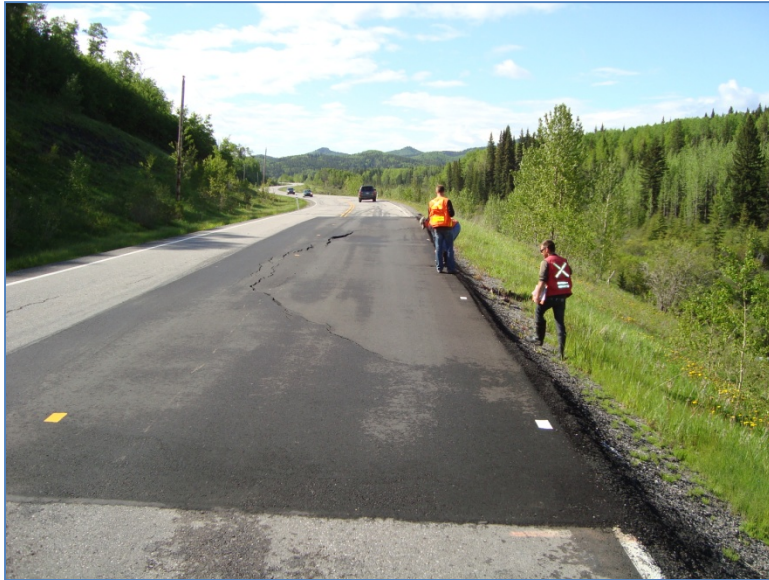
Photo S31-1 (June 2011)
Facing south from the north end of the site. Cracking has developed through the recent overlay patch in a nearly continuous arc formed through the site area. This is the same pattern and extent of cracking noted during previous inspections.

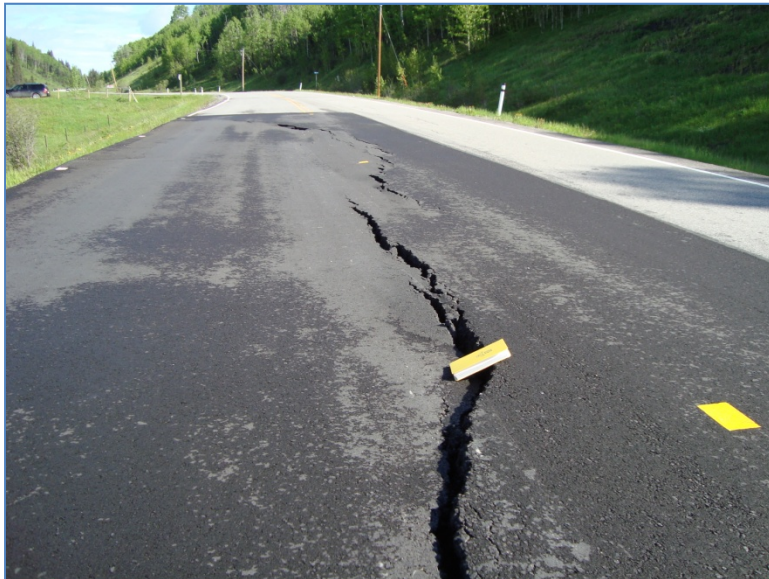
Photo S31-2 (June 2011)
Close-up view of the cracking taken from the south facing north. The cracking has greater aperture and down-drop than the cracking measured during the previous inspections.

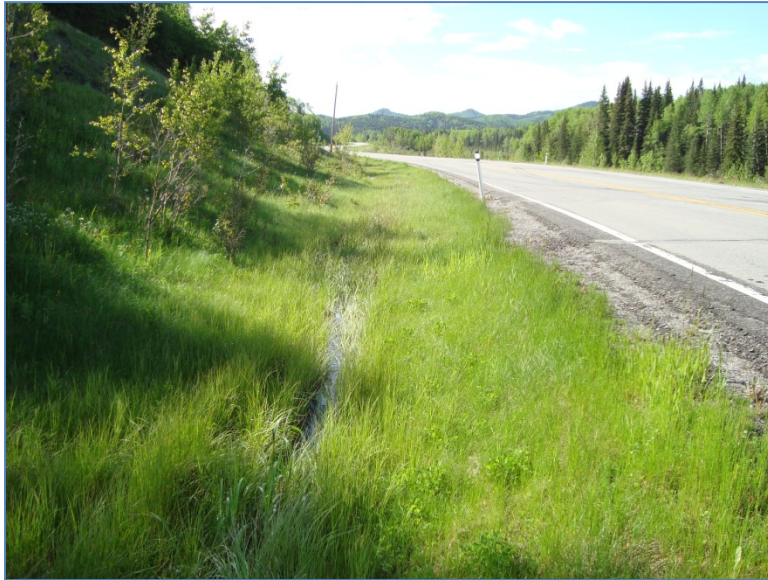
Photo S31-3 (June 2011)

The upslope ditch above the site was noted to be wet and draining very slowly to the south. There was no flow observed at the culvert outlet on the west side of the embankment. The culvert inlet is not visible along the ditch and appears to be buried.
