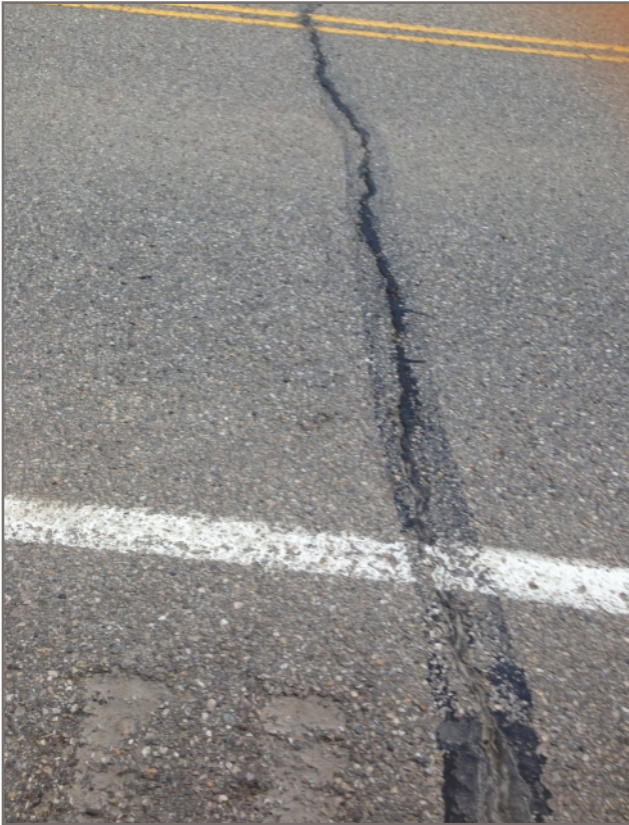
**Photo 1:** Pavement cracking at east flank of the slide area sealed in 2010

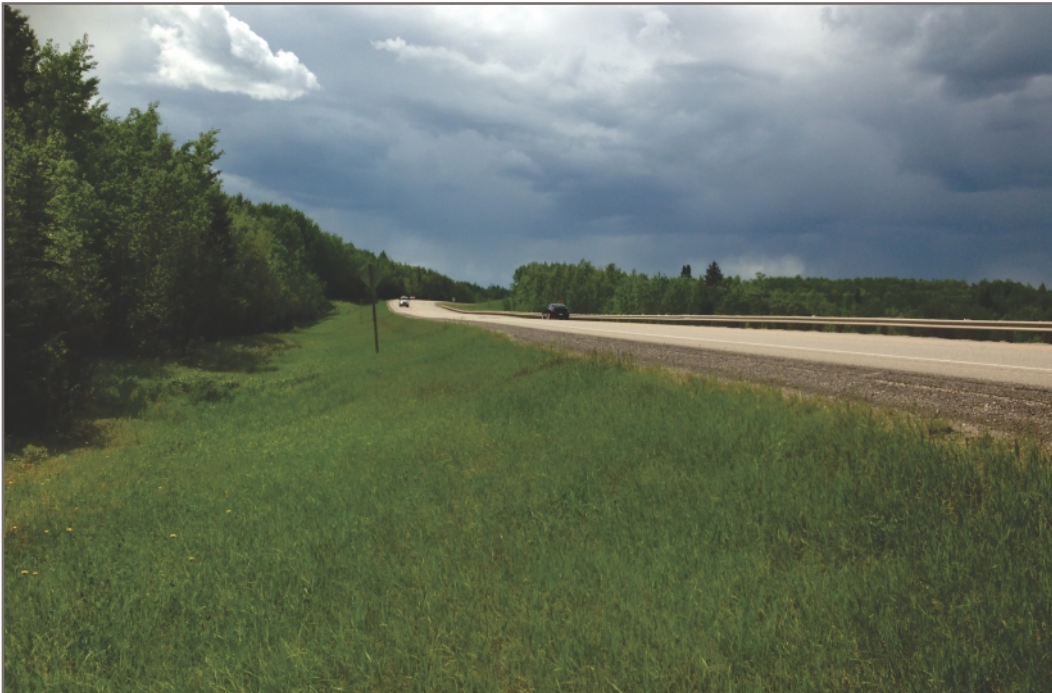
**Photo 2:** Pavement dip in Hwy 39:02 near west flank of slide

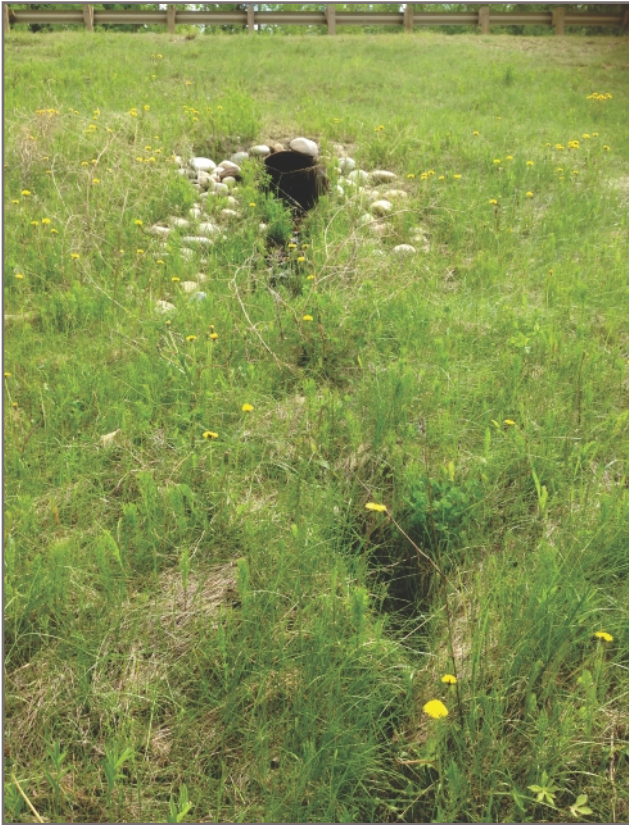
**Photo 3:** Sparse riprap armoring at east culvert outlet

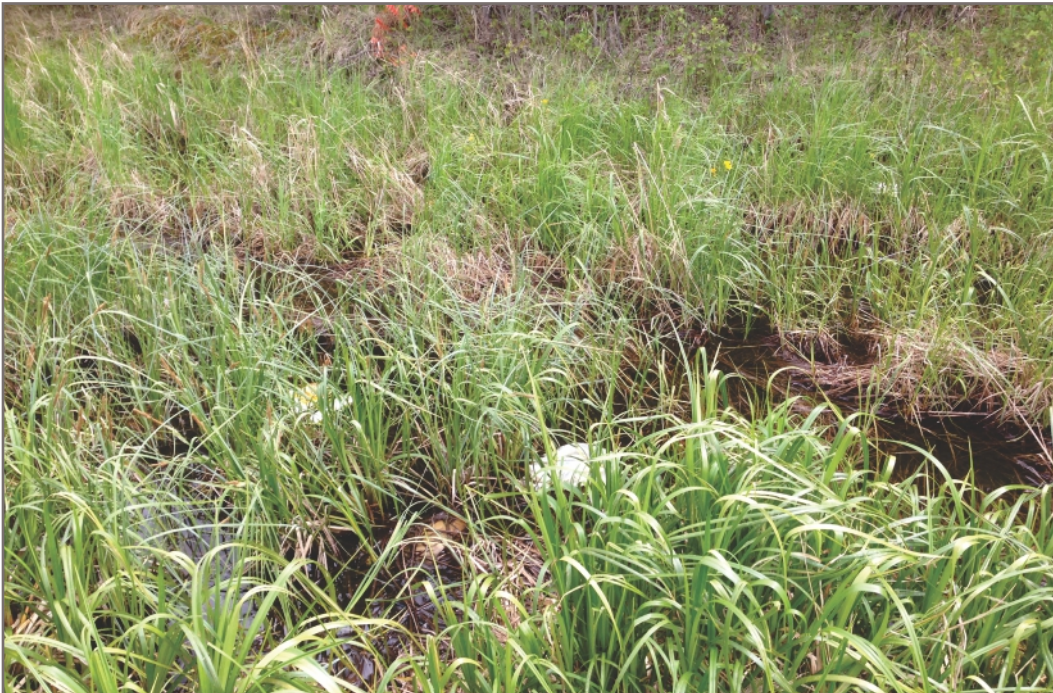
**Photo 4:** Inlet of east culvert above base of ditch leading to ponding

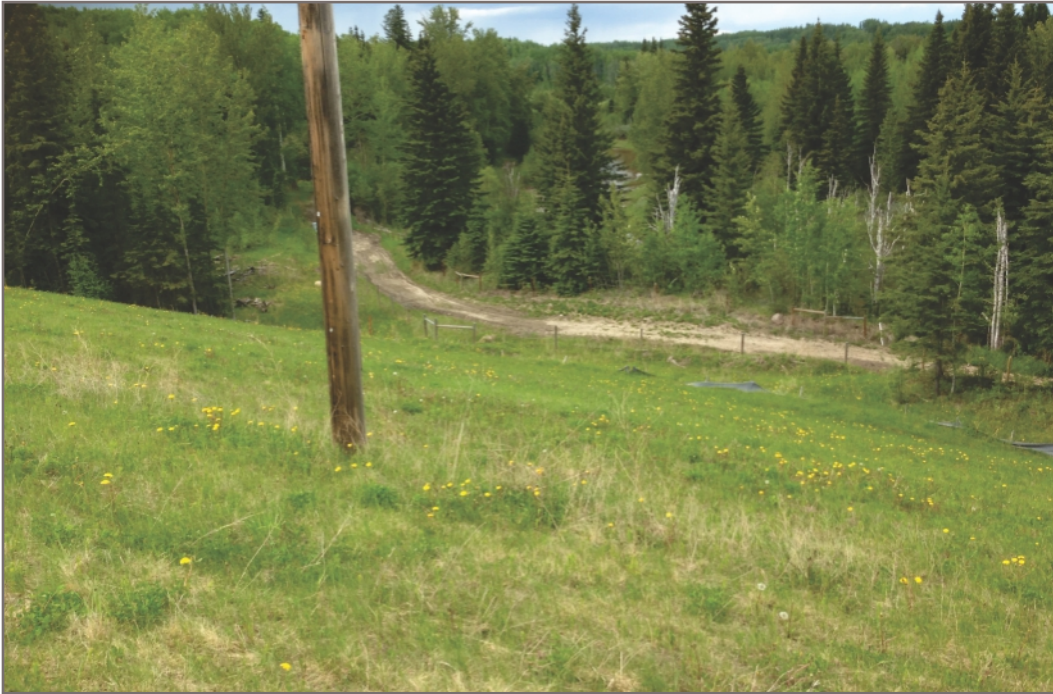
**Photo 5:** North sideslope well vegetated

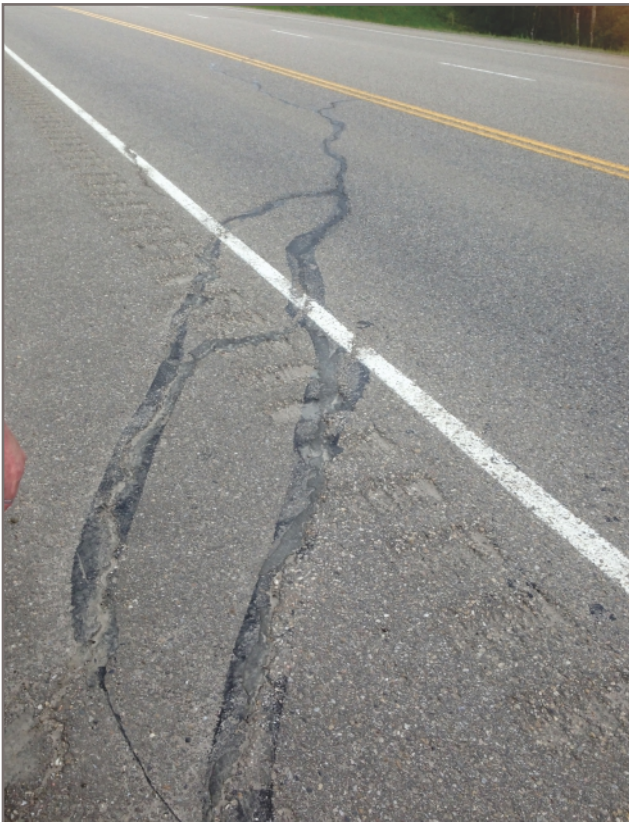
**Photo 6:** Pavement cracking at west flank of slide sealed in 2010

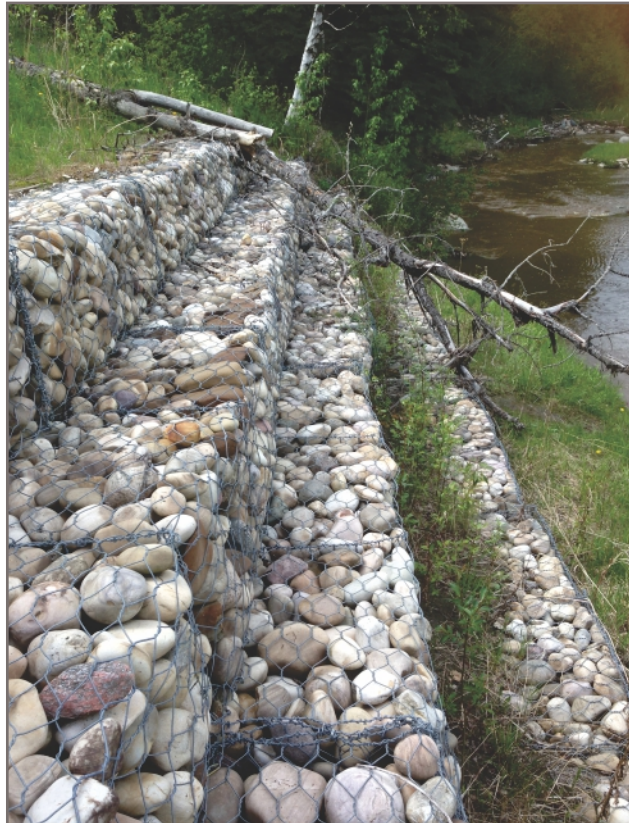
**Photo 7:** Modeste Creek at toe of sideslope protected from erosion with Gabion baskets
