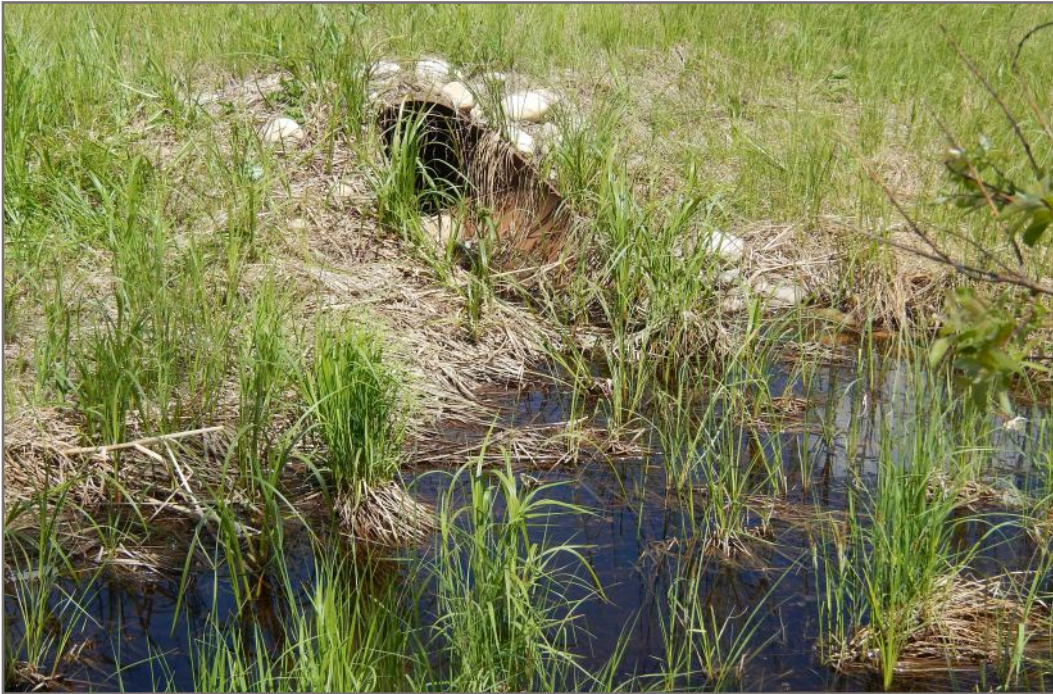
**Photo 1:** Inlet of east culvert above base of ditch leading to ponding

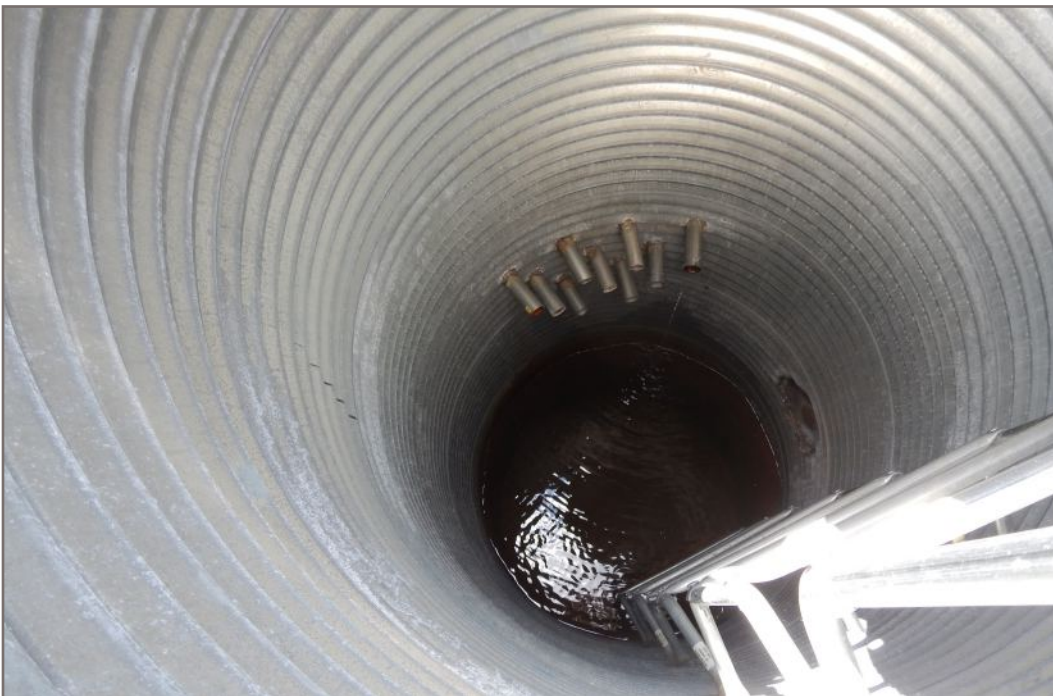
**Photo 2:** East drainage gallery - one of nine drains in operation

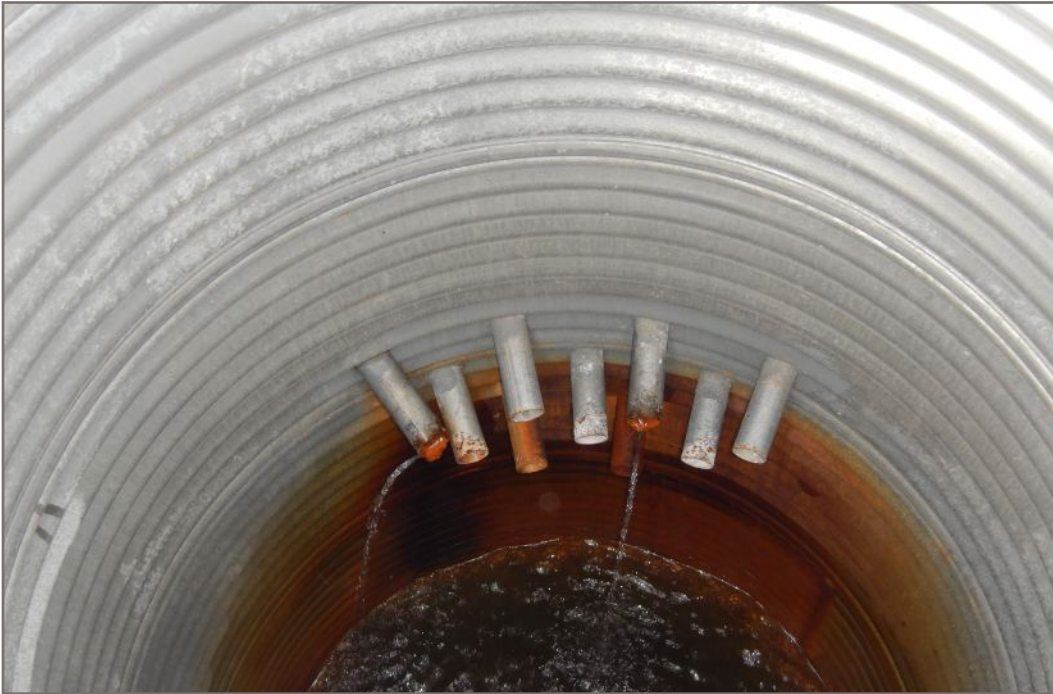
**Photo 3:** West drainage gallery - two of nine drains in operation

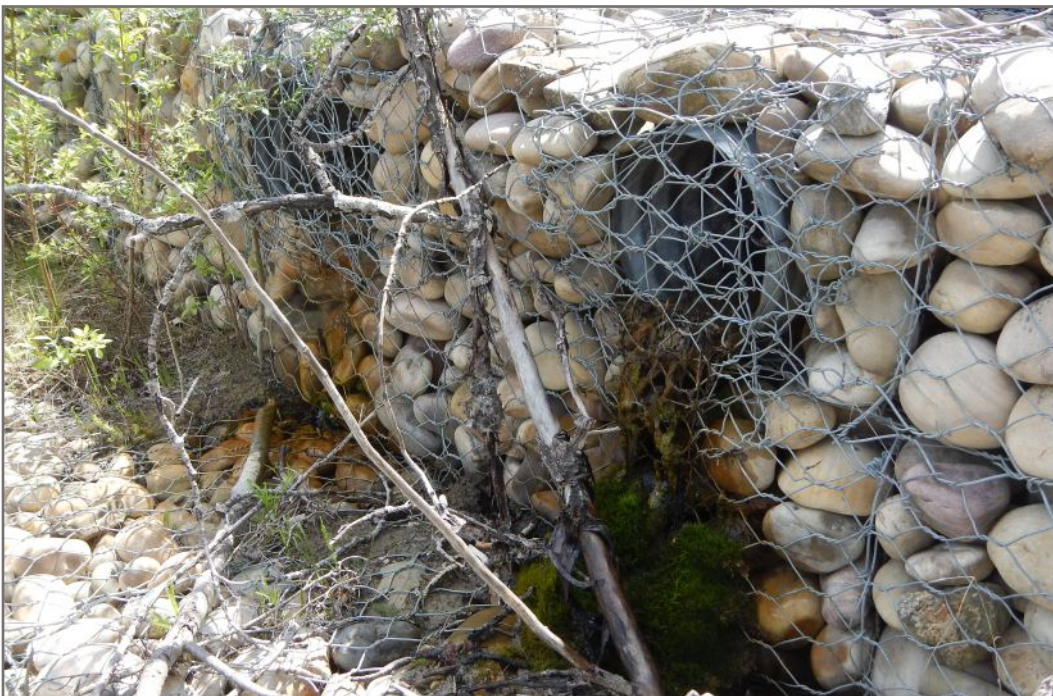
**Photo 4:** Gabion basket wall located at toe of sideslope adjacent to Modeste Creek. Culvert conveying groundwater from drainage galleries to Modeste Creek.

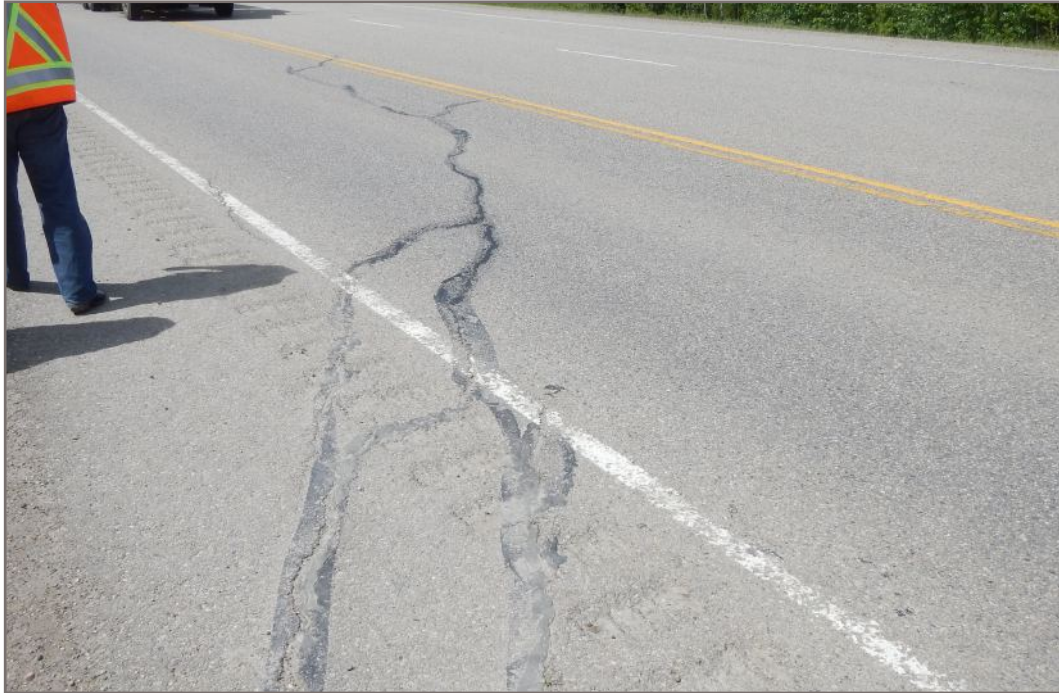
**Photo 5:** Pavement cracking near west flank of slide sealed in 2010.
