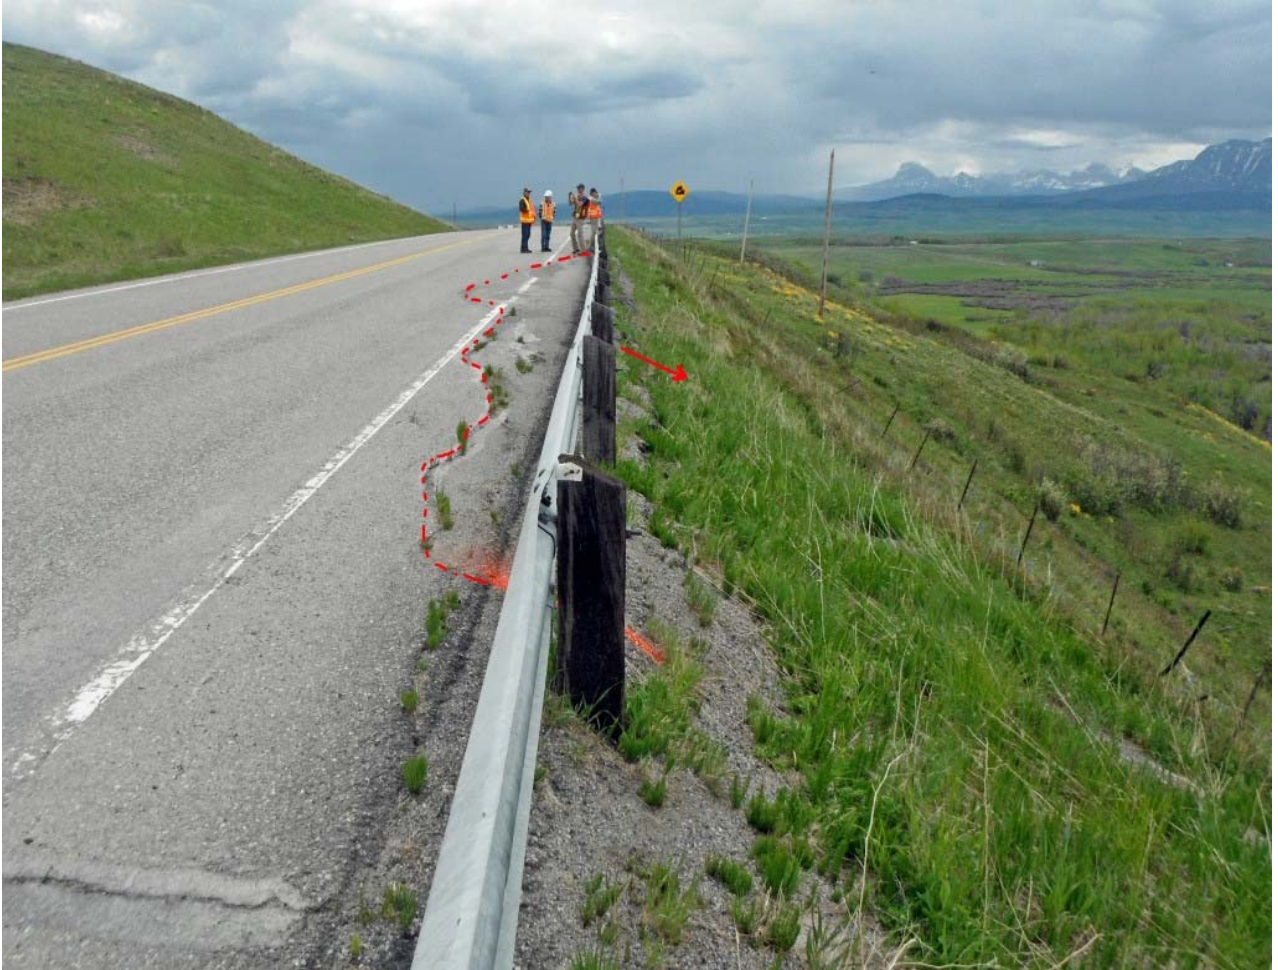
Photo S43-1 (May 2013)

Standing on the southwest road shoulder looking towards the south. The extent of the slide damage within the road surface is outlined in red. The apparent slide direction is shown by the arrow.

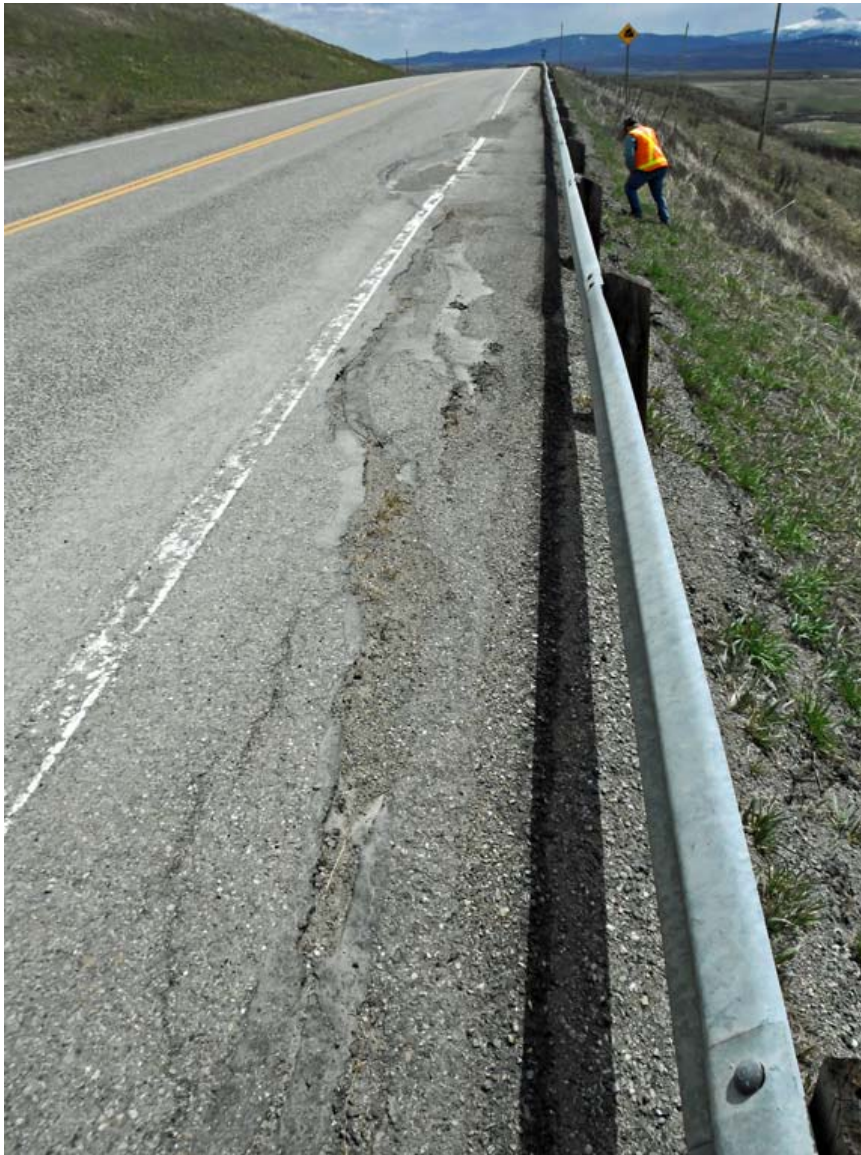
Photo S43-2 (May 2014)
Standing in a similar location to Photo S43-1 and looking to the south at the cracking within the southwest road shoulder. The condition was similar to the 2013 inspection.

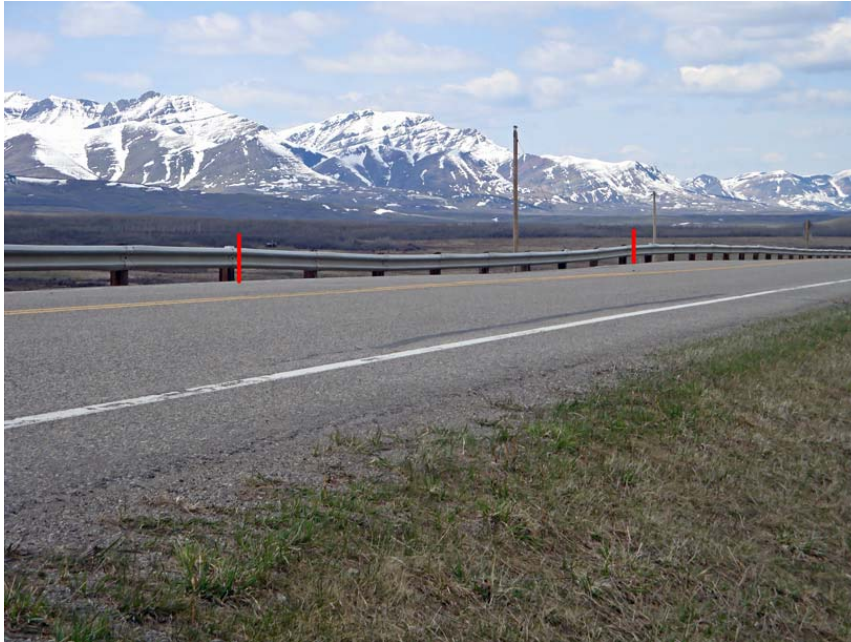
Photo S43-3 (May 2014)
Standing in the upslope ditch looking towards the west at the slide area indicated between the two red lines. Note the settlement visible along the guardrail.

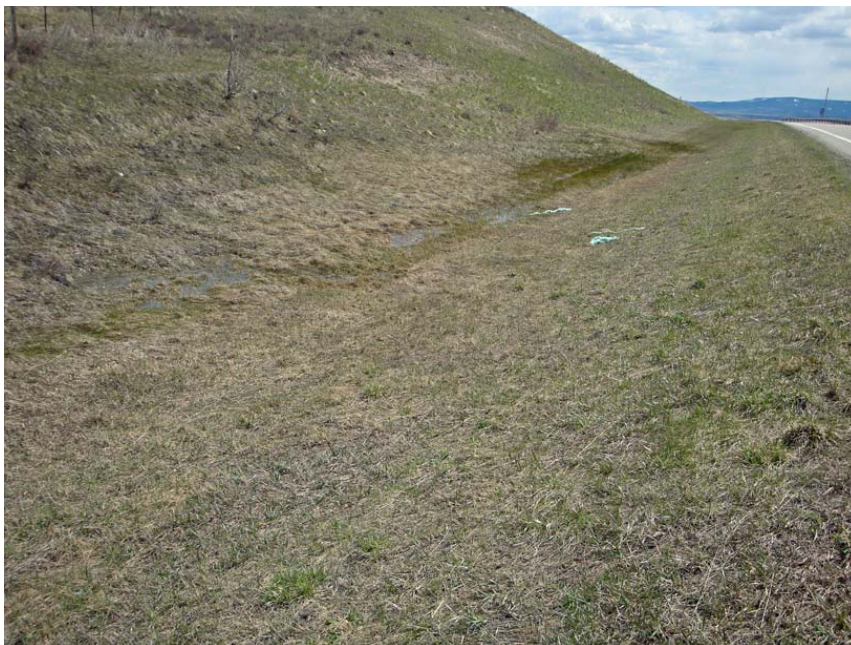
Photo S43-4 (May 2014)
Standing in the upslope ditch looking towards the southeast up the ditch invert. The area is relatively flat and had ponded water.
