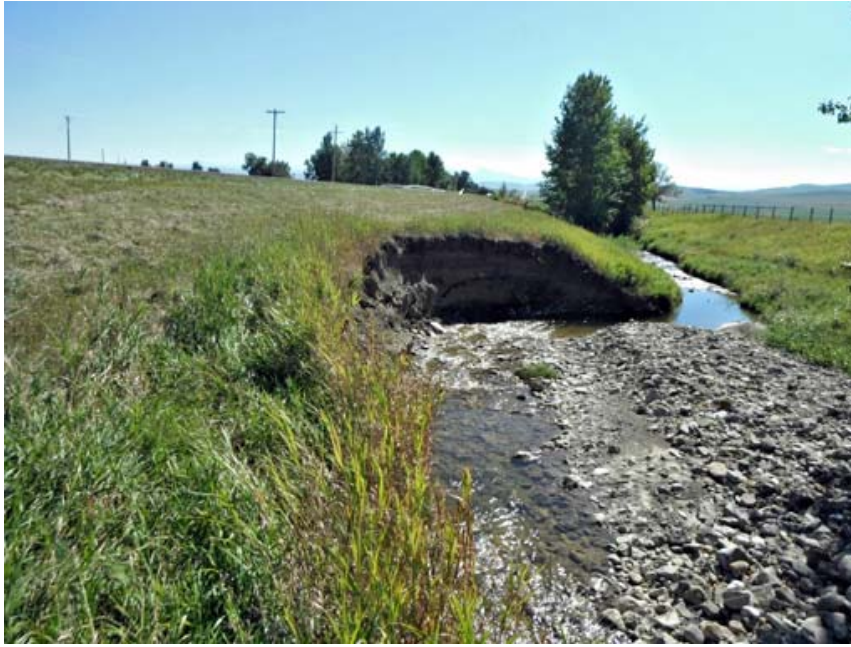
Photo S44-1 (September 2013)
Standing at Site A on the highway's west embankment looking towards the south at the encroachment area. During the 2013 inspection the minimum offset from the bank edge to the road shoulder was approximately 6 to 7 m.

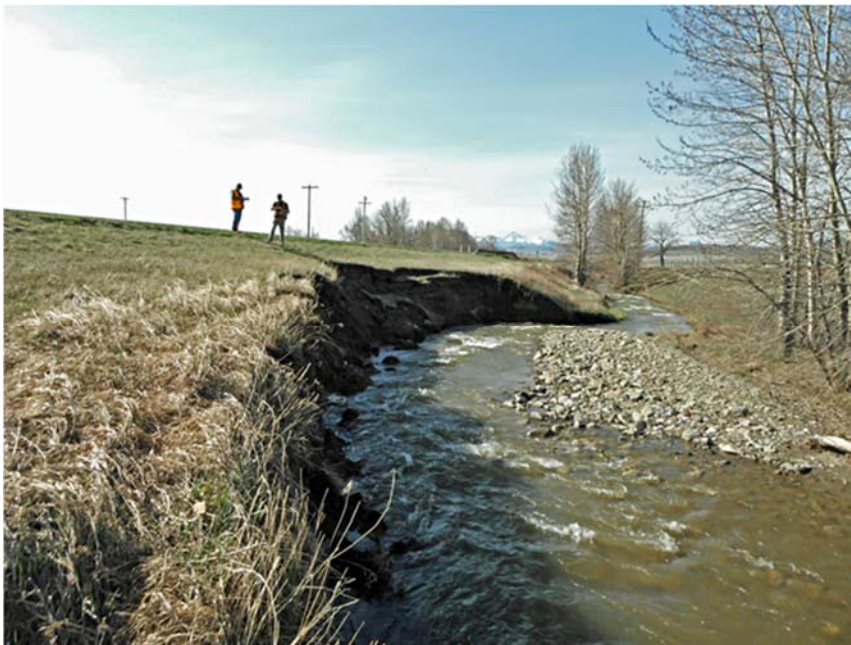
Photo S44-2 (May 2014)
Standing at the same location as the previous photo looking south towards the encroachment area on the west embankment (Encroachment Area A1). There was increased retrogression and erosion visible against the bank relative to the 2013 conditions. The offset from the bank crest to the west road shoulder was approximately 3.8 m.

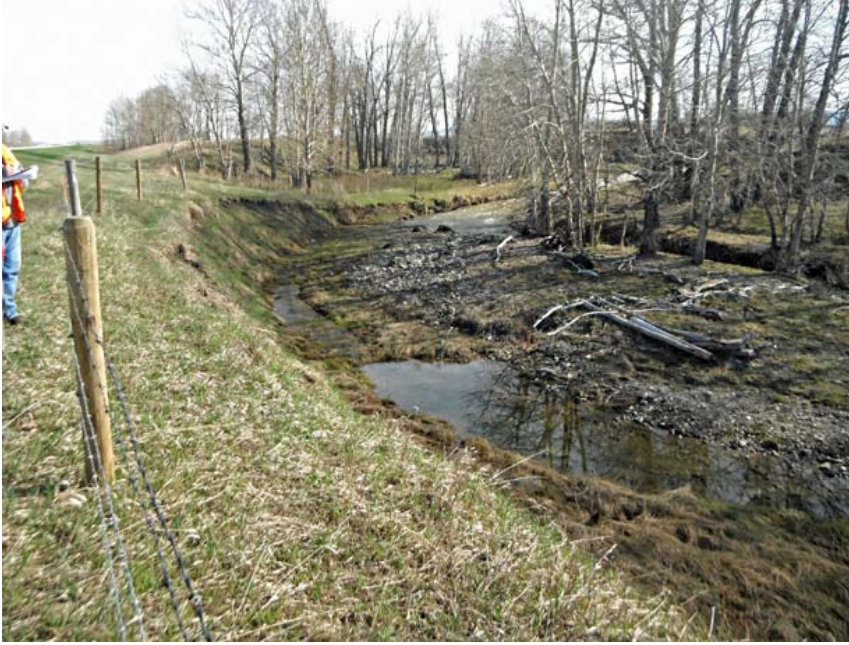
Photo S44-3 (May 2014)
At Site B, standing on the east side of the highway embankment looking towards the northeast at Encroachment Area B1. Note the creek was not flowing in the old meander channel that had caused the original bank erosion.

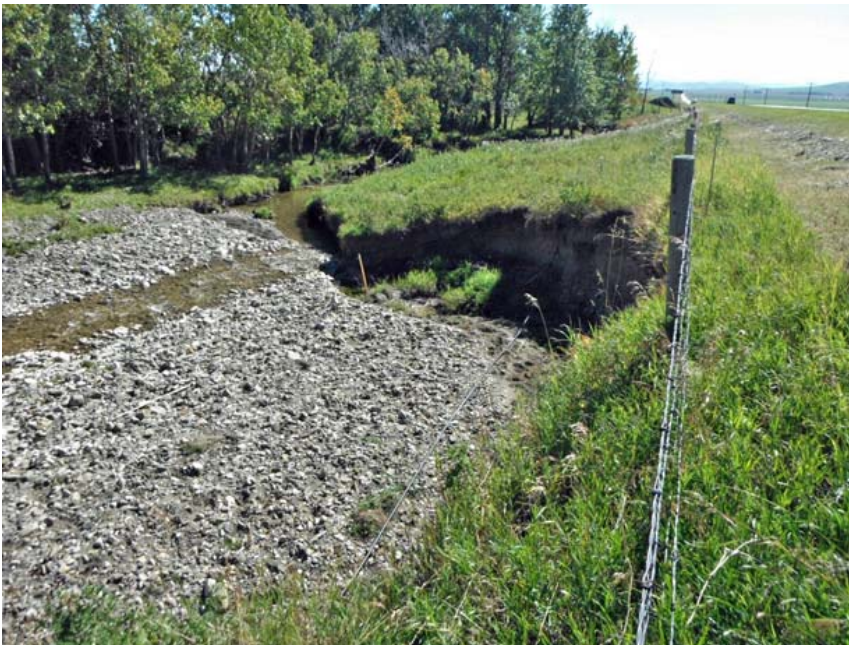
Photo S44-4 (September 2013)
At Site B, standing on the east side of the highway embankment looking towards the south at Encroachment Area B2 in 2013. This area was previously referred to as the northernmost encroachment area at the South Site.

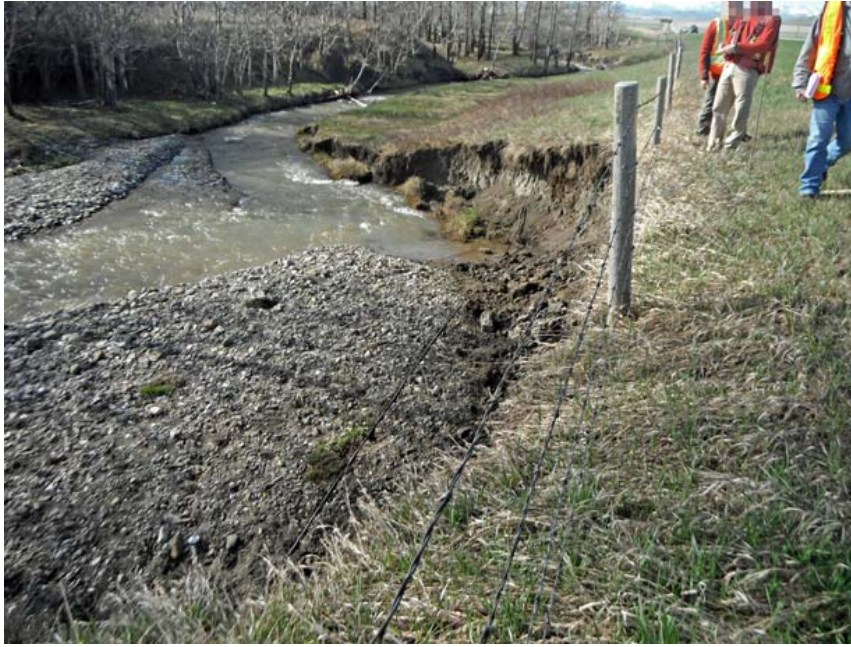
Photo S44-5 (May 2014)
Photo of the same location as the previous photo (S44-4) during the 2014 annual tour. Increased erosion was observed but the minimum offset from the highway shoulder was unchanged. The creek flow had naturally channeled away from the bank in this area except at the south end, as seen here.

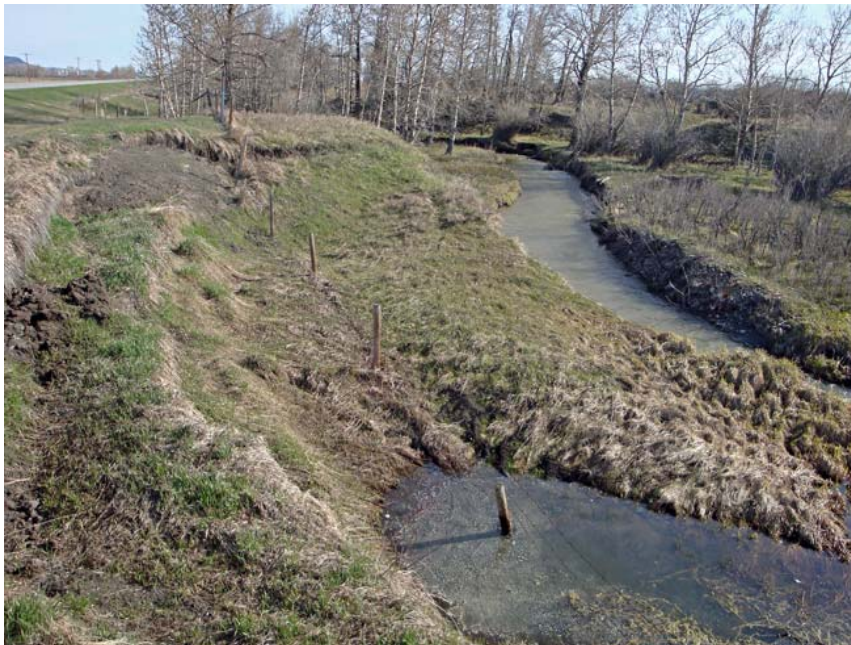
Photo S44-6 (May 2014)
At Site B, standing on the east side of the highway at the south end of Slide Area B1 looking towards the northeast at the circular earth slide within the bank meander.

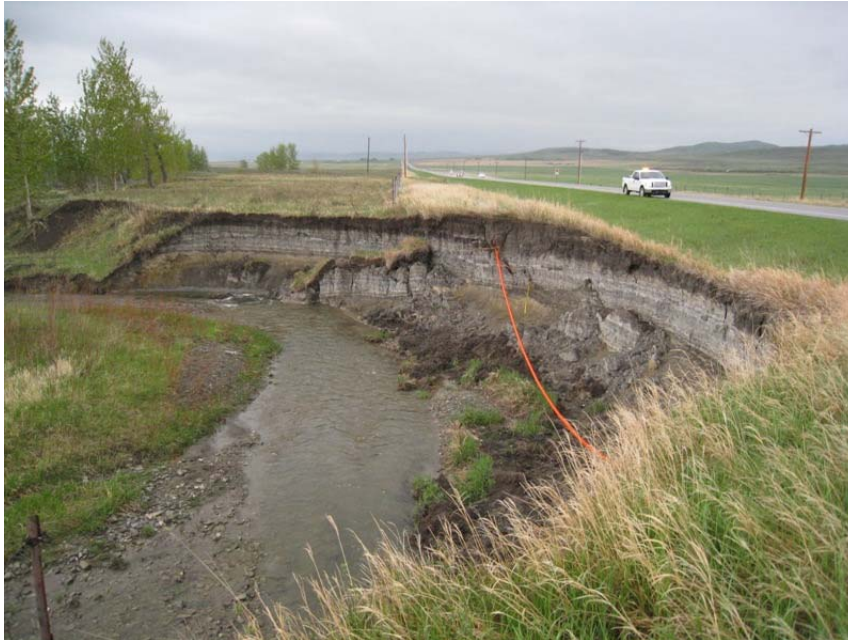
Photo S44-7 (May 2013)
Standing at the South Site on the highway's east embankment looking towards the south at the southernmost encroachment area. The site conditions as observed during the Annual Inspection Tour in May 2013.

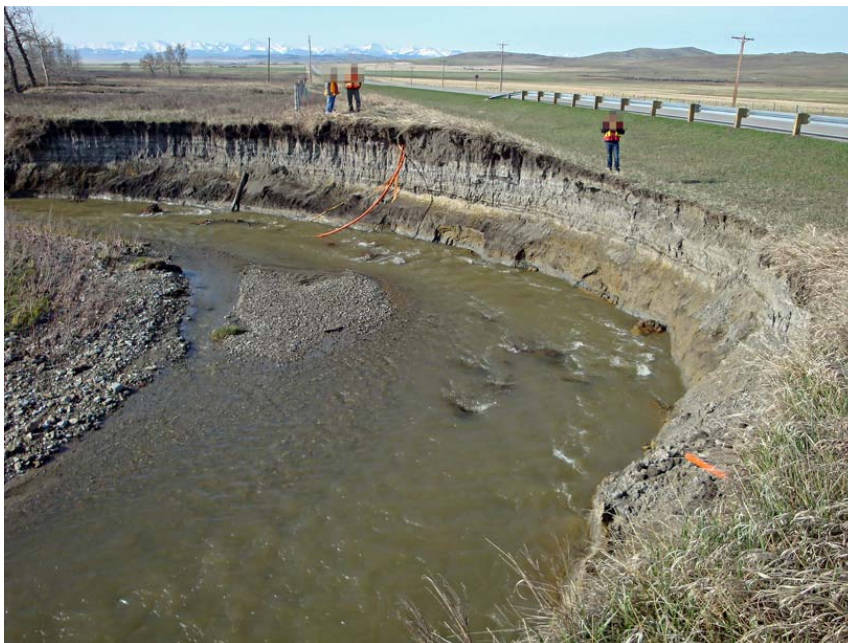
Photo S44-8 (May 2014)
Standing in a similar location as the previous photo looking towards the southernmost encroachment area as viewed during the Annual Inspection Tour in May 2014. Note the erosion of the previously fallen bank soils and new guardrail installment.
