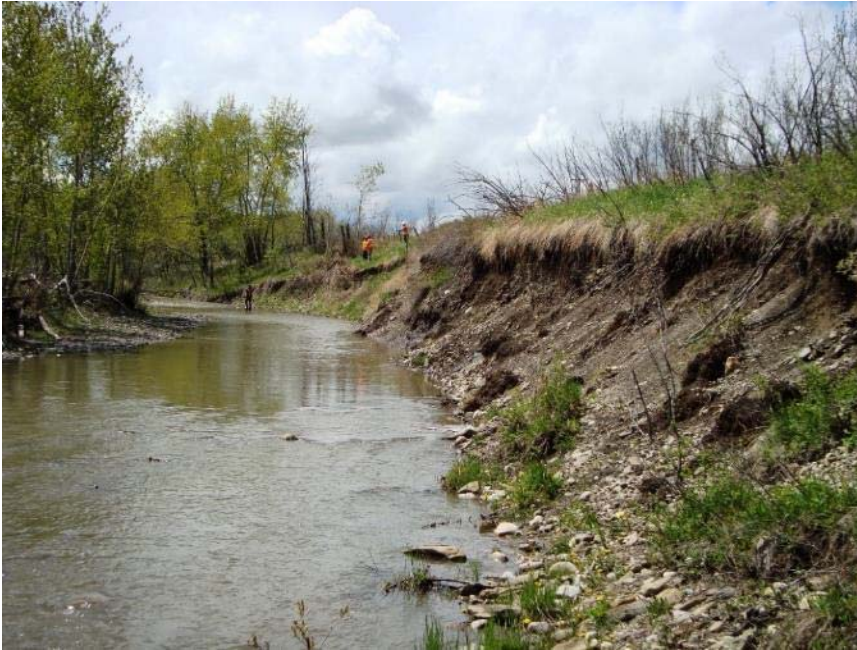
Photo S45-1 (May 2013) – Standing at the creek bank at the east end of the East Site, looking towards the southwest at the bank erosion.

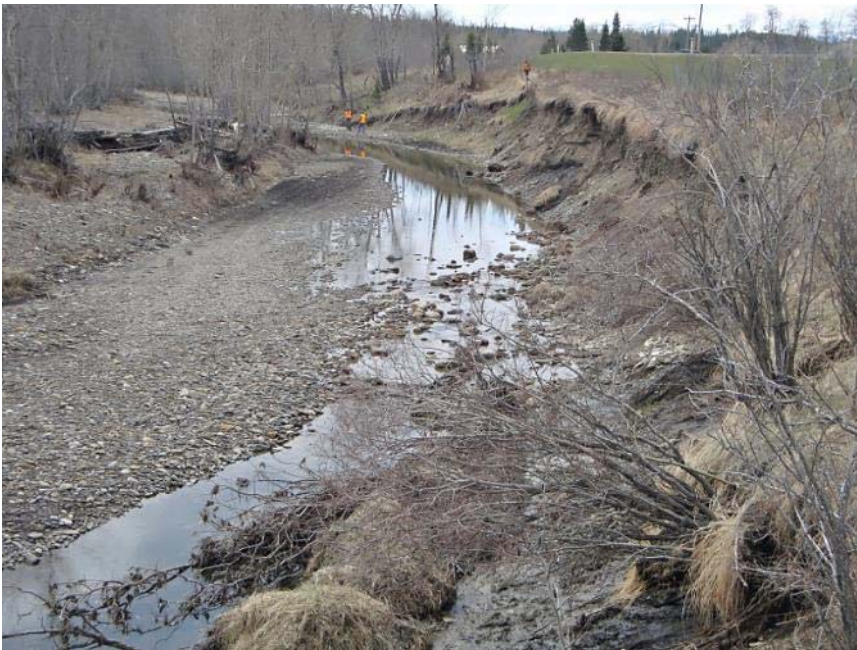
Photo S45-2 (May 2014) – Standing at the creek bank at the east end of the East Site, looking towards the southwest at the bank erosion. Similar location as Photo 1, note the low flow and relatively unchanged bank conditions relative to the 2013 conditions.

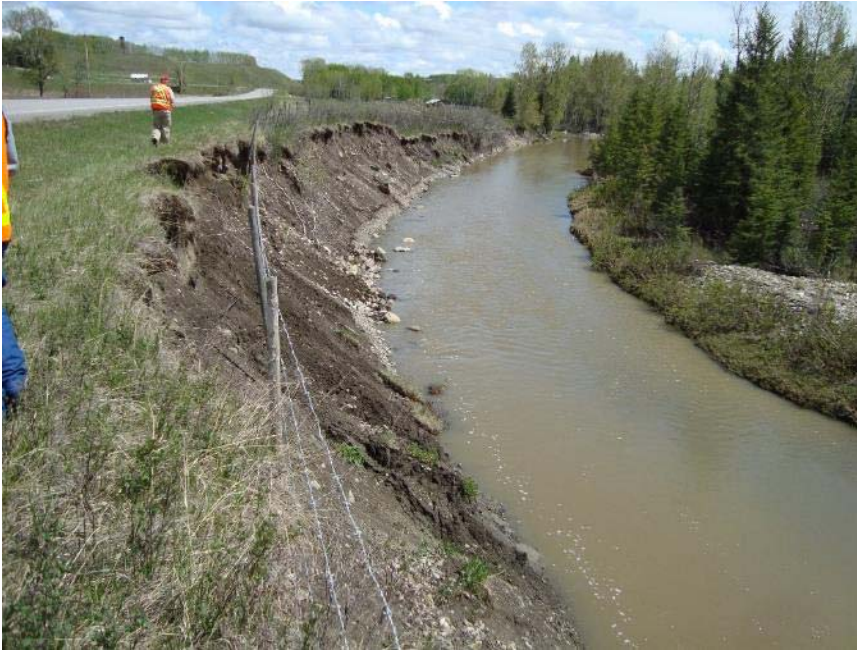
Photo S45-3 (May 2013) – Standing on the bank at the west end of the West Site, looking towards the east at the bank erosion.

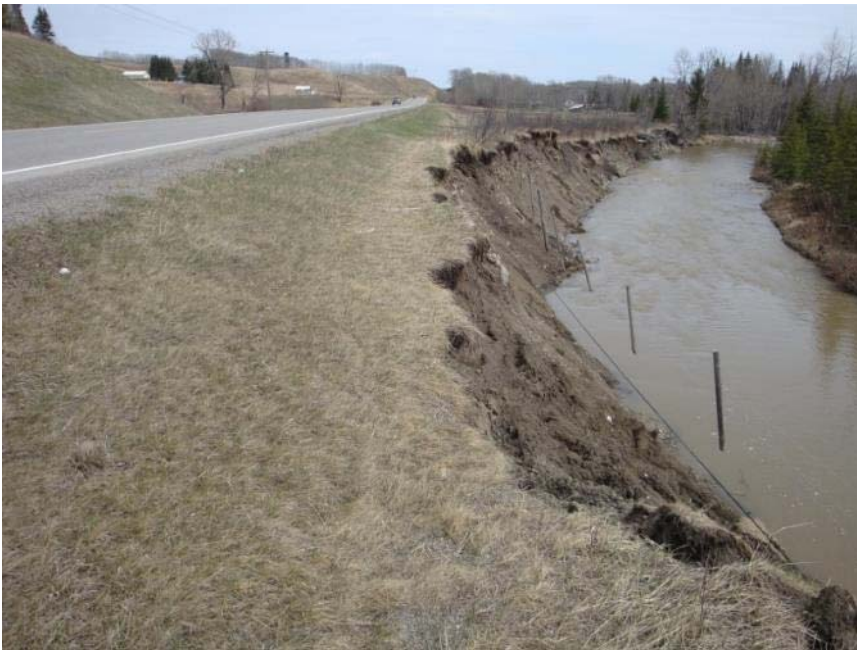
Photo S45-4 (May 2014) – Standing on the bank at the west end of the West Site (similar location to Photo S45-3), looking towards the east at the bank erosion. Note the increased extent of erosion to the east and number of fence posts undermined relative to the 2013 conditions.

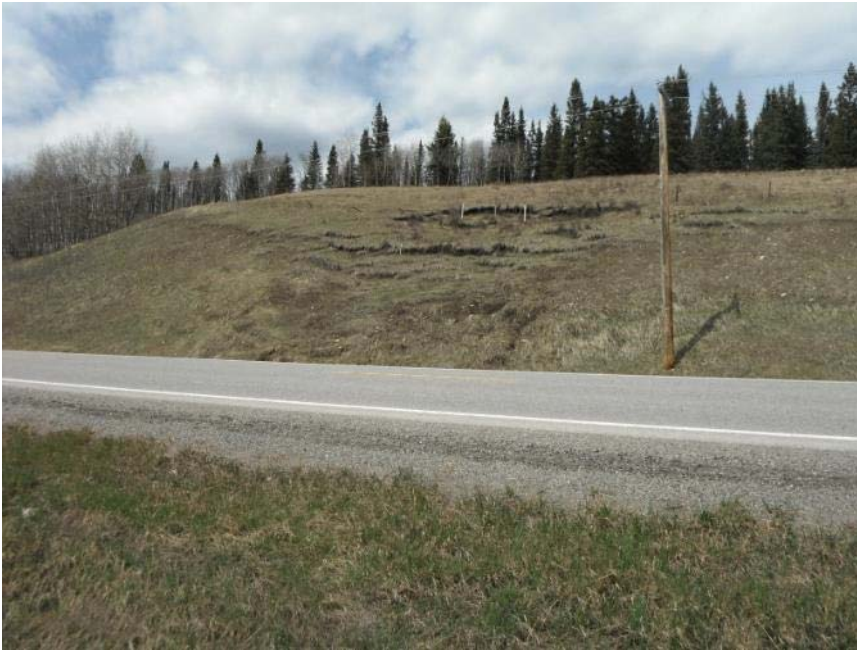
Photo S45-5 (May 2014) –
Standing at the West Site
looking towards the
northeast at the backslope
sliding.
