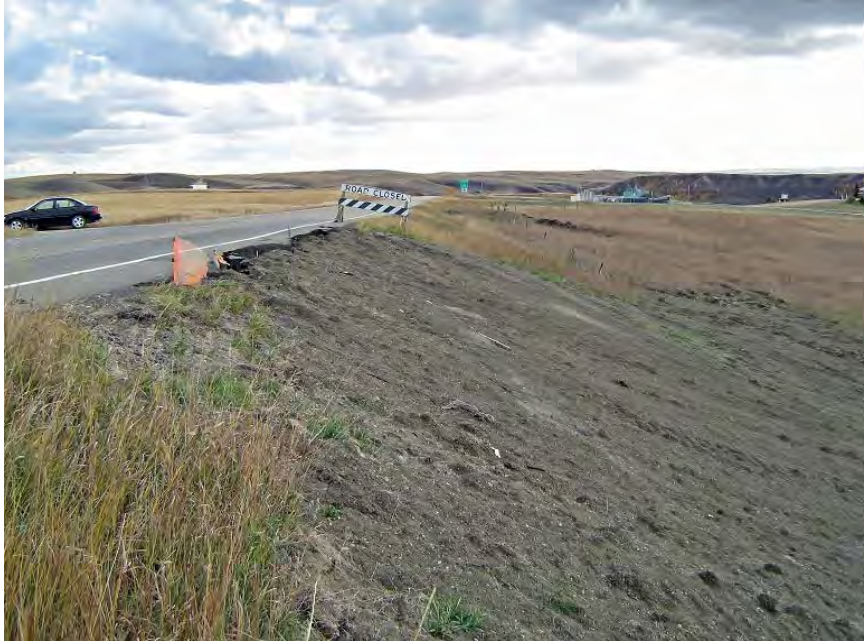
**Photo S46-1 (2007)**  
At the North Site on the west side of the road embankment looking towards the south at the area where landslide damage had occurred and recently been regraded.

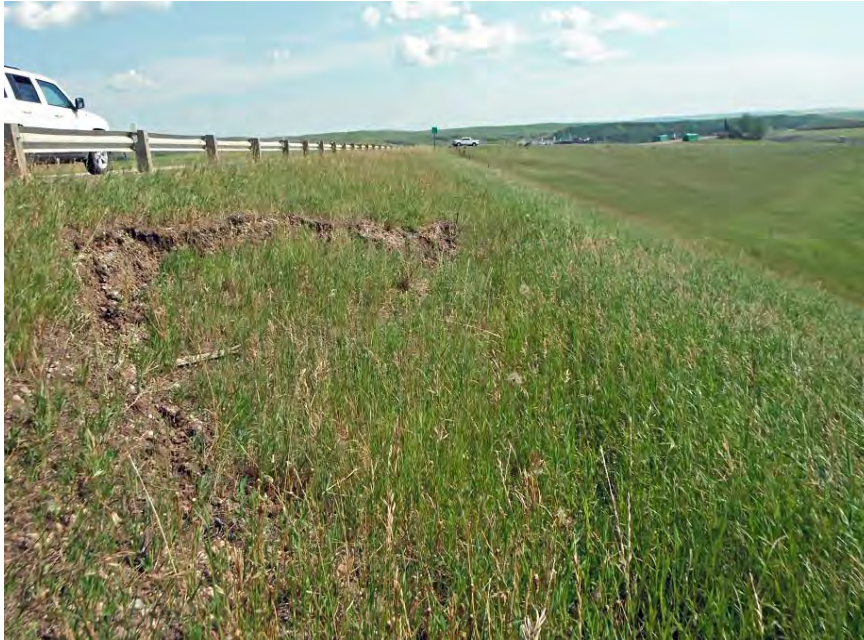
**Photo S46-2 (2013)**  
Standing in a similar location to Photo S46-1 and looking to the south at the area referred to as the North Slide during the 2013 inspection. An arc-shaped crack was observed developing within the road embankment. Note that a guardrail has been installed on the west side of the road since 2007.

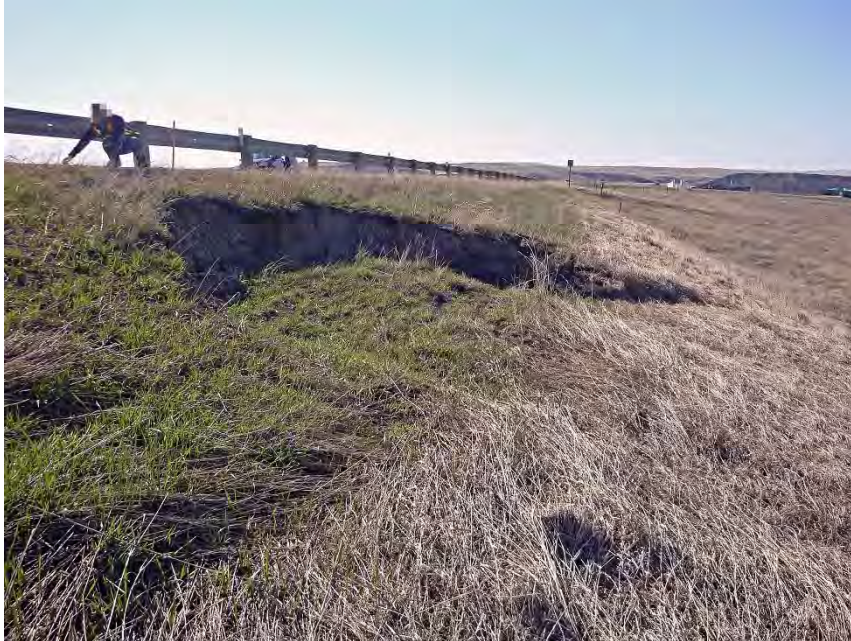
**Photo S46-3 (2014)**  
Taken in the same location as the previous photo (S46-2), looking south at the circular earth slide within the road embankment. Note the increased downdrop and downslope displacement relative to the 2013 conditions.

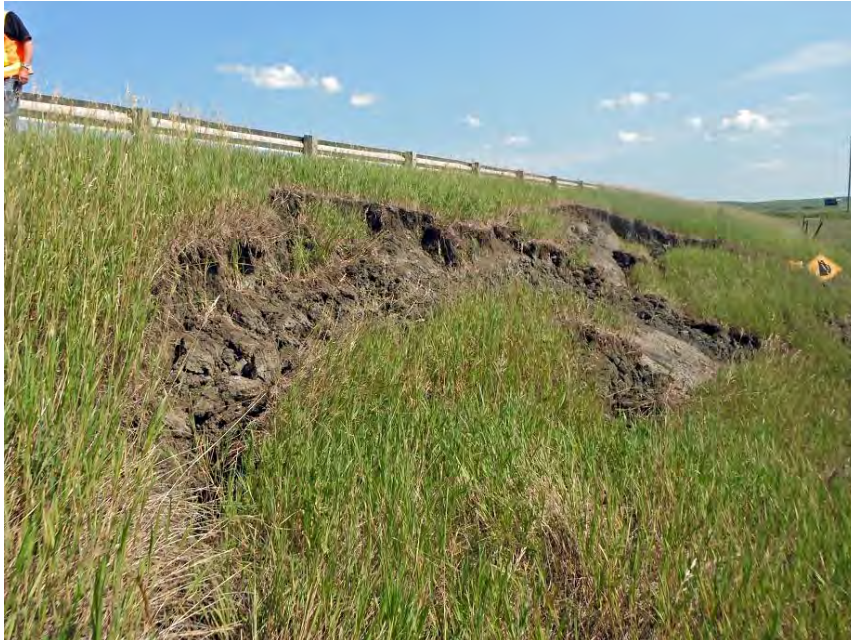
**Photo S46-4 (2013)**  
At the Southern Slide area, standing on the west side of the highway embankment looking towards the south at the headscarp of the landslide that formed within the year. Movement is towards the right side of the photo.

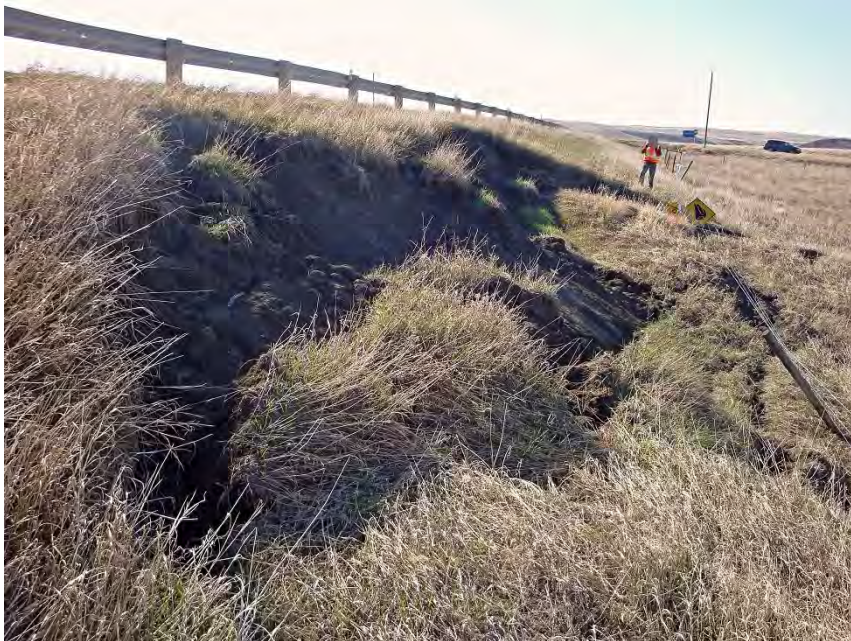
**Photo S46-5 (2014)**  
Standing in the same location as the previous photo (S46-4) looking at the Southern Slide. Note the increased downslope movement of the failed soil mass exposing more soil near the headscarp.

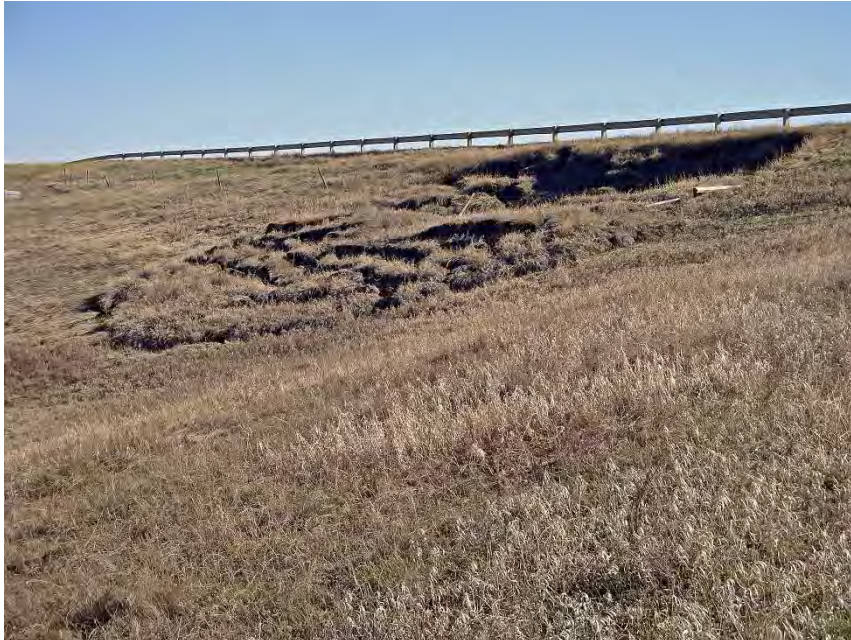
**Photo S46-6 (2014)**  
Near the base of the west side of the road embankment looking upslope towards the northeast at the Southern Slide area.
