NC1 - WHITECOURT EAST HILL
2015 Annual Inspection Photographs

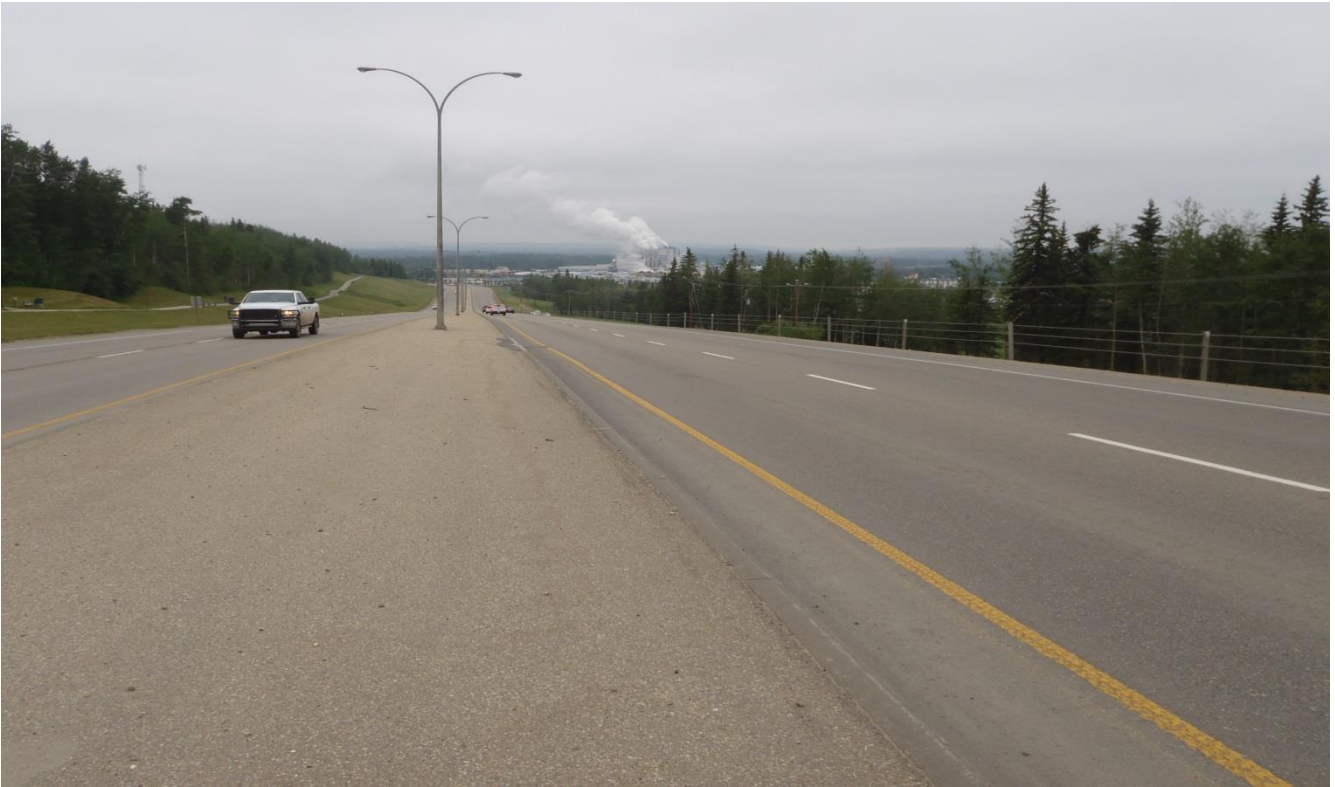
PHOTOGRAPH 1: East and westbound lanes overlaid in the Fall of 2014, facing west.

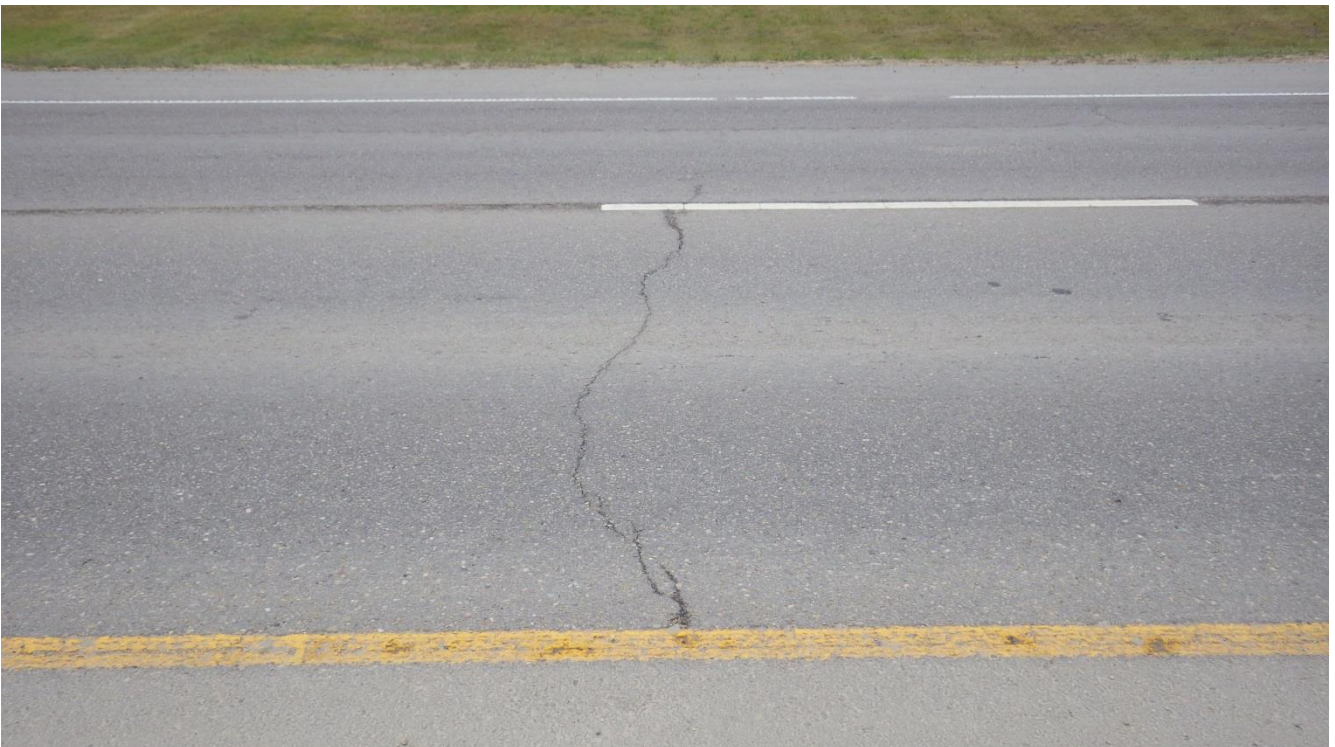
PHOTOGRAPH 2: Transverse crack in eastbound lane near Station 1+950, facing south.

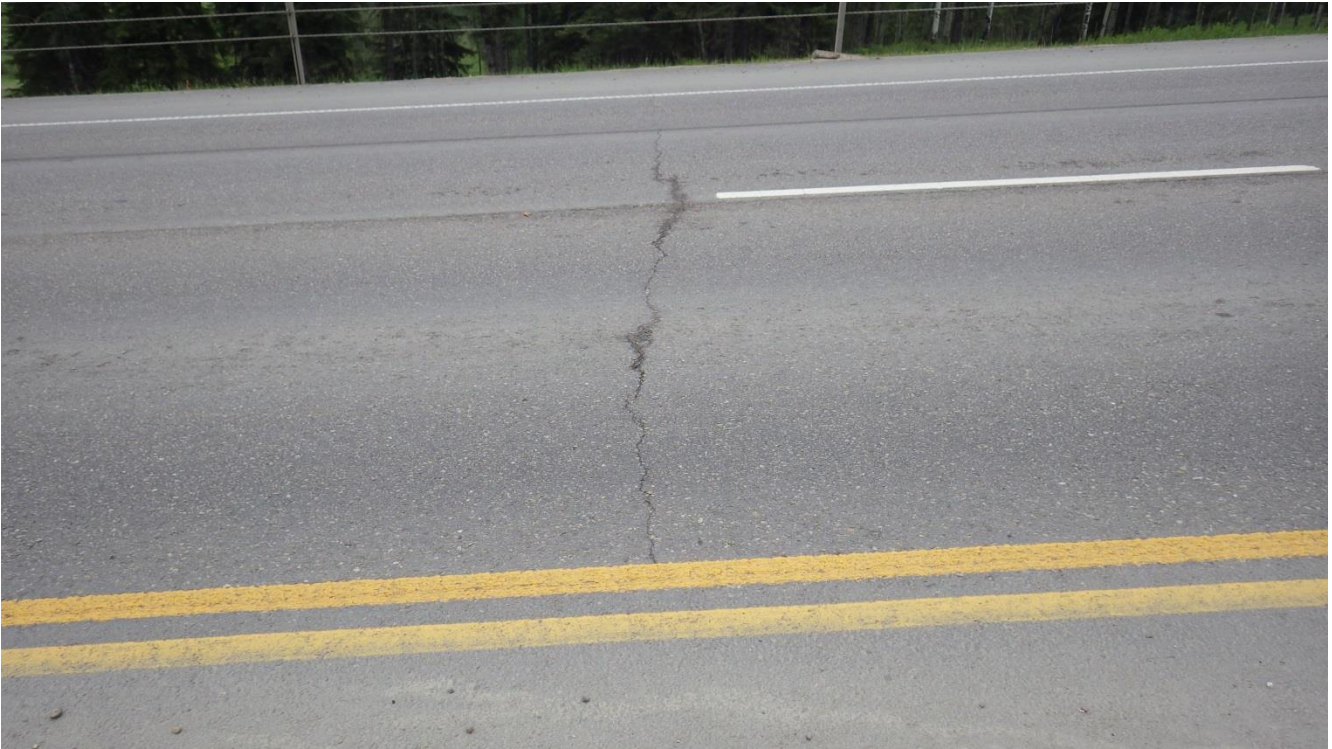
PHOTOGRAPH 3: Transverse crack in westbound lane near Station 1+800, facing north.

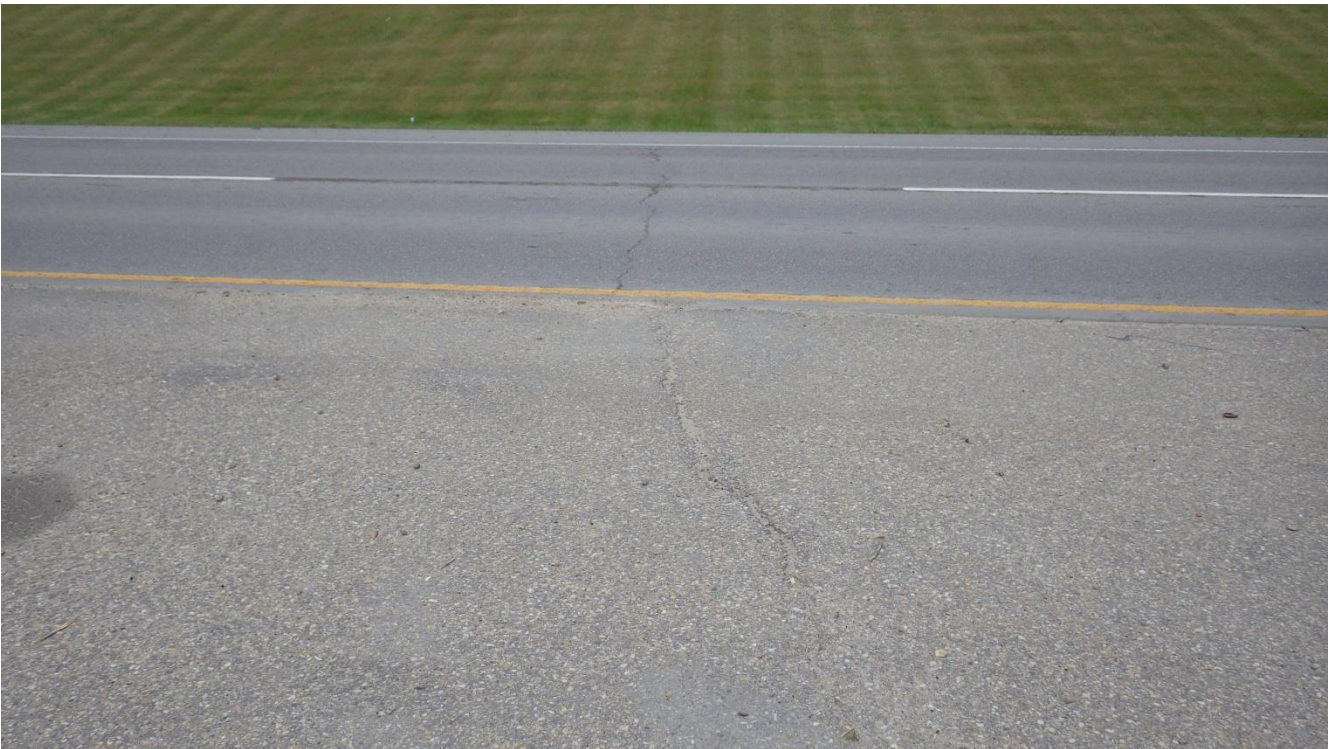
PHOTOGRAPH 4: Transverse crack in westbound lane and on median near Station 1+775, facing north.

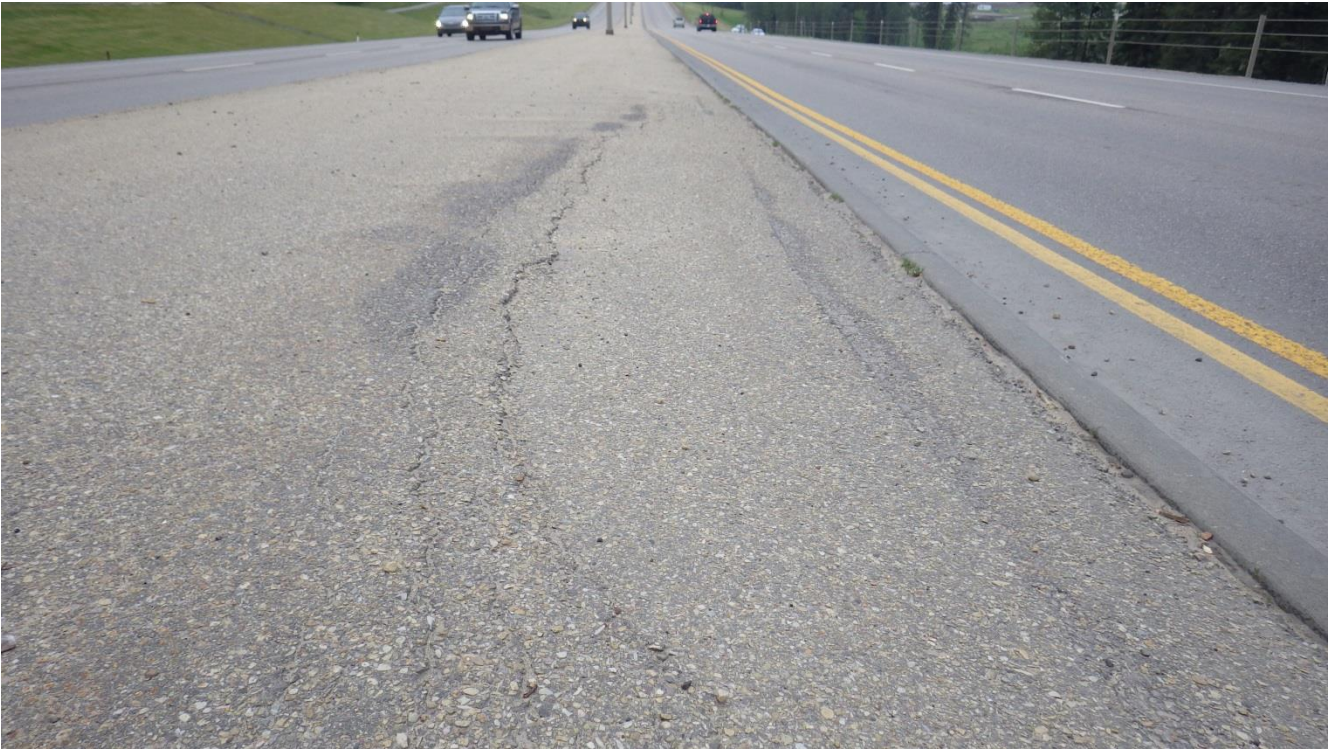
PHOTOGRAPH 5: Crack in meridian near west crack, facing west.

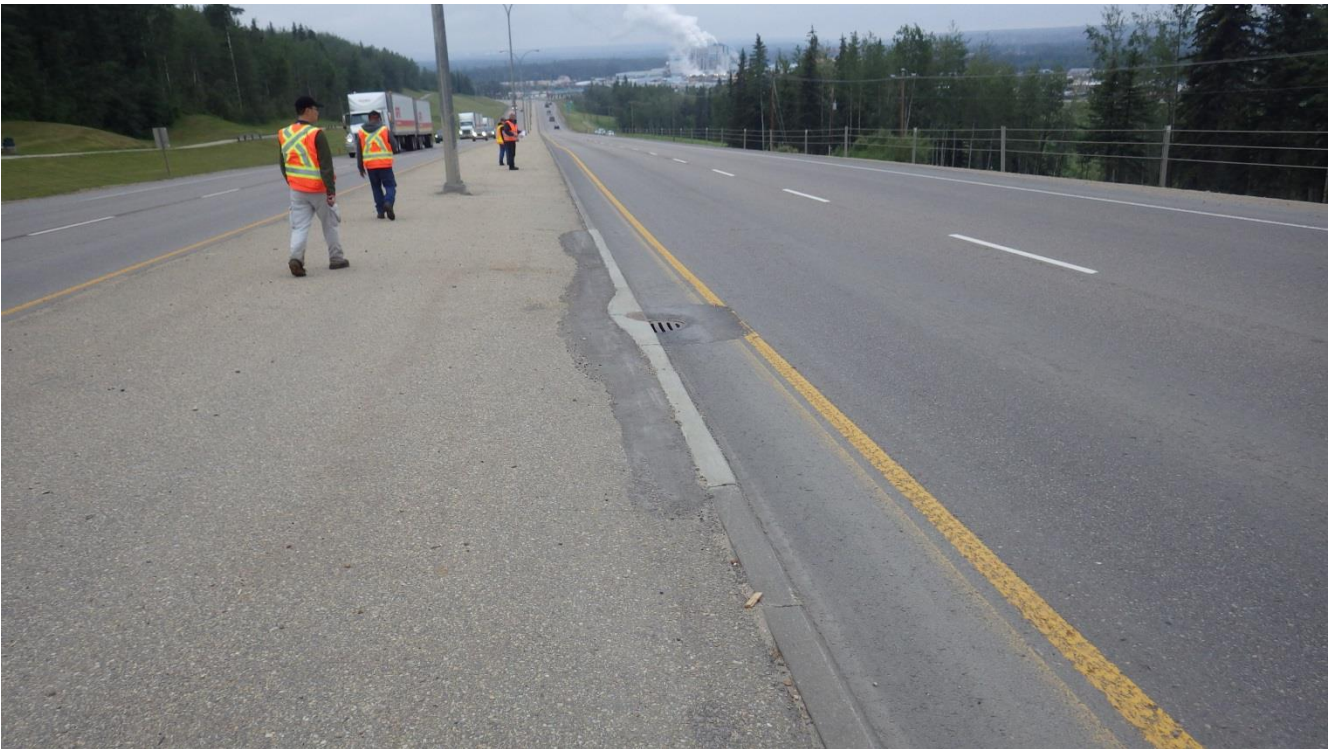
PHOTOGRAPH 6: Patching completed around the catch basin, facing west.

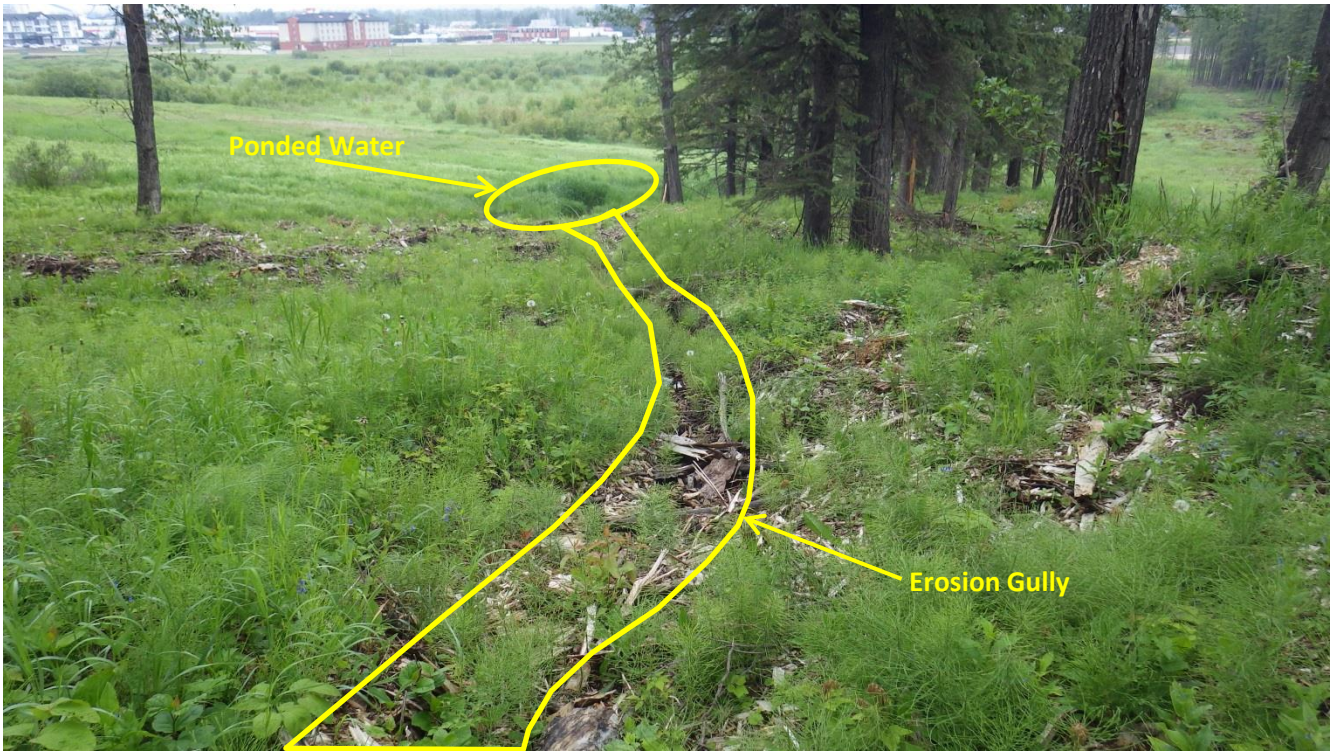
PHOTOGRAPH 7: Erosion gully and ponded water on west side of road allowance, facing north.

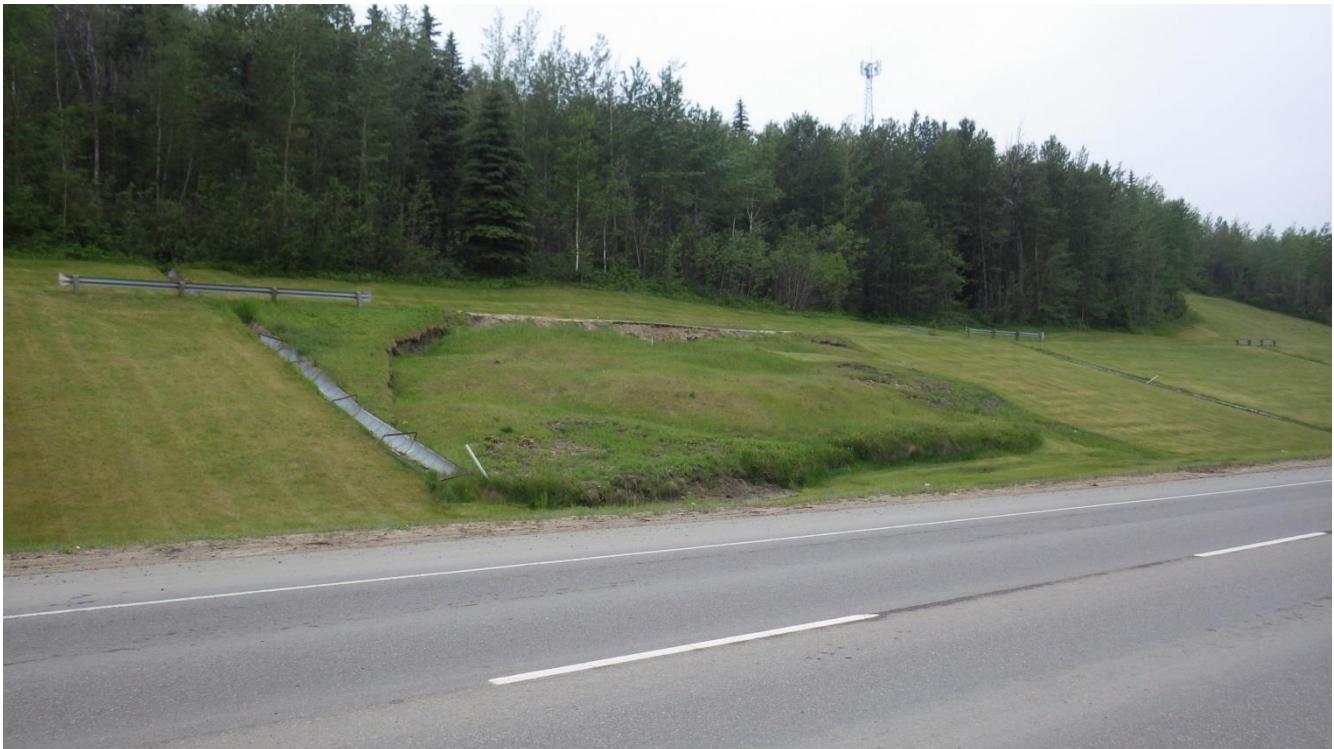
PHOTOGRAPH 8: Surficial backslope failure, facing southwest.

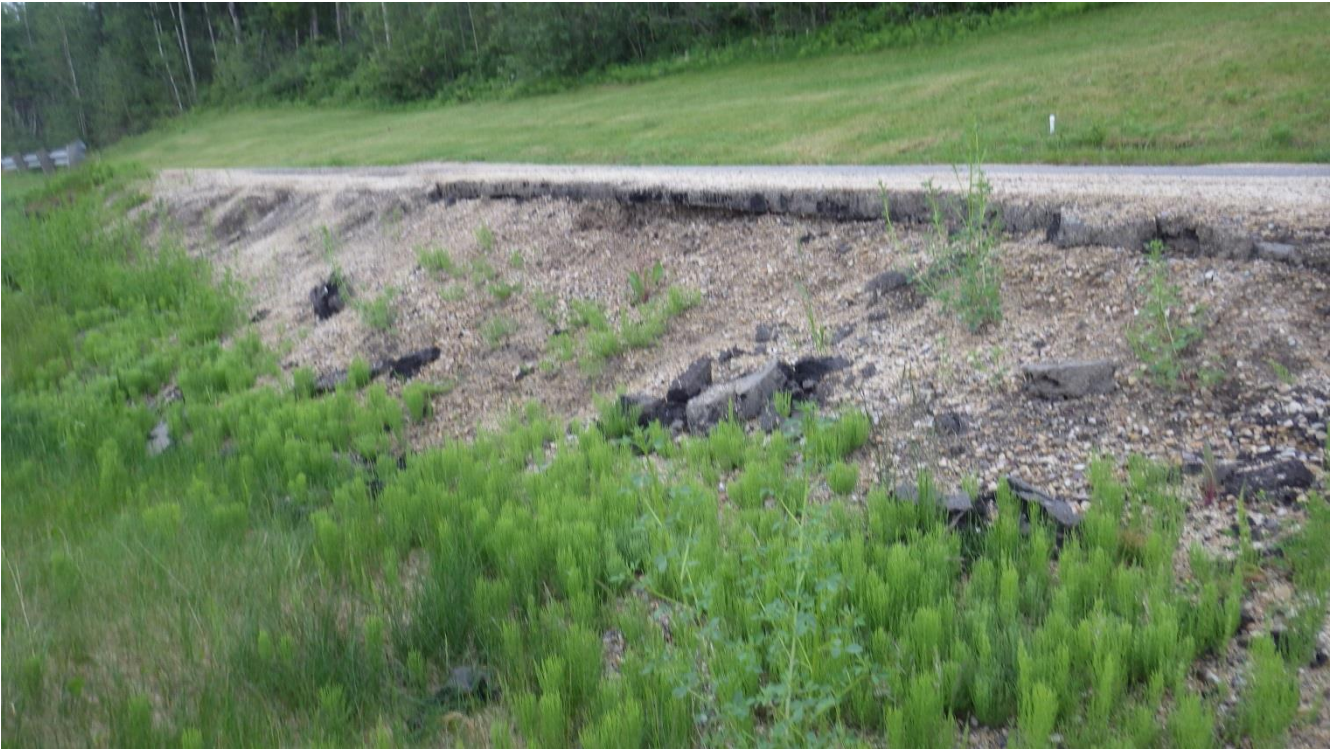
PHOTOGRAPH 9: Backscarp of surficial failure undermining walking trail, facing south.

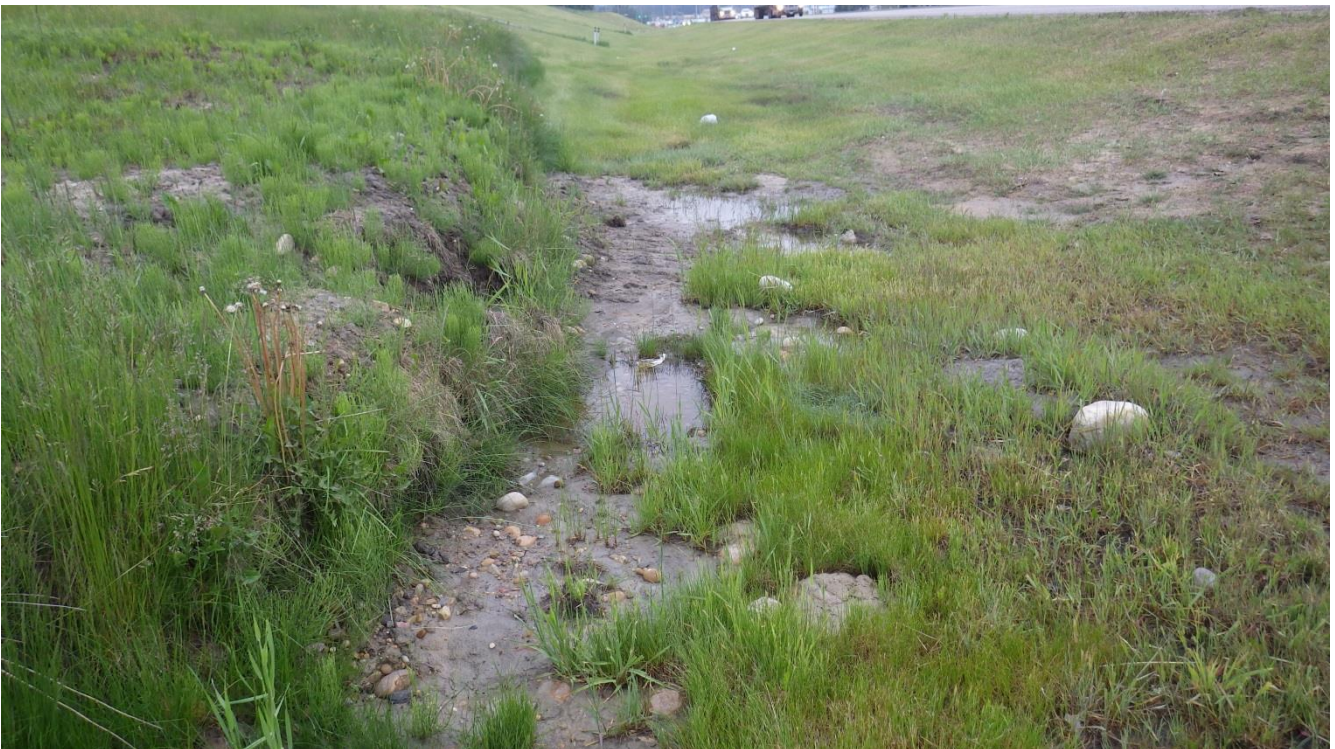
PHOTOGRAPH 10: Ponded water near toe of surficial failure, facing west.

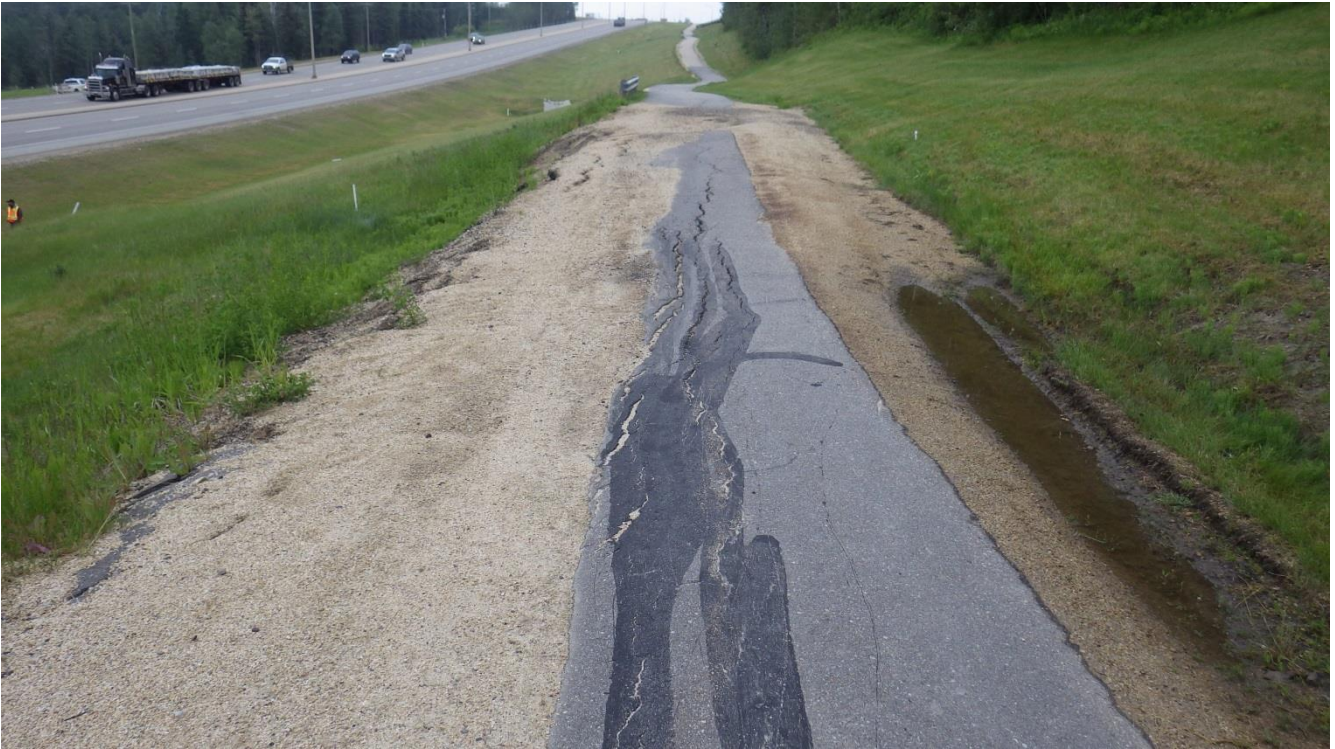
PHOTOGRAPH 11: Pondered water on south side of walking trail above the surficial failure, facing east.

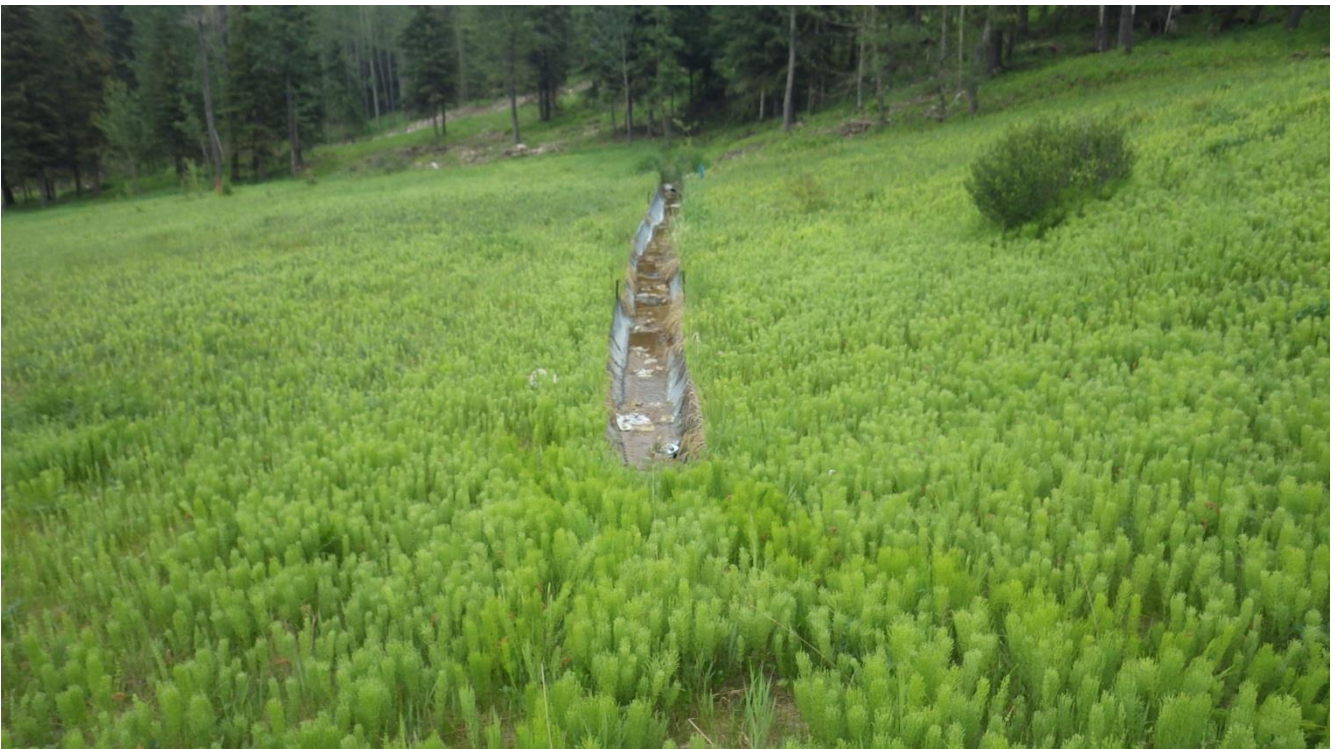
PHOTOGRAPH 12: Garbage accumulating in half-round culverts, facing east.
