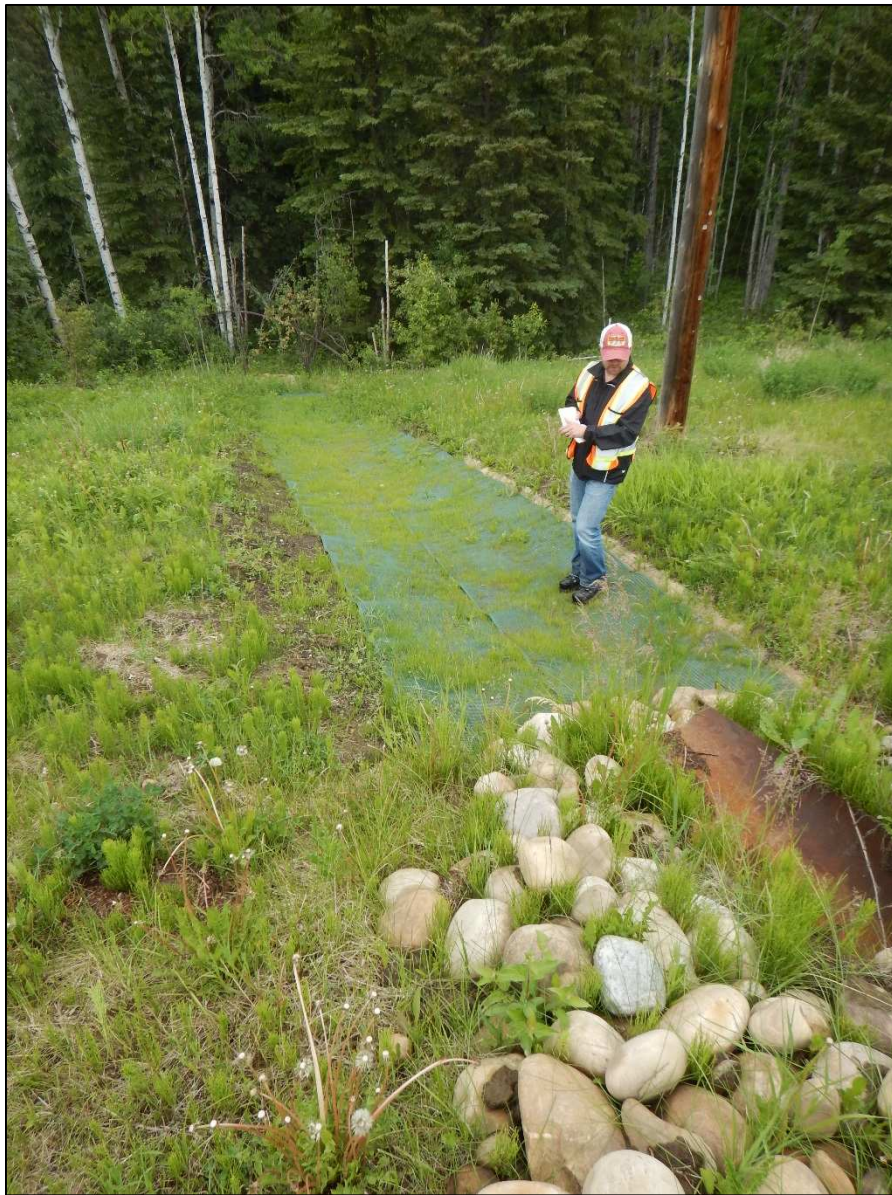
**Photo 1:** Recently installed erosion and sediment control at outlet of east culvert

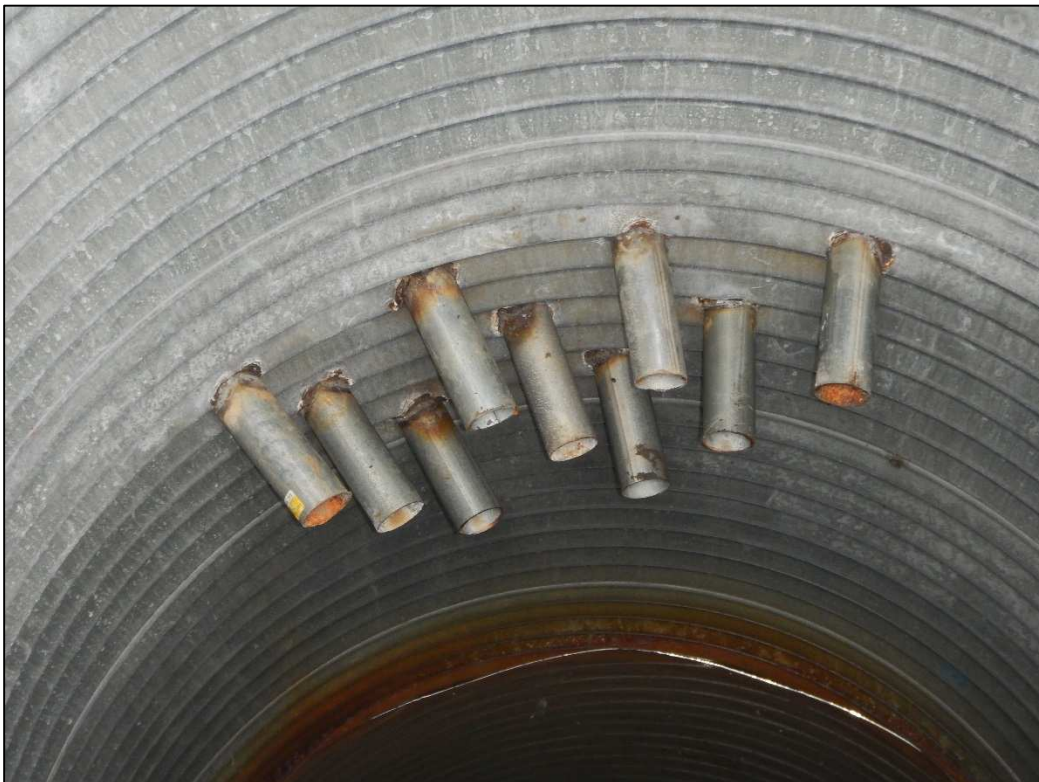
**Photo 3:** East drainage gallery – zero of nine running

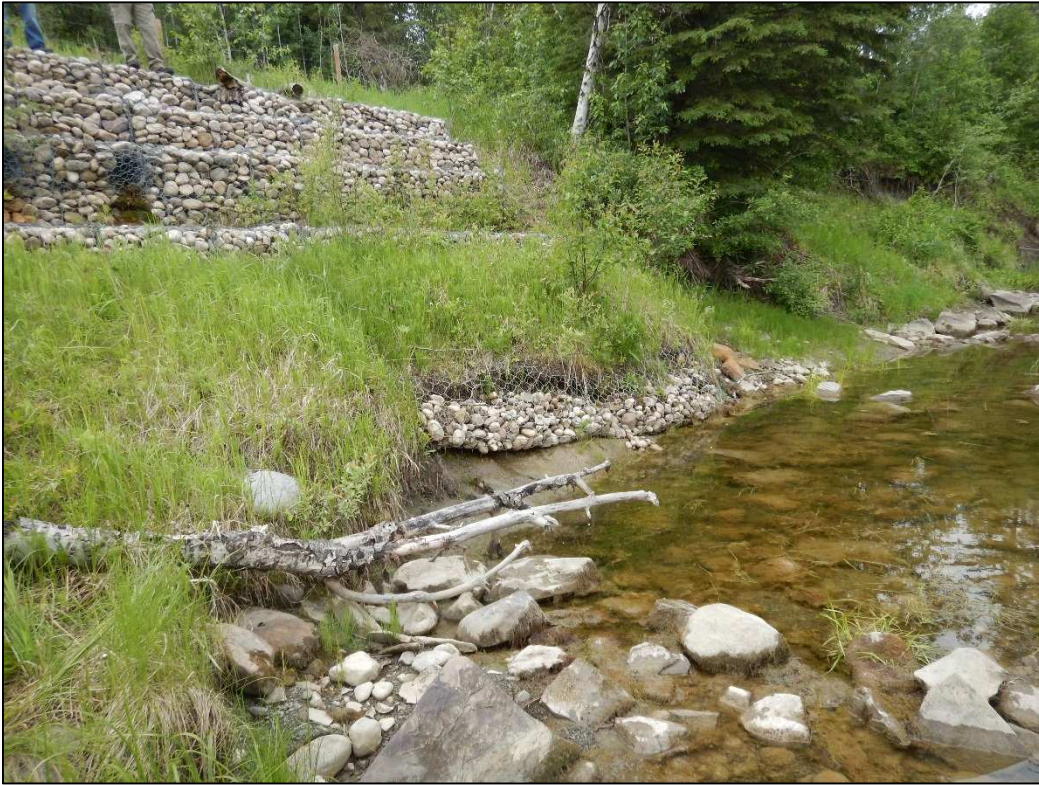
**Photo 4:** Erosion and deformation of gabion baskets along riverbank at toe of slope

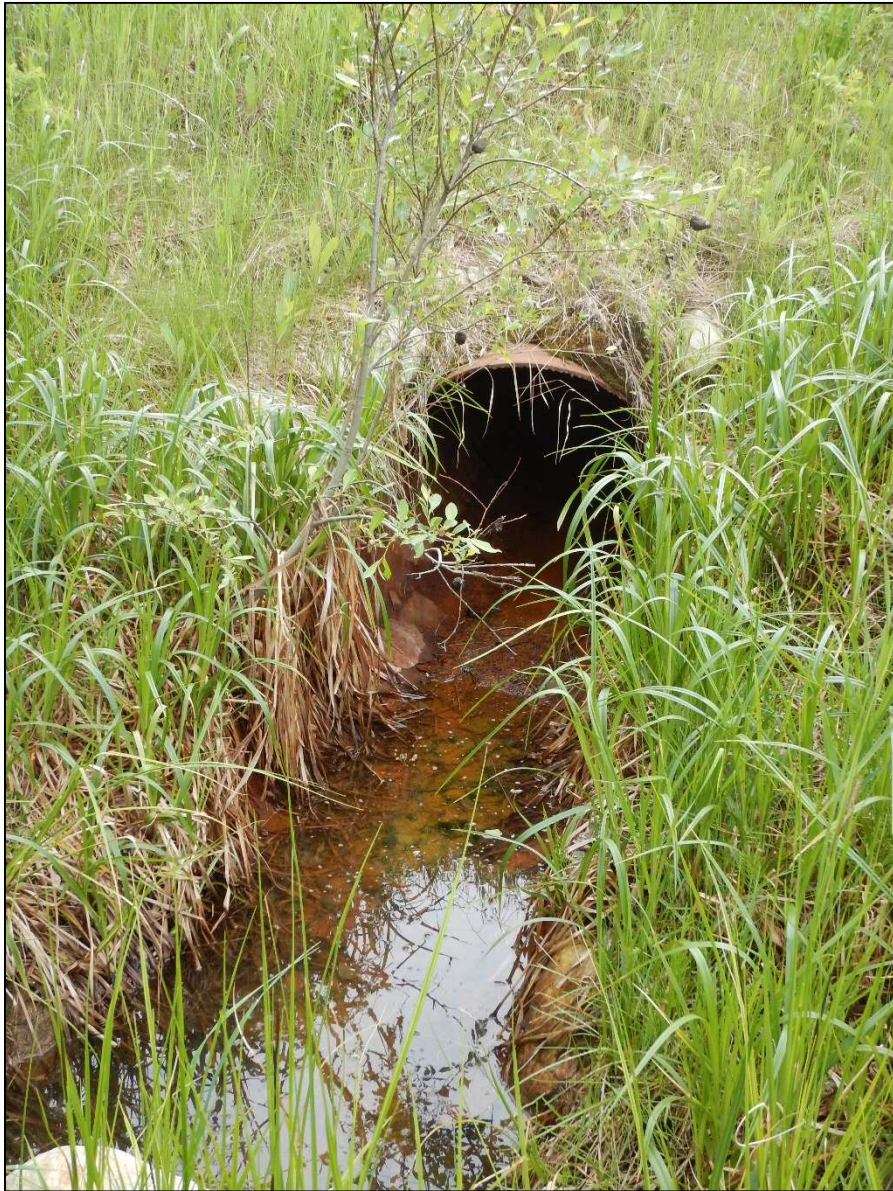
**Photo 5:** Ponding water at west culvert outlet

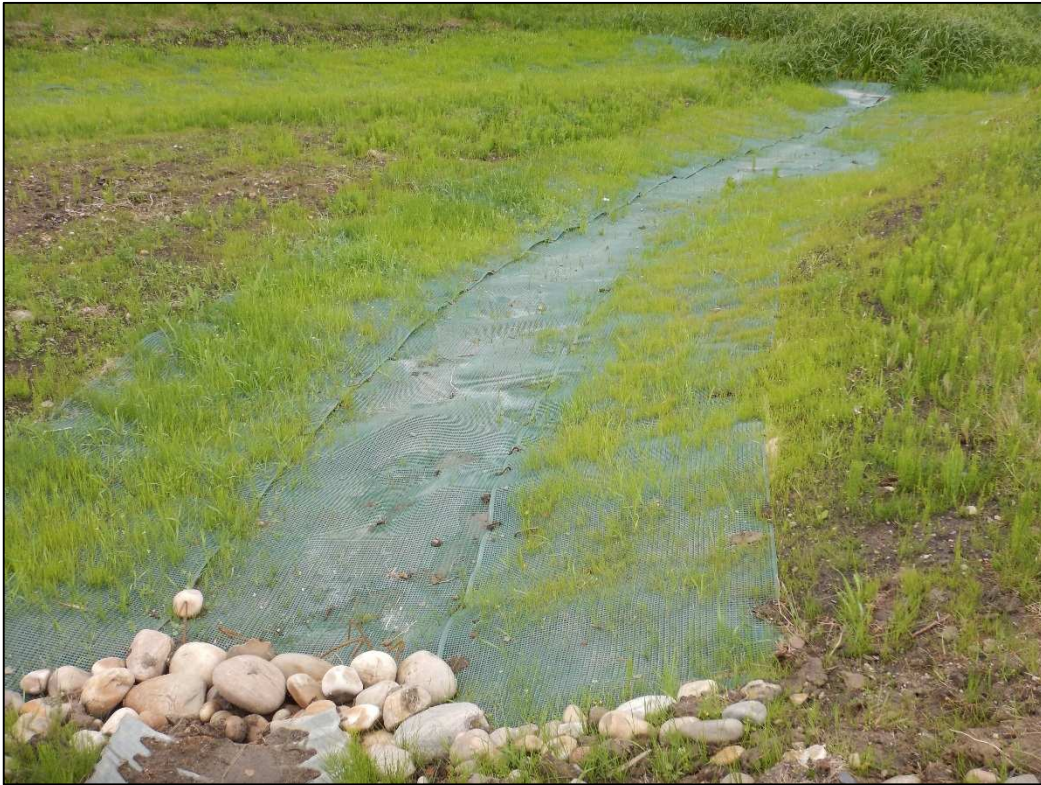
**Photo 6:** Erosion and sediment control installed along drainage path immediately west of the site

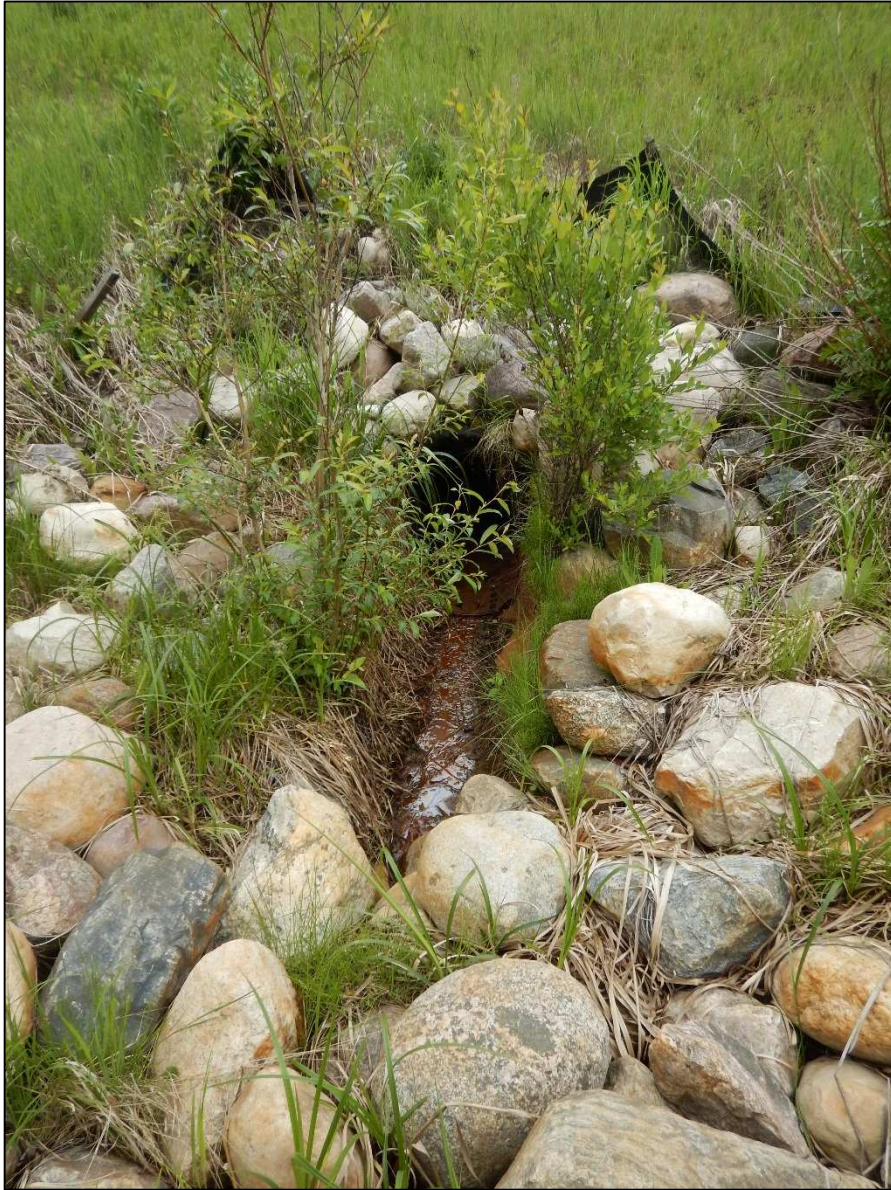
**Photo 7:** West culvert inlet protection well vegetated
