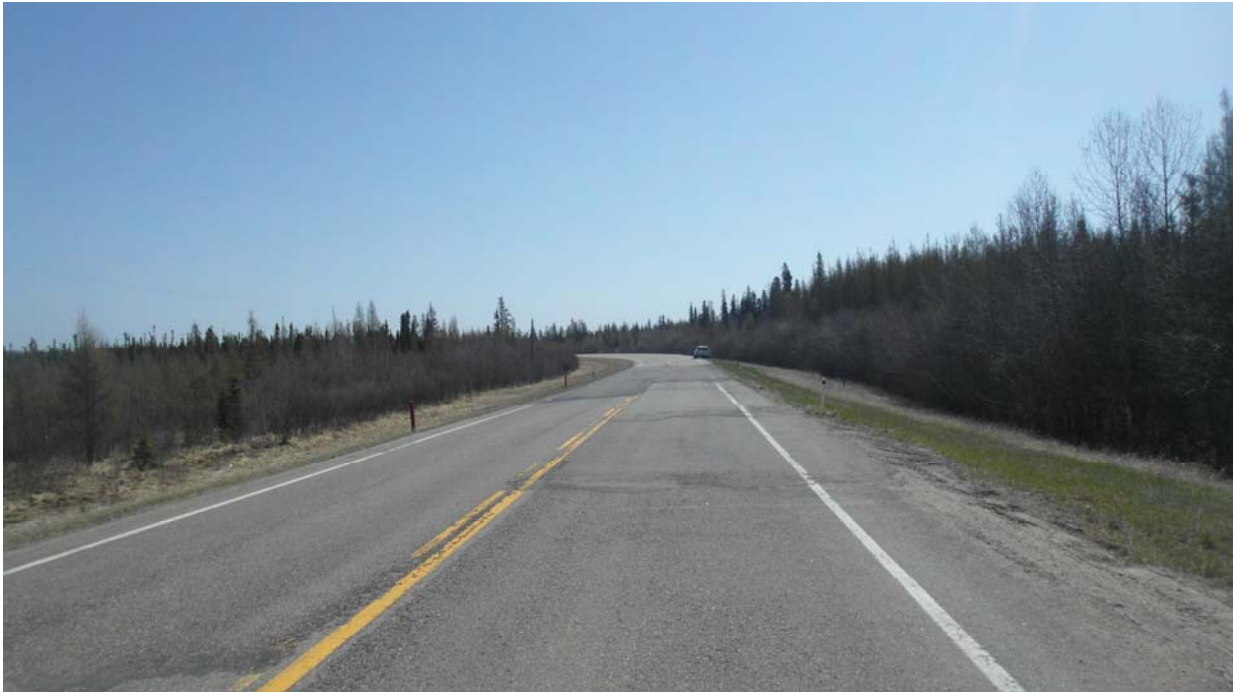
**Photo #1** General view of the highway looking east; note the ACP patch placed on the highway surface

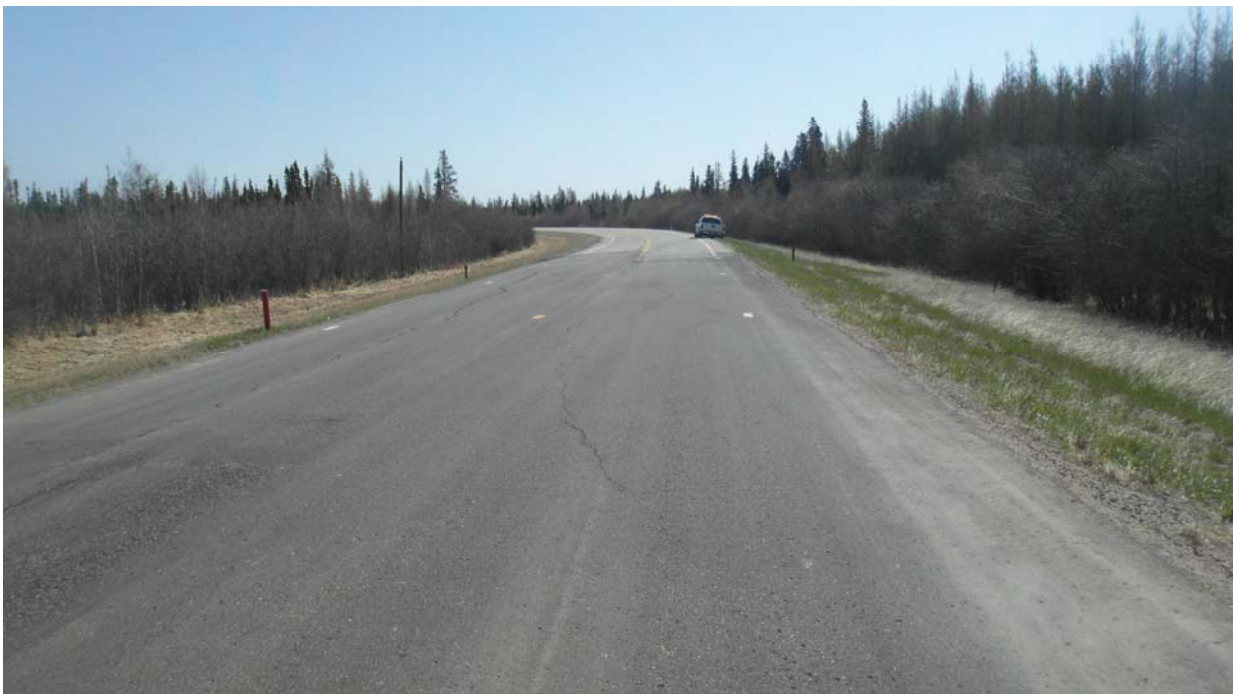
**Photo #2** Looking east from the western flank of the landslide at a reflective diagonal crack in the highway EBL (NC58)

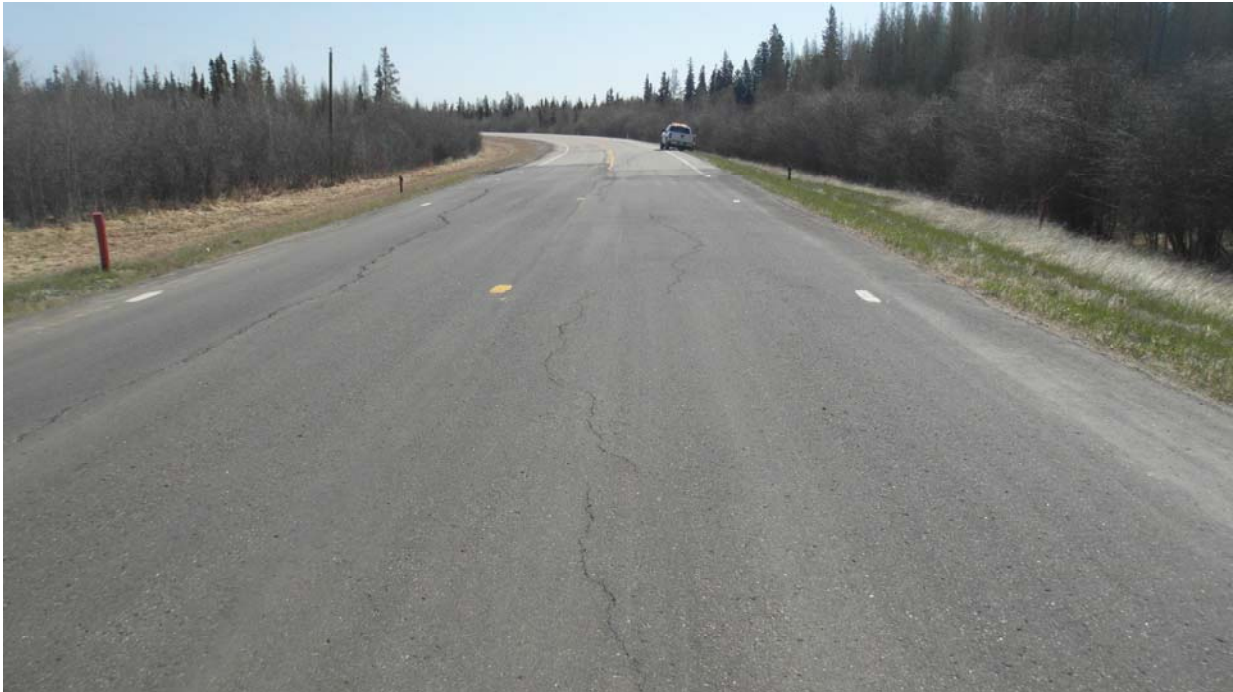
**Photo #3** Looking east from the western limit of the landslide at open longitudinal reflective cracks in the highway EBL (NC58)

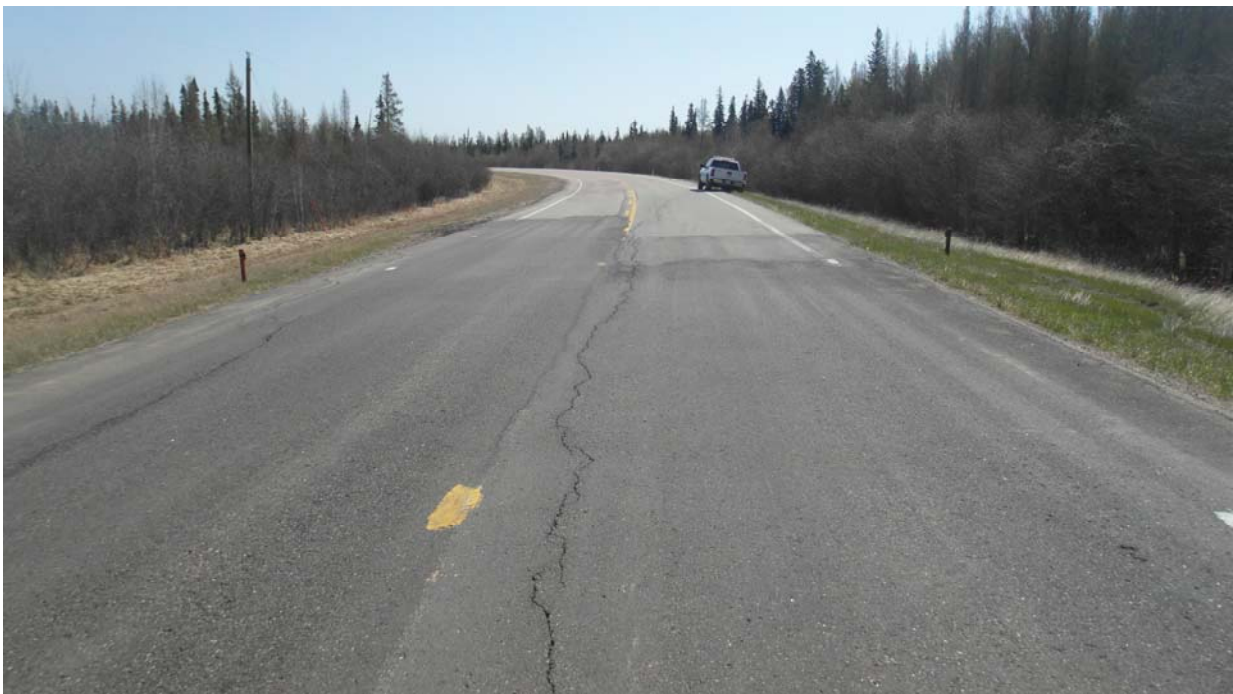
**Photo #4** Looking east from near the eastern limit the landslide at a longitudinal reflective crack in the highway EBL (NC58)

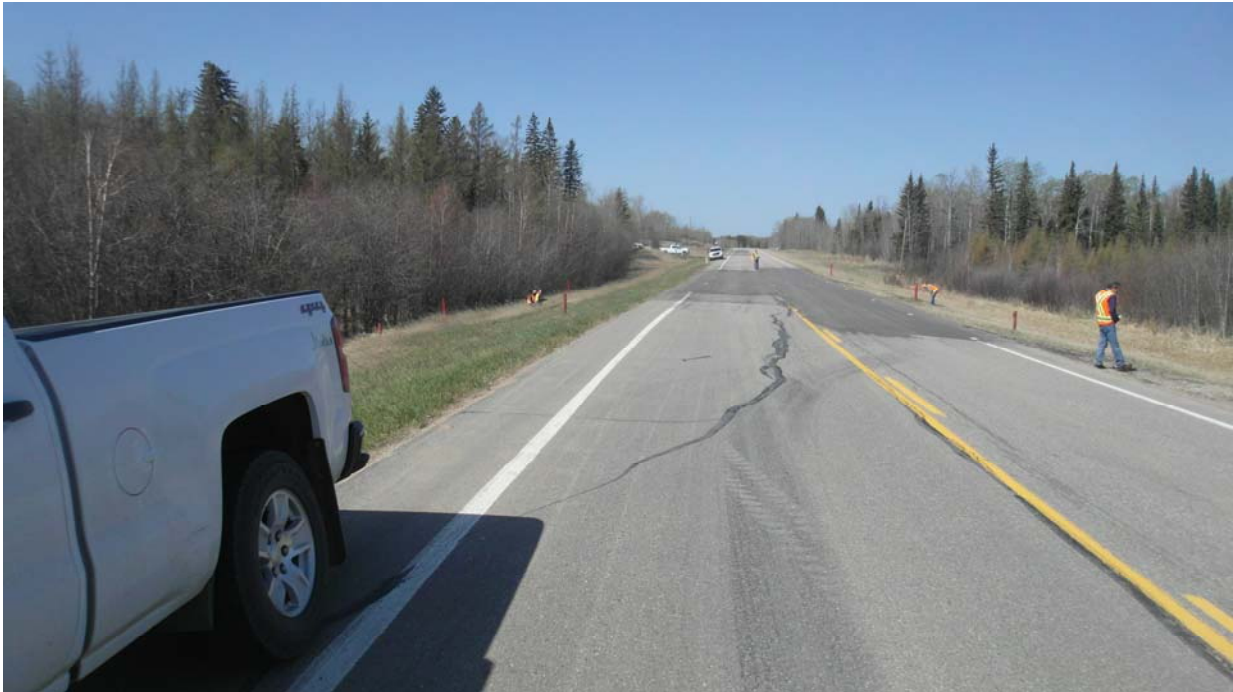
**Photo #5** Looking west from the eastern flank of the landslide at a reflective diagonal crack in the highway EBL (NC58)

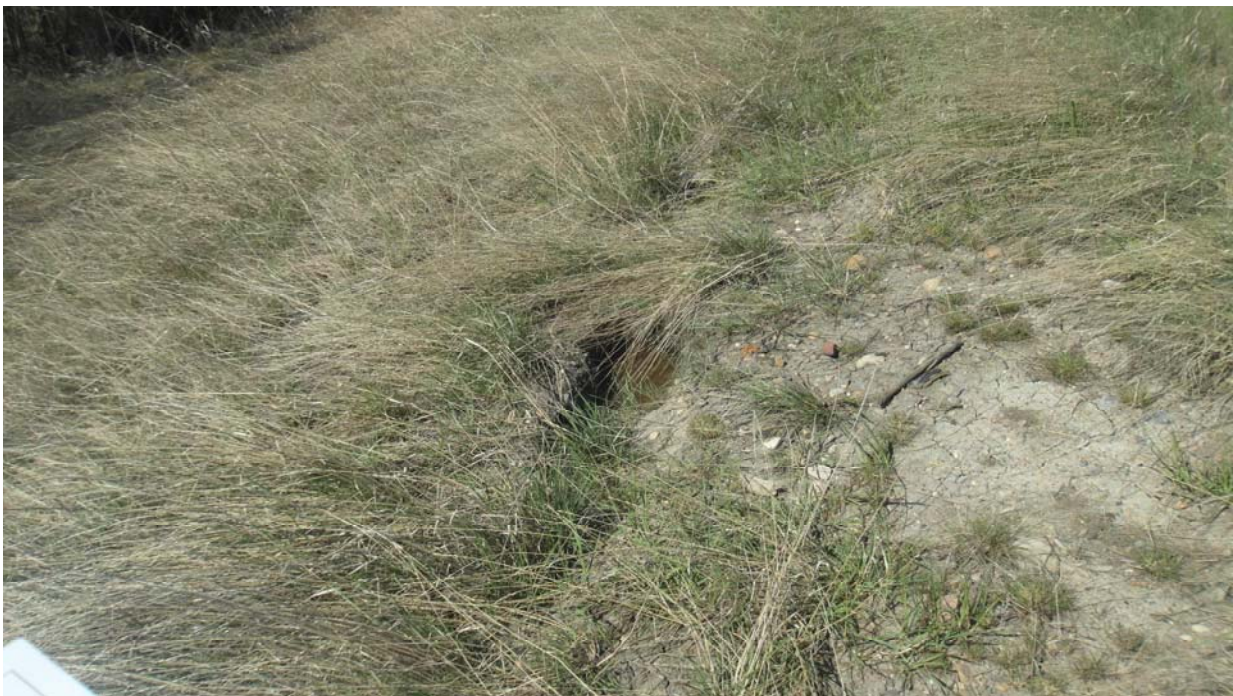
**Photo #6** Looking at voids formed at a few locations along the tops of the piles (NC58)

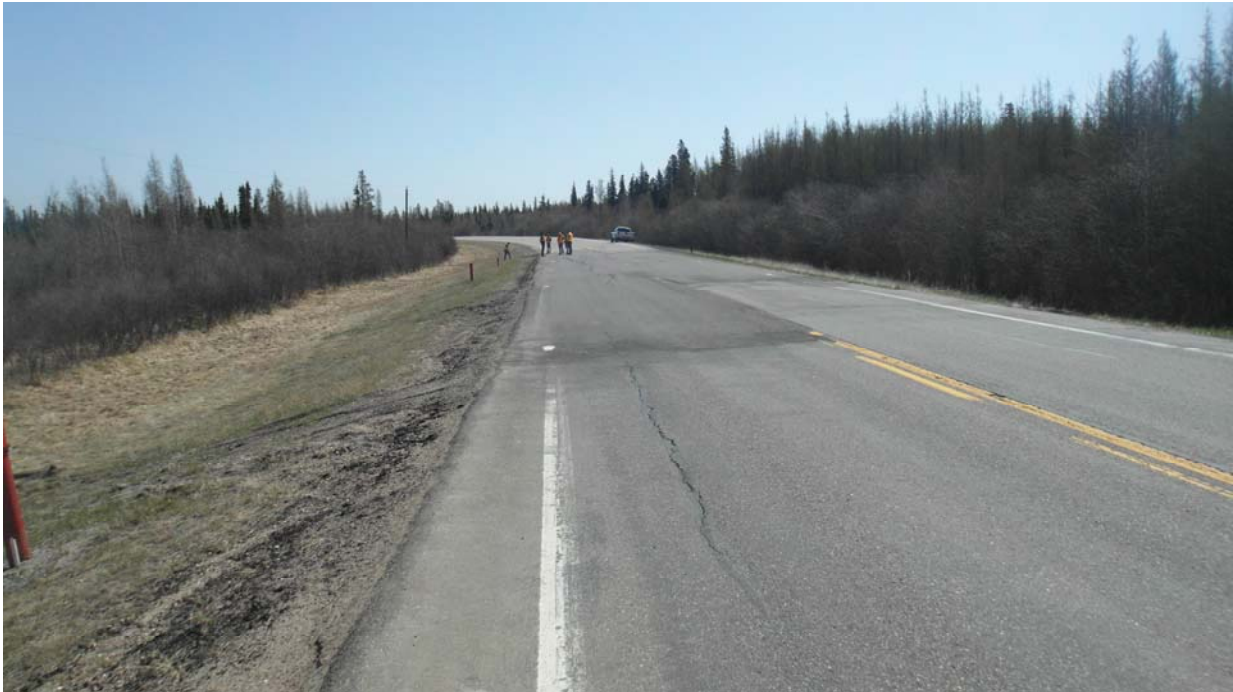
**Photo #7** Looking east at an open longitudinal crack in the highway WBL (NC58A)

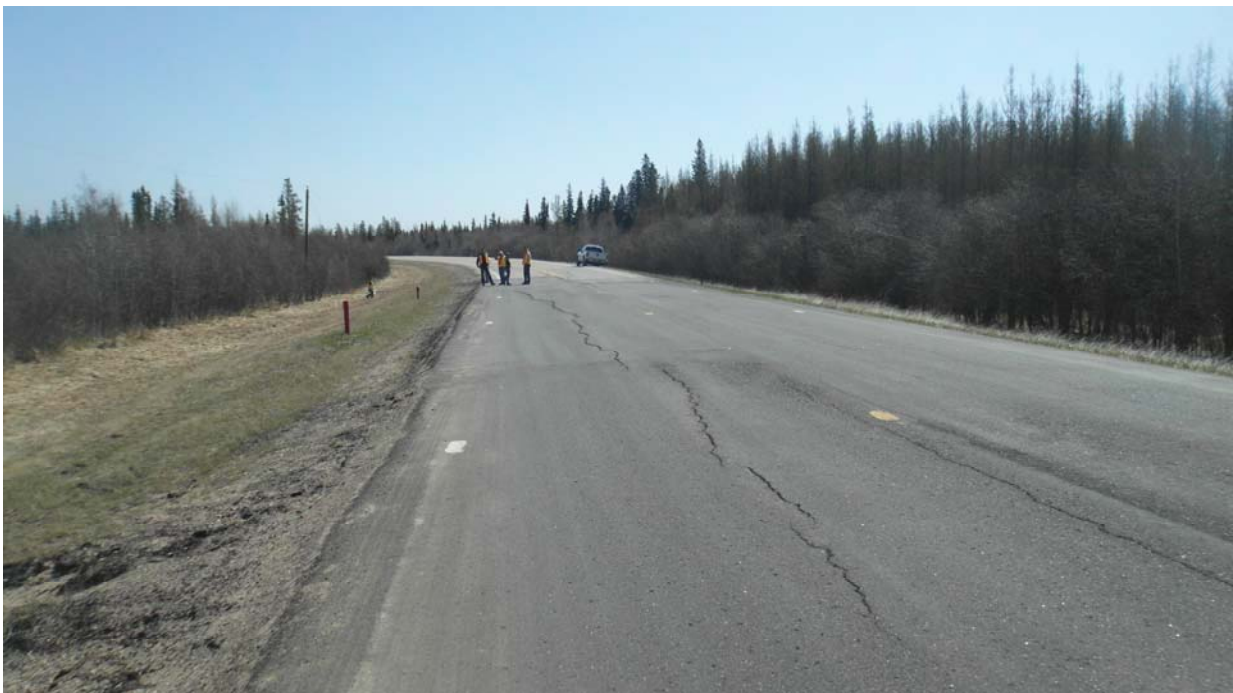
**Photo #8** Looking east at open cracks on the highway surface (NC58A); note existing dip

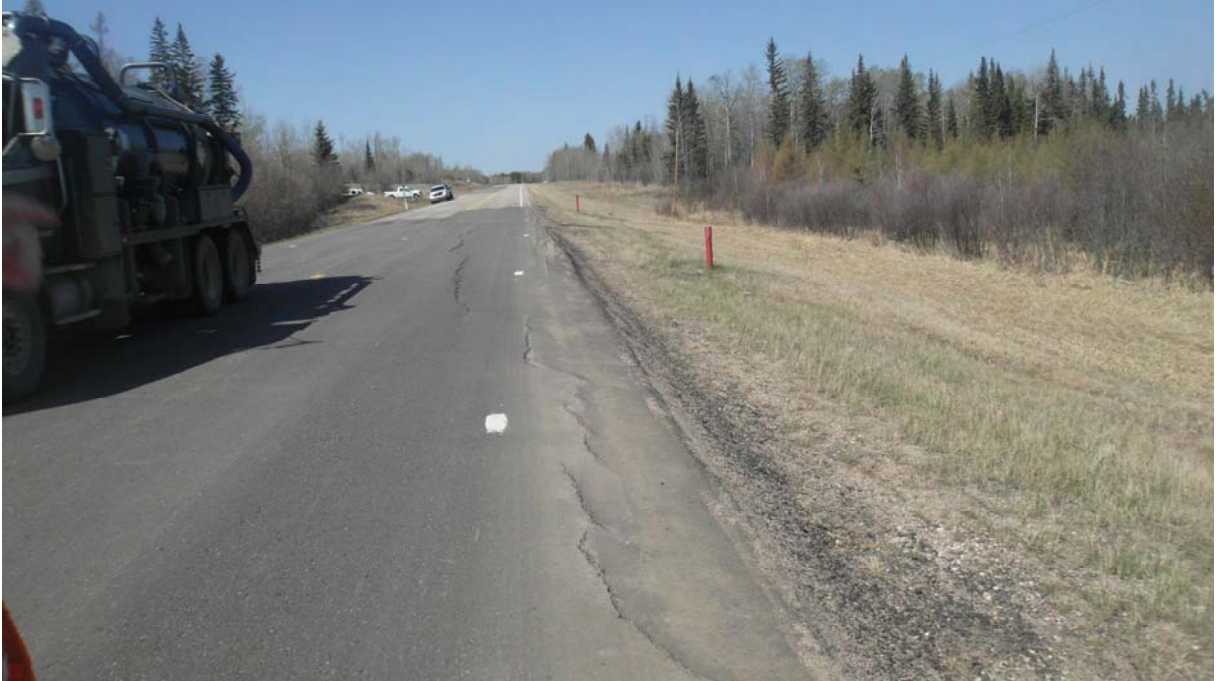
**Photo #9** Looking west from the eastern flank of the landslide at the dip bounded by the highway cracks (NC58A)
