SITE NUMBER AND NAME C7 H16:30 Kenilworth Lake		HIGHWAY & KM	PREVIOUS INSPECTION DATE May 23, 2002	INSPECTION DATE May 19, 2010
LEGAL DESCRIPTION NE 28-50-4-4	NAD 83 COORDINATES N 5910800 E 532788		RISK ASSESMENT PF: 7 CF: 2 TOTAL: 14

PRIMARY SITE ISSUE: <p align="center">Slope instability, fill settlement.</p>	
APPROXIMATE DIMENSIONS:	
DATE OF ANY REMEDIAL ACTION: September 2001

Central Region GeoHazard Assessments
Site C07 H16:30 Kenilworth Lake Slide
May 2010 Site Assessment Report

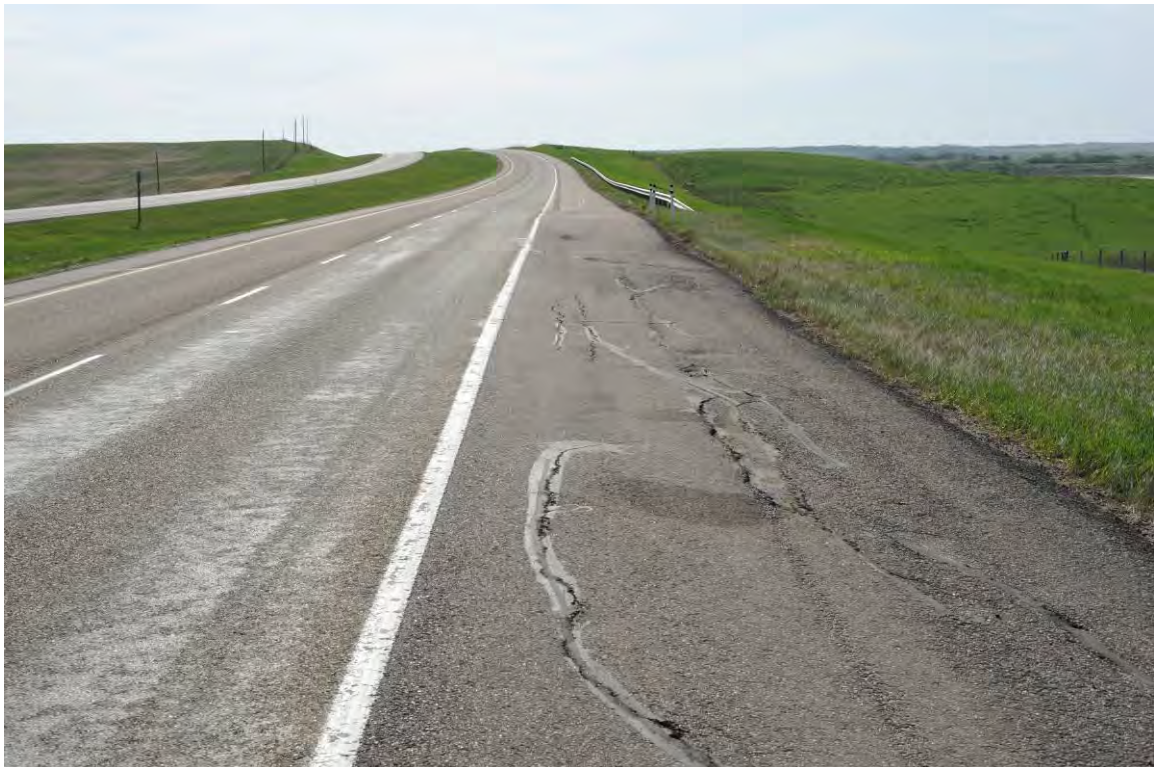
Photo 1 Site Conditions May 19, 2010

ITEM	CONDITION EXISTS		DESCRIPTION AND LOCATION	NOTICABLE CHANGE FROM LAST INSPECTION	
	YES	NO		YES	NO
Pavement Distress	X		Cracking of the pavement and settlement was observed on the shoulder. Some cracking extended into the driving lane.	X	
Slope Movement	X				X
Erosion					
Seepage					
Culvert Distress

The site was last inspected in May 2002, the spring after construction was complete. Vegetation has established and the site appears to be performing relatively well. However, as shown in the photos below, cracking and settlement was observed on the shoulder above the slope. One crack extends into the driving lane. As shown in Photo 2, a semicircular area has dropped by a few centimetres.

It is considered that the observed distress in the pavement is due to residual slide movement and settlement of the fill. However, it is recommended that two inclinometers be installed in the slope to confirm the nature and rate of any movement. It is recommended that the instruments extend below the assumed weak zone at about elevation 597 m and about 5 m into bedrock.
