SITE NUMBER AND NAME C07 H16:30 Kenilworth Lake		HIGHWAY & KM	PREVIOUS INSPECTION DATE June 19, 2012	INSPECTION DATE May 15, 2013
LEGAL DESCRIPTION NE 28-50-4-4	NAD 83 COORDINATES N 5910800 E 532788		RISK ASSESMENT PF: 9 CF: 2 TOTAL: 18

**Central Region GeoHazard Assessment
Site C7 H16:30 Kenilworth Lake Slide
Site Inspection & Instrumentation Report**

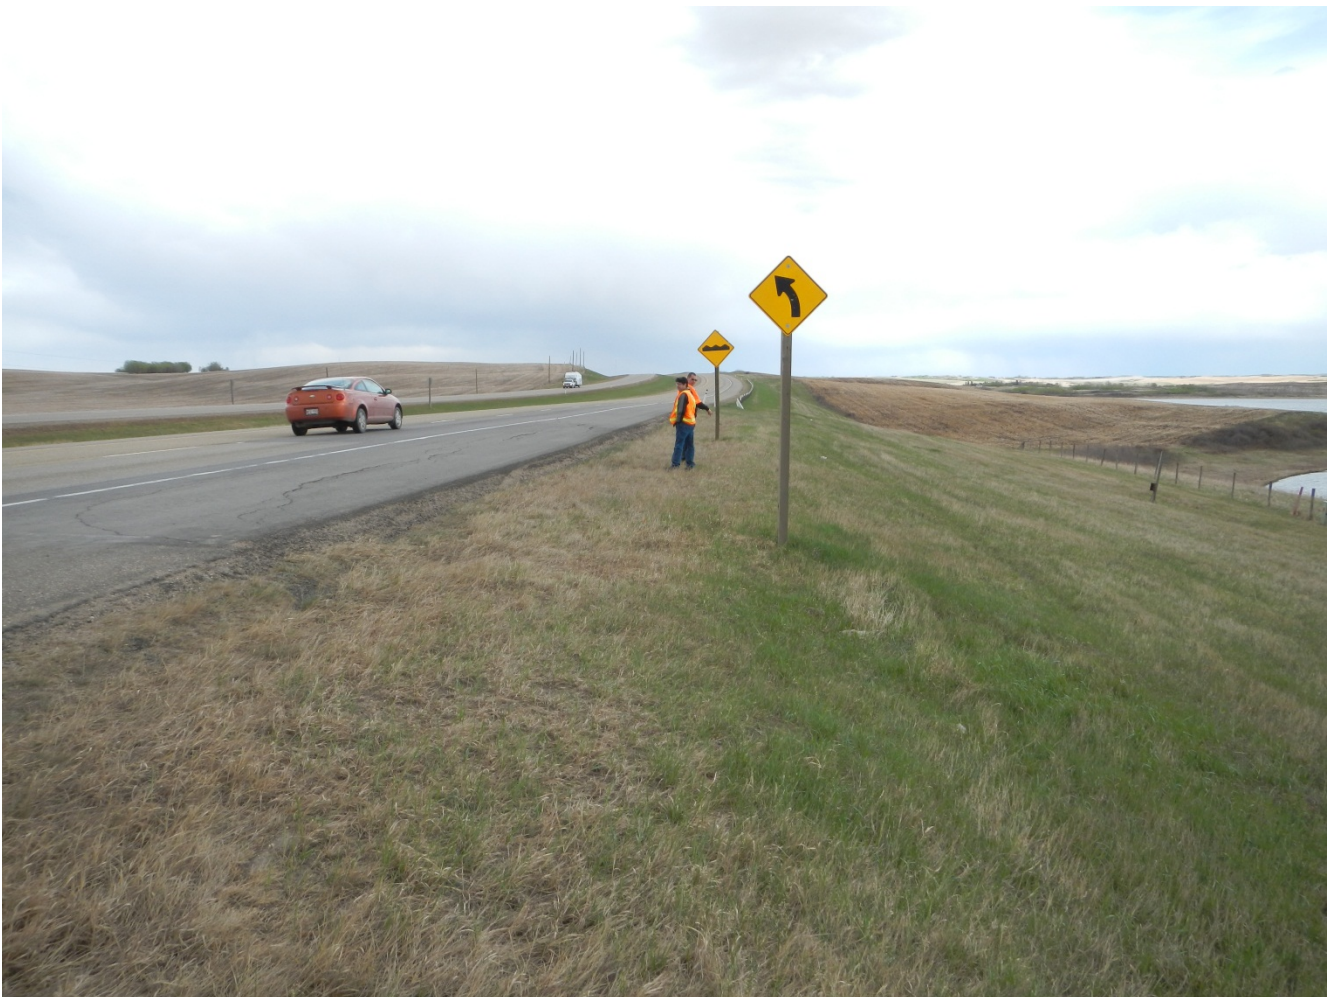
Photograph 1 **Pavement Condition May 2013**

Prior to 2010, the site was last inspected in May 2002, the spring after construction was complete. Vegetation had established and the site appeared to be performing relatively well. However, cracking and settlement was observed on the shoulder above the slope in 2010. One crack extended into the driving lane and a semicircular area on the shoulder had dropped by a few centimetres.

By June 2012, the cracking extended almost to the centerline of the eastbound portion of the highway. Additional settlement, necessitating repaving, continued to occur in 2011, 2012 and 2013. However, no visible distress was observed on the slope.

Movements appear to be occurring on a shear plane in the clay till located at a depth of about 7 m to 8 m below the existing ground surface. As noted previously, the till contains high plasticity bentonitic and reworked shale layers and the failure is likely located in a low strength zone. A stability analysis was undertaken on section shown in Figure 2 to determine the estimated friction angle of the material in the shear zone. Using the latest groundwater data, the stability results determined a clay friction angle of about 10°. This value is consistent with a high plasticity clay material at a residual strength.

The slide movements have likely become more noticeable at this site due to the higher precipitation levels in recent years. Kenilworth Lake is now full of water while in 2001, at the time of the repair, the lake was dry. Stability analyses indicate to achieve a factor of safety of 1.5, a slope angle of about 10H:1V is required. This would require a fill volume of about 6,000 m³ and an estimated project cost of about \$150,000 to \$200,000.

Alternatively, a line of driven steel H piles could be provided along the shoulder for a distance of about 20 m (about 25 piles). Each pile would be about 15 m to 20 m long. The estimated cost of this

option is about \$100,000. The pile option offers a number of advantages over an earthworks approach including a lower cost, rapid construction, and minimal environmental impact.
