May 25, 2001

Central Region Landslide Assessment Site C12
H841:02 Ditch Erosion
2001 Annual Inspection Report

This report was prepared by Klohn Crippen Consultants Ltd. for Alberta Transportation Central Region under Contract No. CE053/2000.

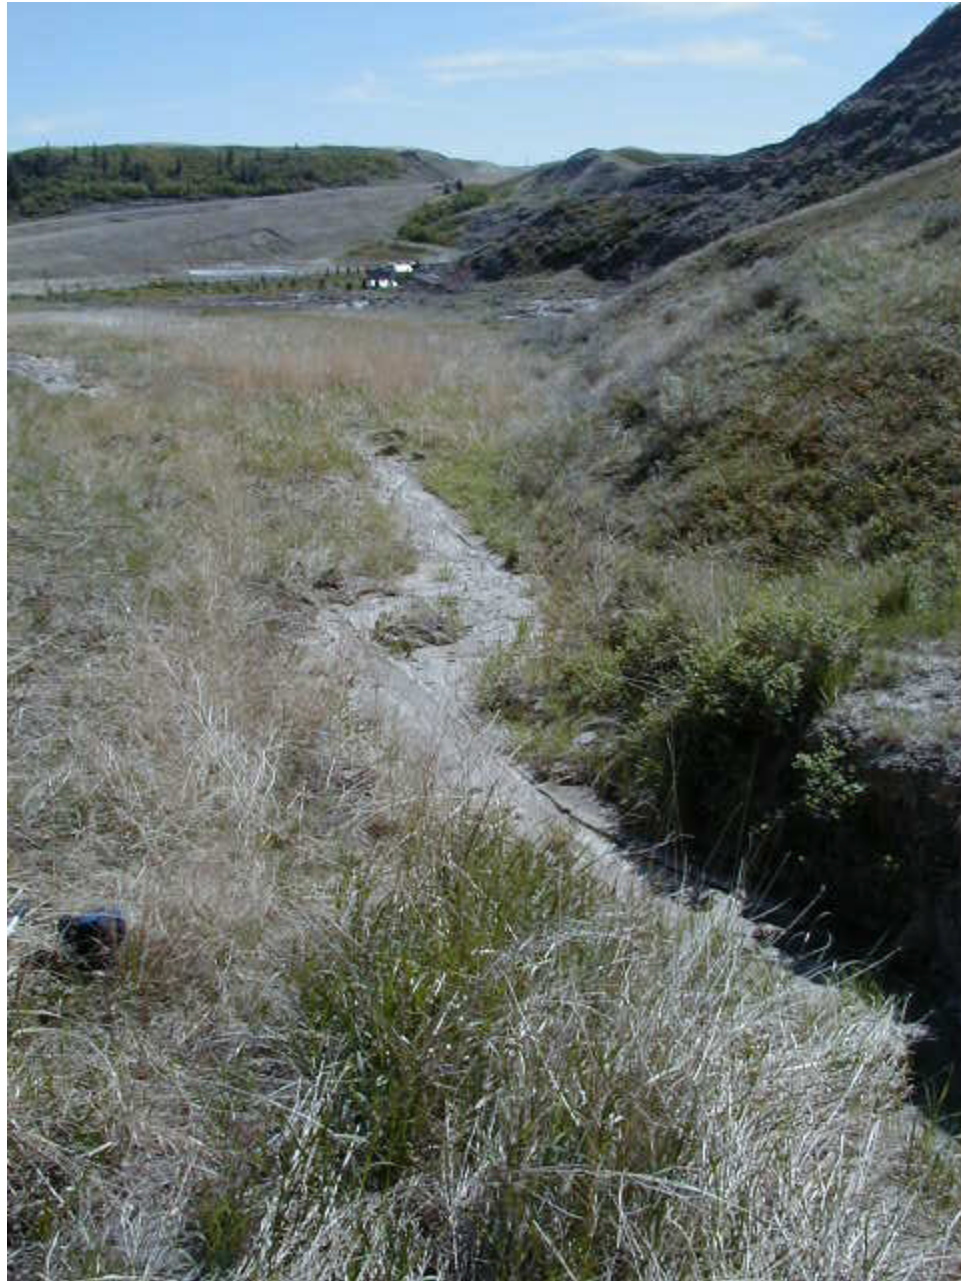
South end of erosion gully

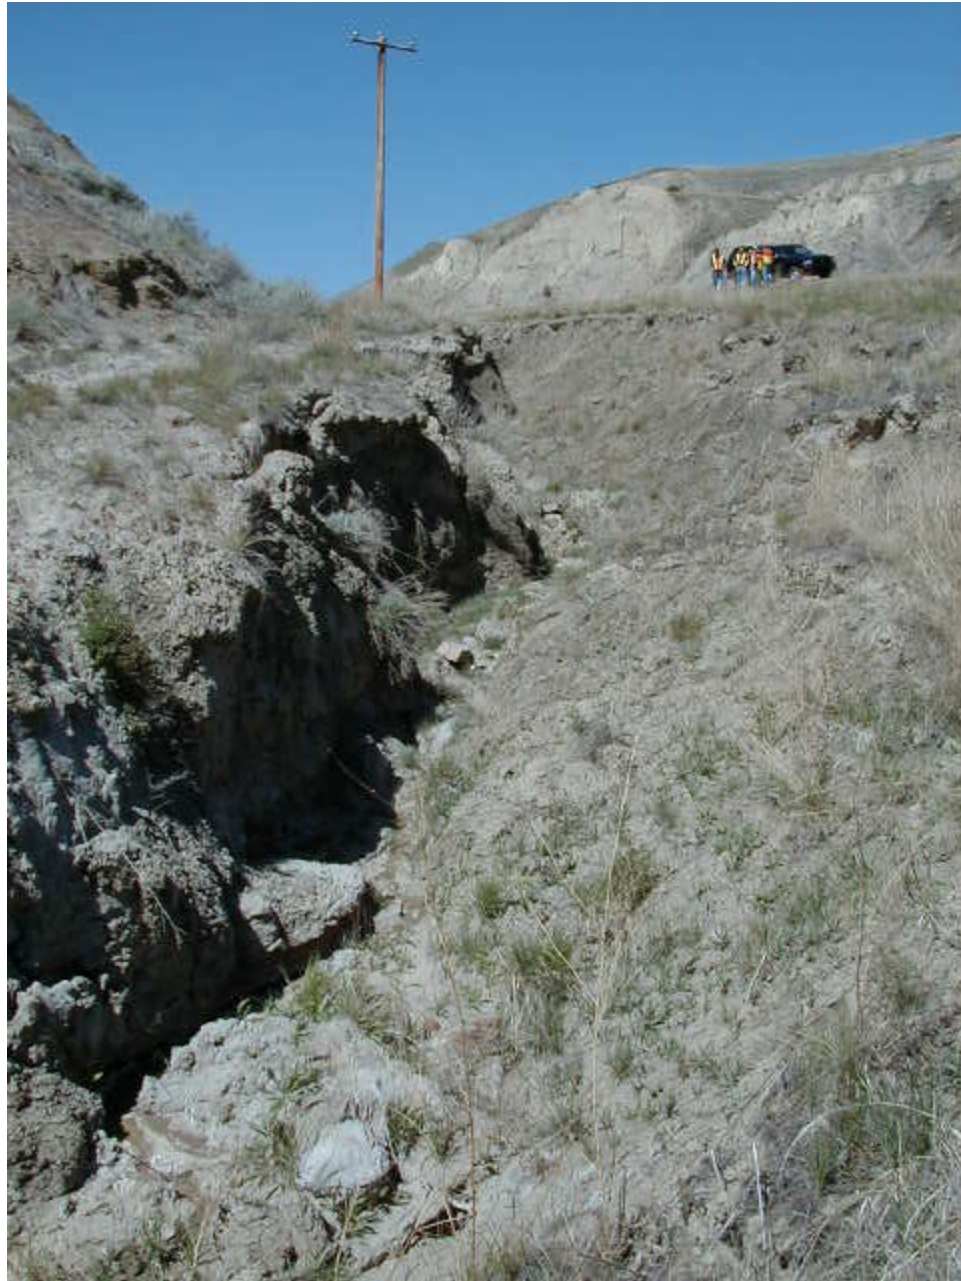
Looking north

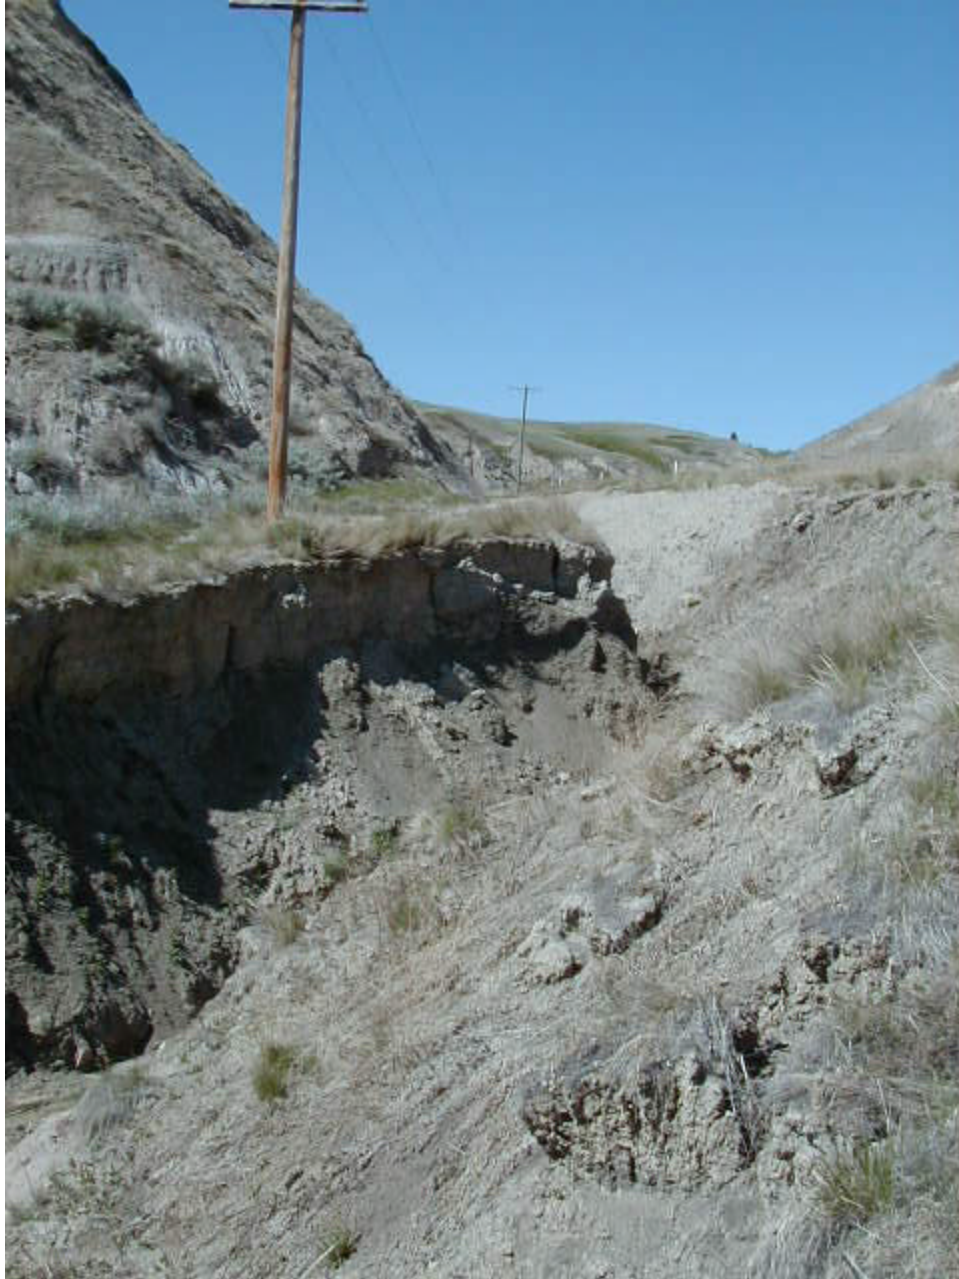
Prior to the recent May 2001 site visit, some of the south portion the ditch was backfilled. The work stopped however at a power pole location where the eroded ditch was outside the 9 m clear zone. The eroded section of the ditch is approximately 5 m deep and 10 m wide and extends over a distance of about 65 m. As the ditch grade flattens to the south, the depth of erosion tapers out and disappears.

Looking north. Gully is about 5 m deep at power pole.

- It is considered that protection should only be provided within 9 m of the highway edge. However, some backfilling of the deep erosion channel is recommended to prevent the loss of the power pole.

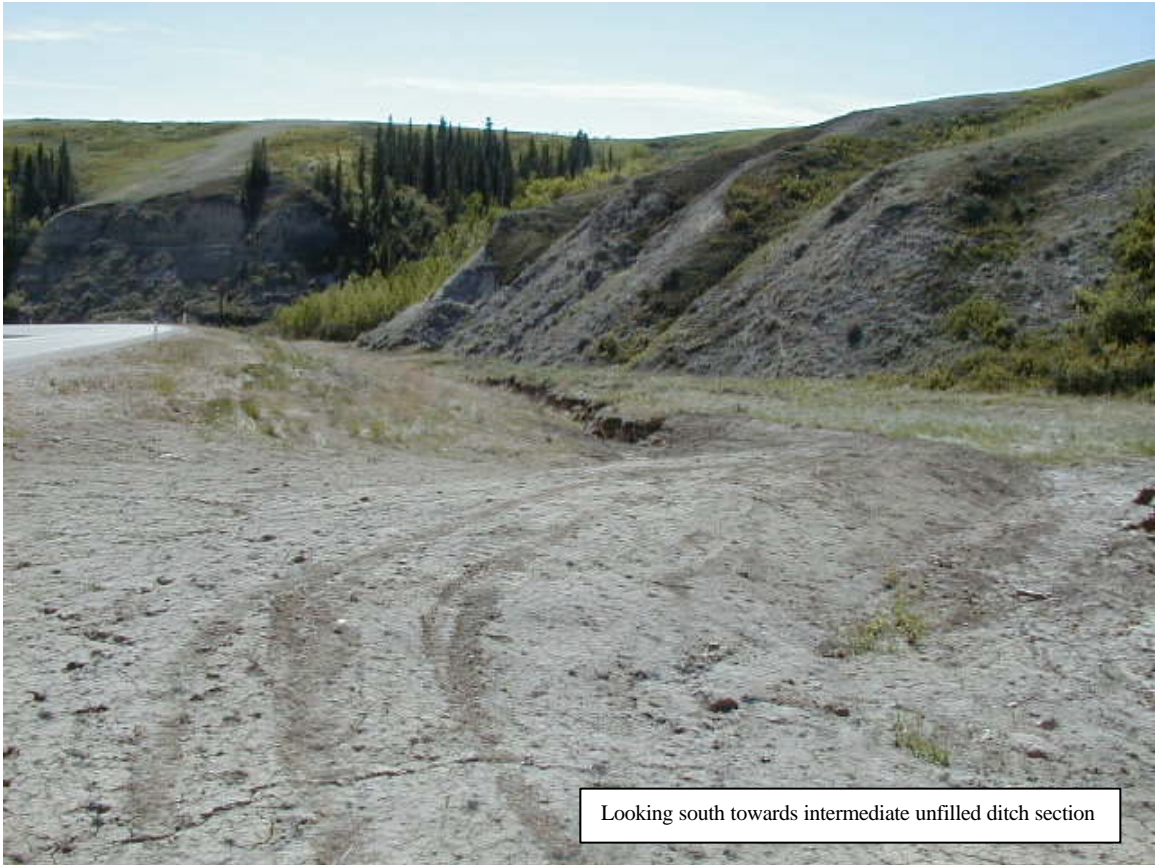
Looking south towards intermediate unfilled ditch section

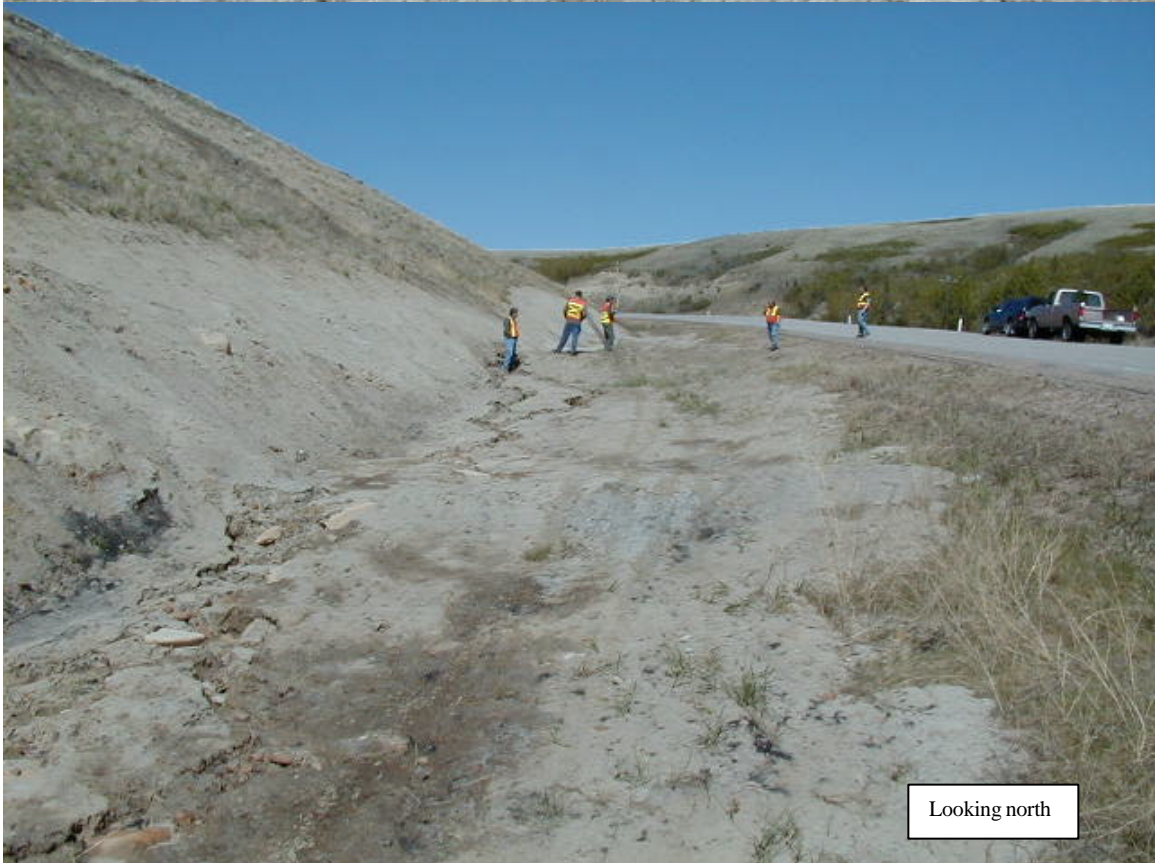
Looking north
