Alberta Transportation
Central Region
#401, 4902 – 51 Street
Red Deer, Alberta
T4N 6K8

Central Region Landslide Assessment Site C18
SH837:02 Riverbank Slide @ km 1.9
July 2001 Inspection Report & Repair Recommendations - DRAFT

This report was prepared by Klohn Crippen Consultants Ltd. for Alberta Transportation Central Region under Contract No. CE053/2000.

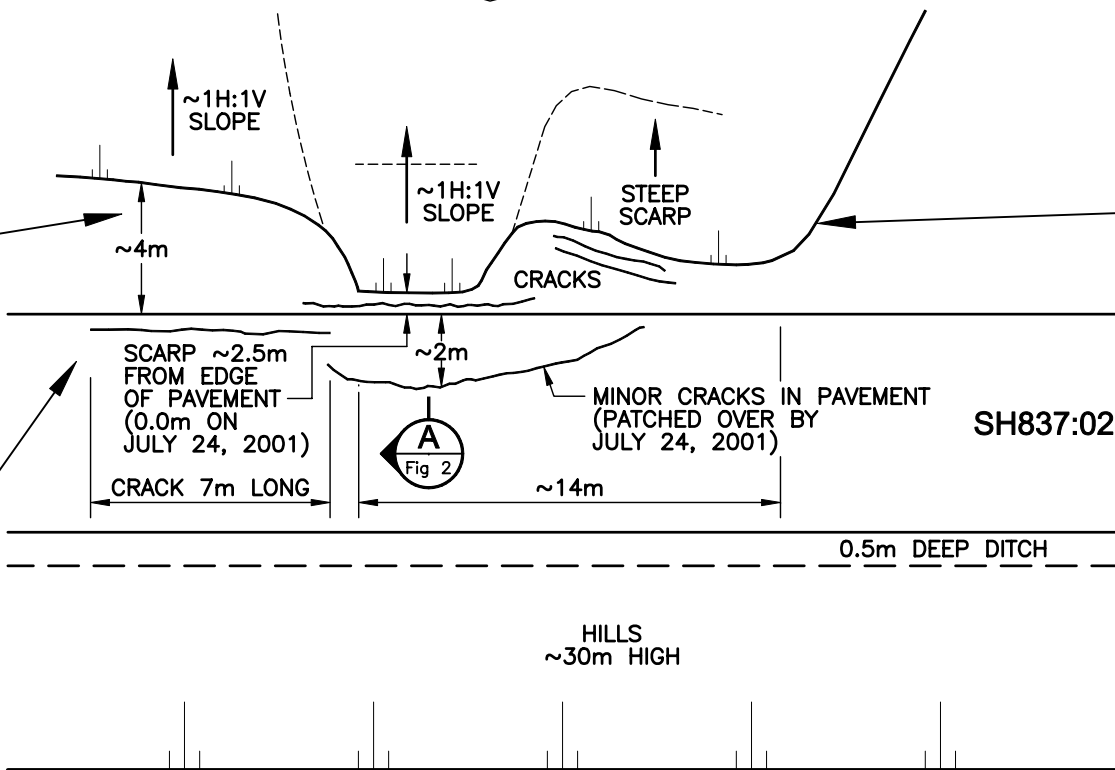
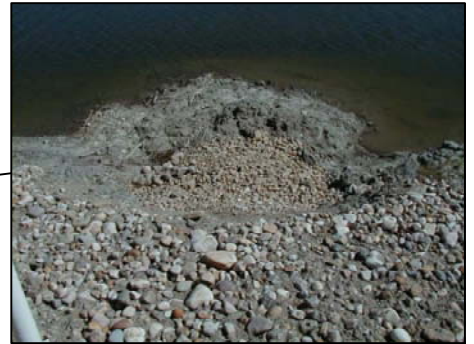
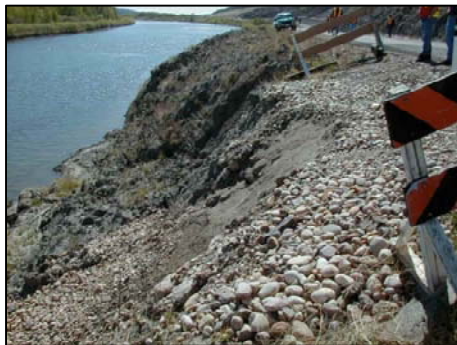
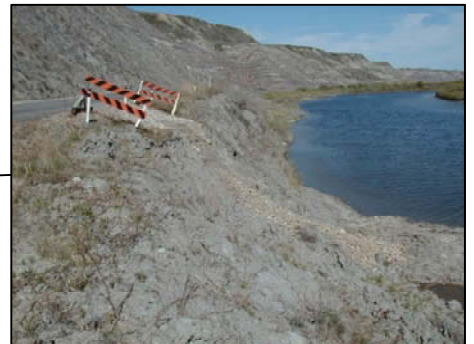
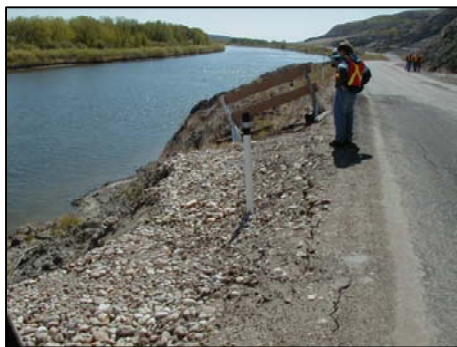
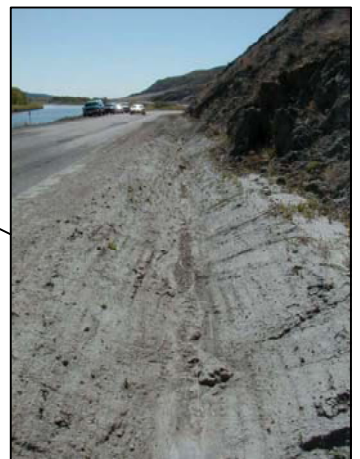
The current features of the site are illustrated in Figure 1 and in the attached photographs.

The slide area appears to be extending both upstream and downstream. Beyond the slide itself, cracks are appearing at the crest of the riverbank. The location of the cracks would tend to suggest that the near vertical banks located immediately to the north and south are becoming unstable. The overall extent of the unstable riverbank measures approximately 40 m.

DISPLACED SOIL
FAN IN RIVER
