June 11, 2002

Alberta Transportation
Central Region
#401, 4902 – 51 Street
Red Deer, Alberta
T4N 6K8

**Central Region Landslide Assessment Site C18
SH837:02 River Scour @ km 1.9
2002 Annual Inspection Report**

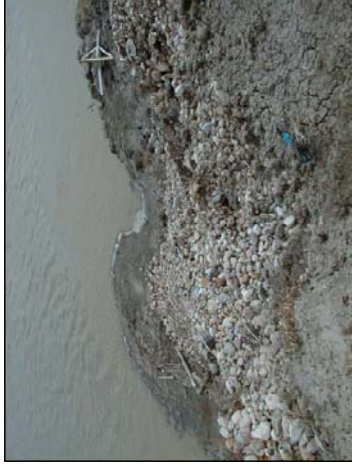
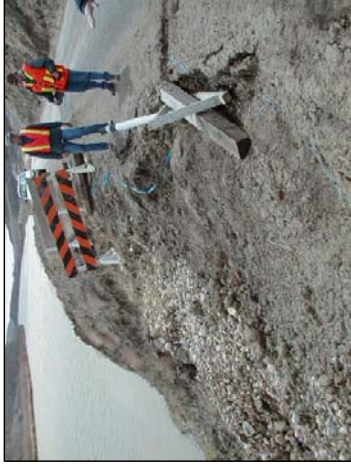
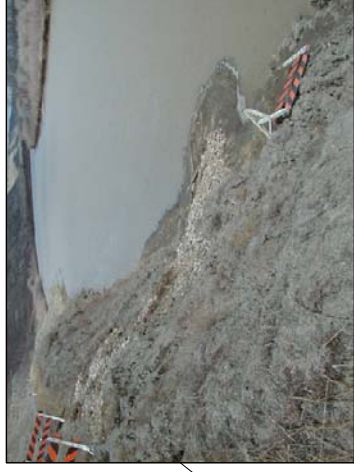
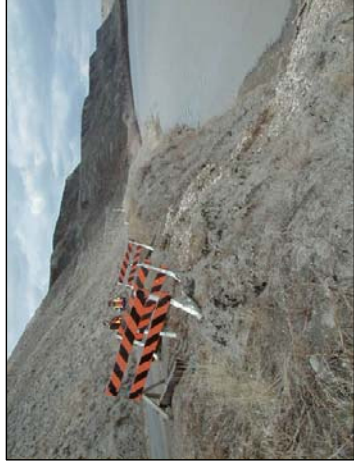
1. PHOTOS TAKEN
MAY 16, 2002

The slide is essentially unchanged from the previous visit on October 3, 2001, however additional minor cracks are forming at the crest of the riverbank and in the highway surface. The location of the cracks would tend to suggest that the near vertical bank that is located immediately to the north is becoming unstable.

The slide area appears to be extending both upstream and downstream. Beyond the slide itself, cracks are appearing at the crest of the riverbank. The location of the cracks would tend to suggest that the near vertical banks located immediately to the north and south are becoming unstable. The overall extent of the unstable riverbank measures approximately 40 m.

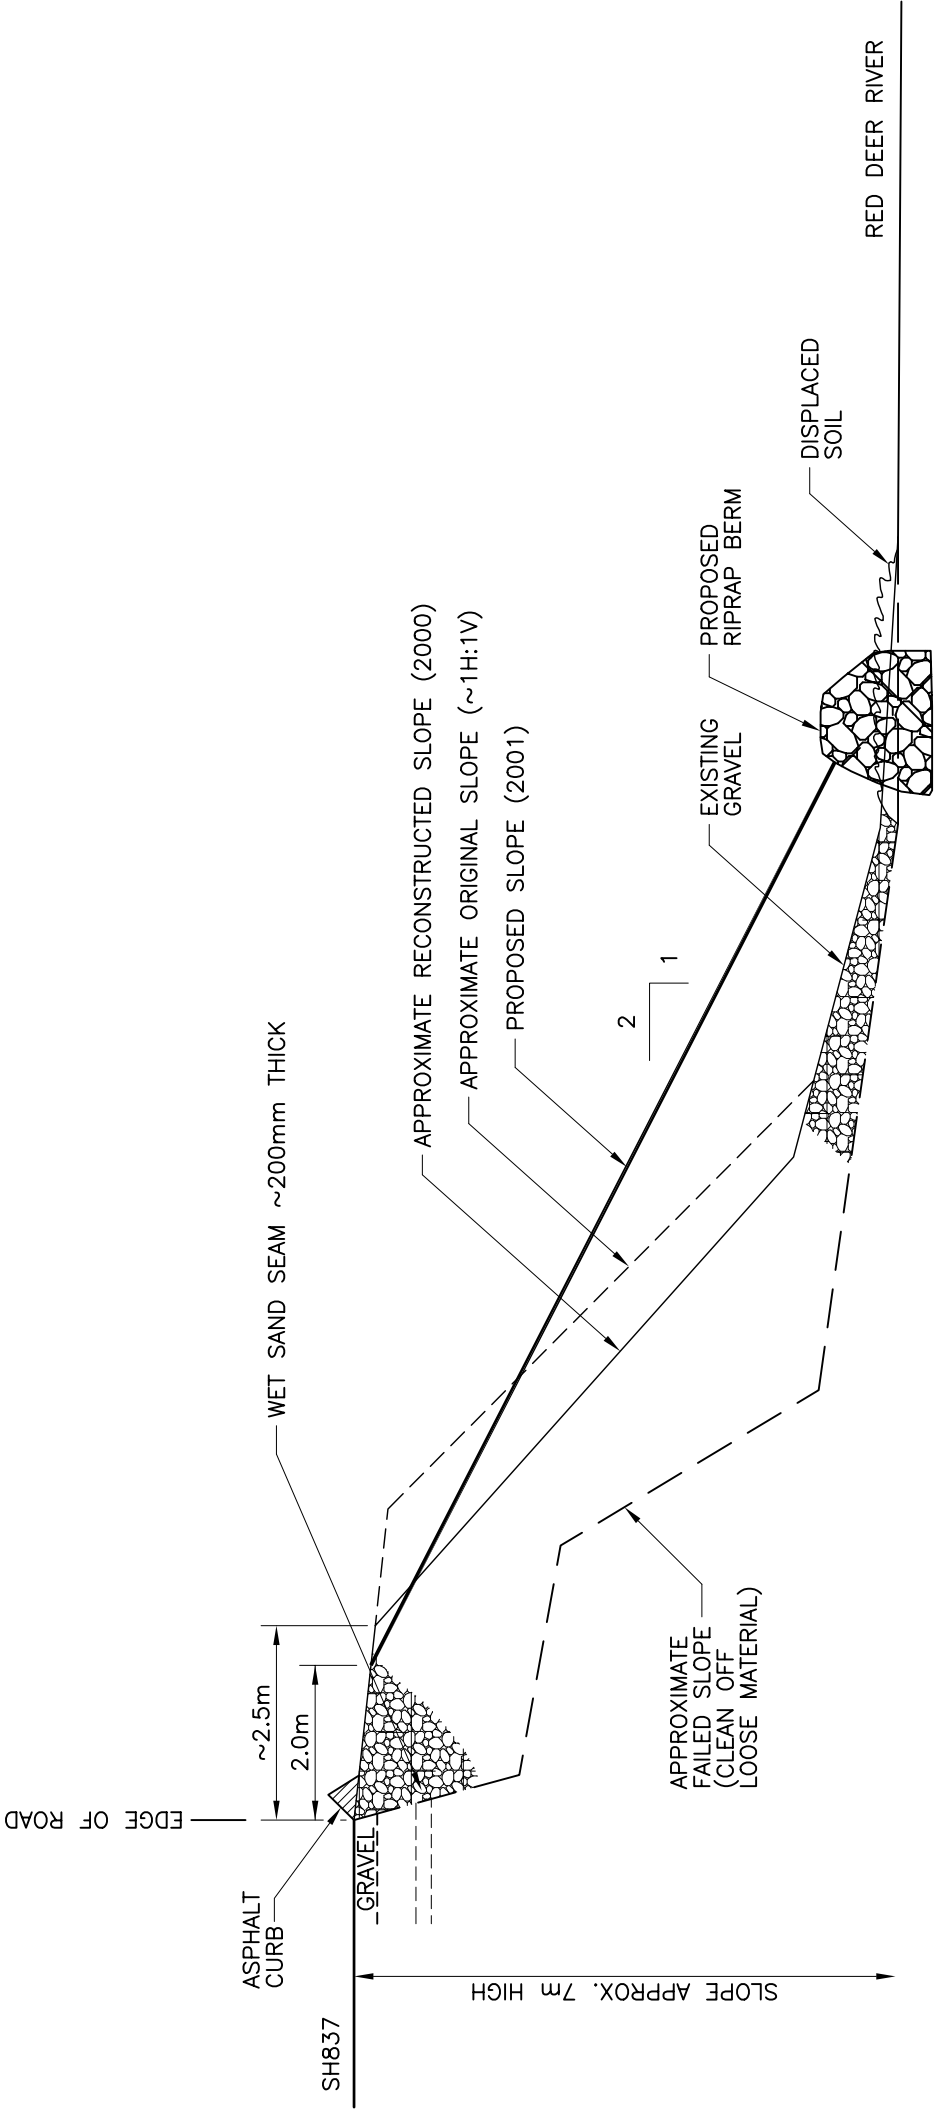
</div>										CENTRAL REGION							
												LANDSLIDE RISK ASSESSMENT							
												TITLE							
												SITE C18 : SH837 RIVER BANK SLIDE SECTION A-A							
												DATE		SHEET		DRAWING No.		REV.	
												MAY 2002		3 of 3		FIGURE 3		B

SECTION A
1:100
(Fig 1)

It is believed that the most efficient remedial action to take is the use of a protection/retention toe berm in conjunction with compacted pit run gravel to reinstate the slope to about 2H:1V (Figure 3). To effectively stabilize the slope, the reinstatement must occur working from the bottom to the top.

At the request of DFO, the toe berm is to comprise traditional Class II rock riprap with no instream work occurring between April 16 and June 30. To place the berm, a backhoe or similar equipment could be used to lower the rocks into place. The pit run gravel can be placed by dumping from the road edge and compacting in horizontal lifts with hand operated tampers or small compaction equipment.

1. PROPOSED LENGTH OF RECONSTRUCTED SLOPE IS 40m (FIELD FIT CONFIGURATION SHOWN TO SUIT SITE CONDITIONS).
