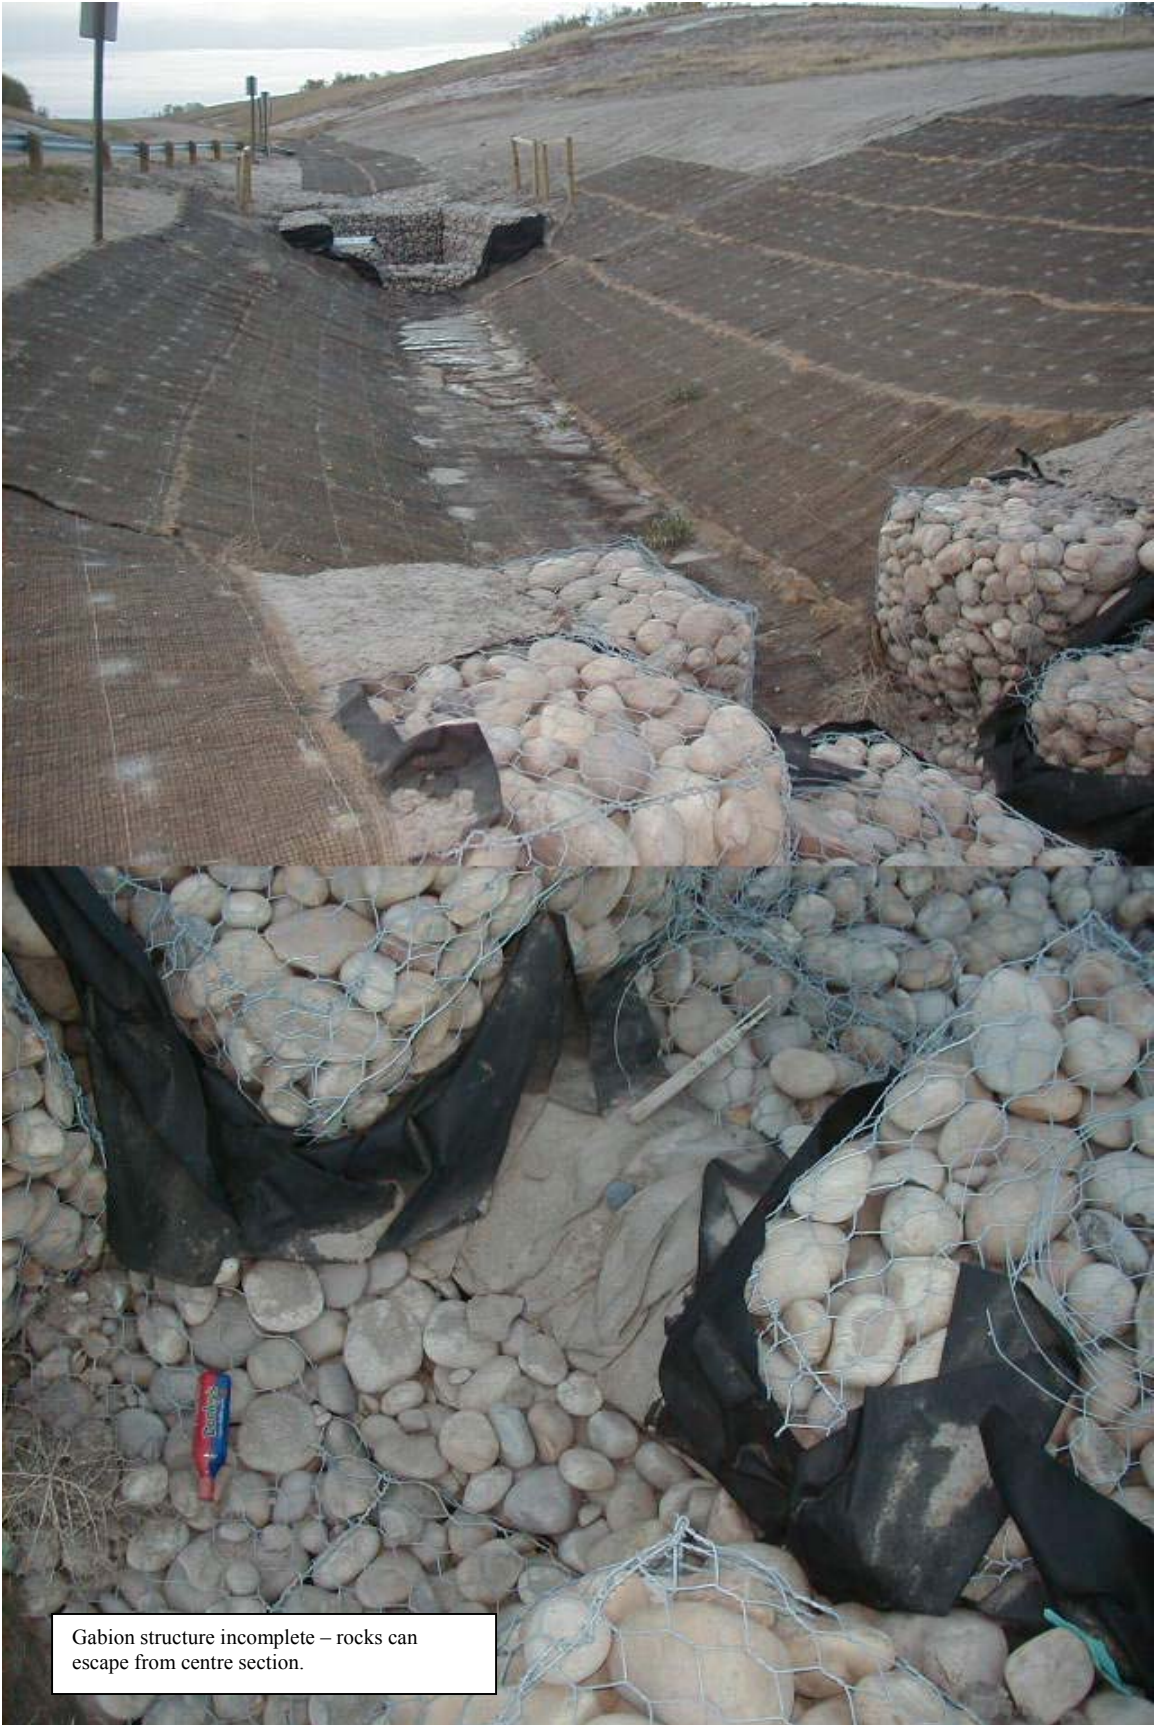
Gabion structure incomplete – rocks can escape from centre section.

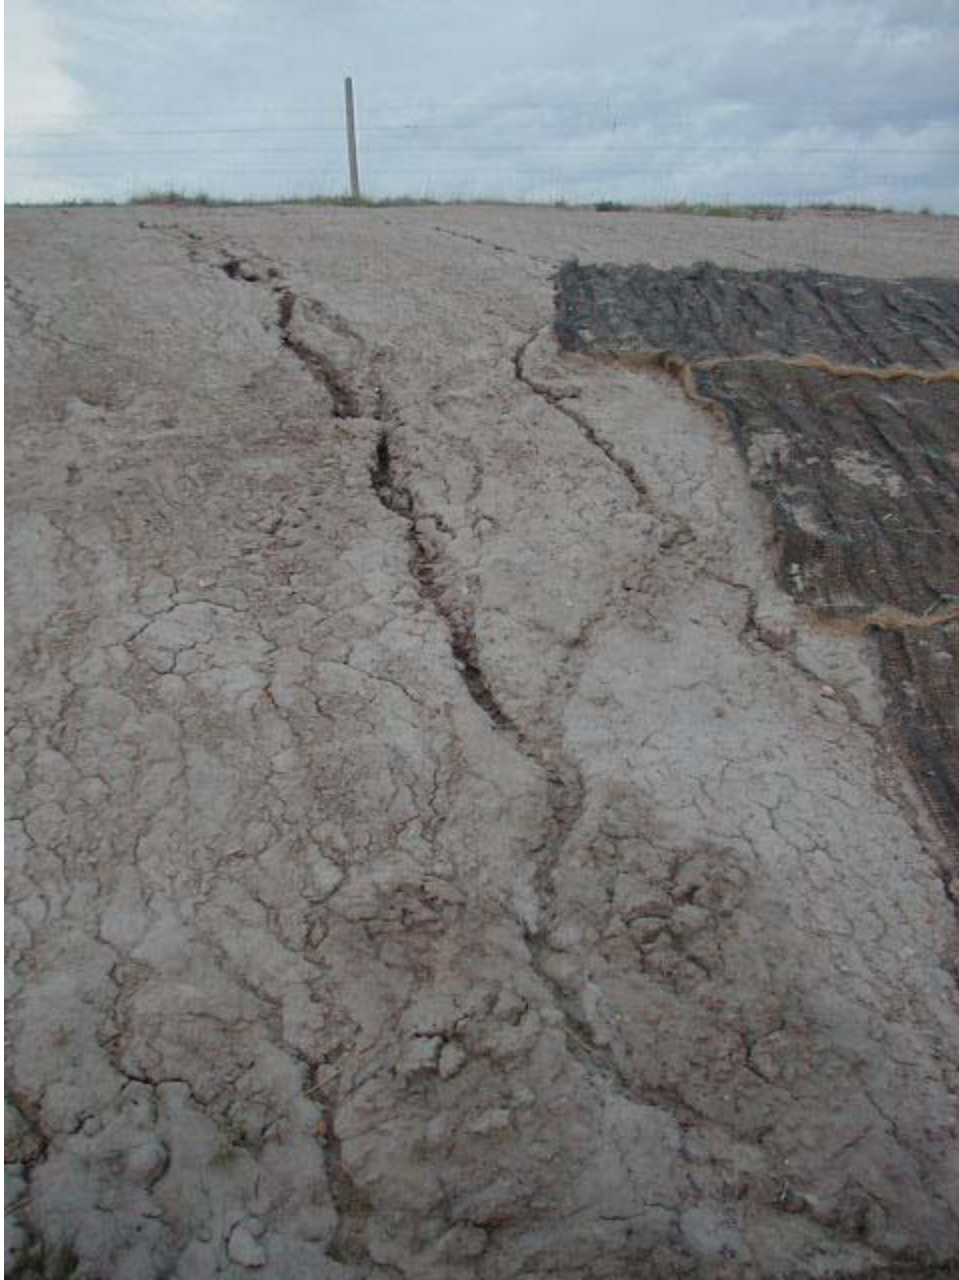
Minor rill erosion beyond matting
