SITE NUMBER AND NAME C24 H564:10 Slide		HIGHWAY & KM 32.29 – 32.47	PREVIOUS INSPECTION DATE Oct. 26, 2009	INSPECTION DATE May 18, 2010
LEGAL DESCRIPTION SW 21-27-18-W4	NAD 83 COORDINATES N 5686020 E 396380		RISK ASSESMENT PF: 2 CF: 2 TOTAL: 4

Central Region GeoHazard Assessments
Site C24 H564:10 Kenilworth Lake Slide
May 2010 Site Assessment Report

Alberta Transportation has initiated a process of risk management at specific geohazard sites that includes a document control system. This annual site assessment report forms Section B of the document control system for the above site.

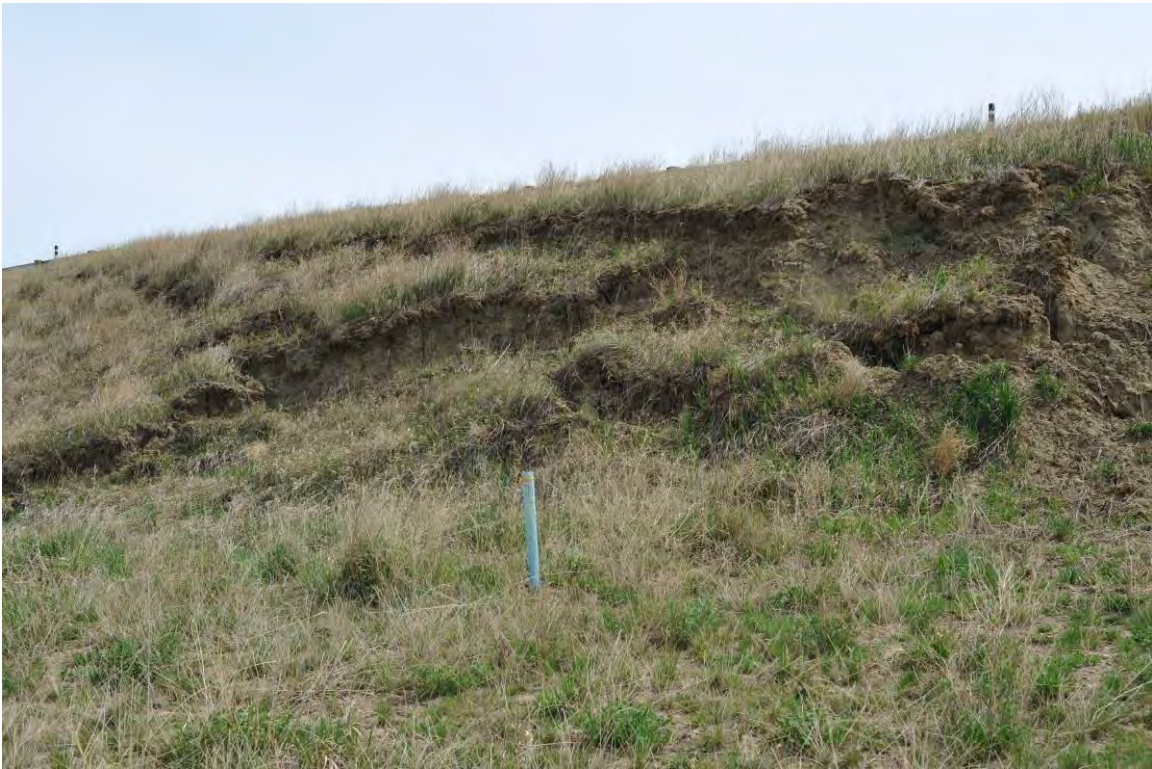
The site has been monitored at least twice per year since the 2007/2008 construction. Some cracking and settlement have been observed in the remediated area. However, in the May 2010, it was noted that the area immediately east of the soil nailed area had slumped and a near vertical backscarp was apparent adjacent to the roadway, as shown in Photo 1 below. Some minor cracking was also apparent in the roadway above the new slump zone.

Photo 1 Site Conditions May 18, 2010 (SI4 in foreground, see Figure 1)

Based on the observed new movement and cracking in the area, it is recommended that slope inclinometers be installed to monitor the location and current rate of movement. It is suggested that 4 slope inclinometers be installed at the crest of the slope along the roadway and an additional 2 slope inclinometers be installed on the bench below the road level.
