June 23, 2011

Central Region GeoHazard Assessments
Site C24 H564:10 Slide
May 2011 Site Assessment Report

This report was prepared by Klohn Crippen Berger Ltd. for Alberta Transportation Central Region under Contract No. CE101/2008.

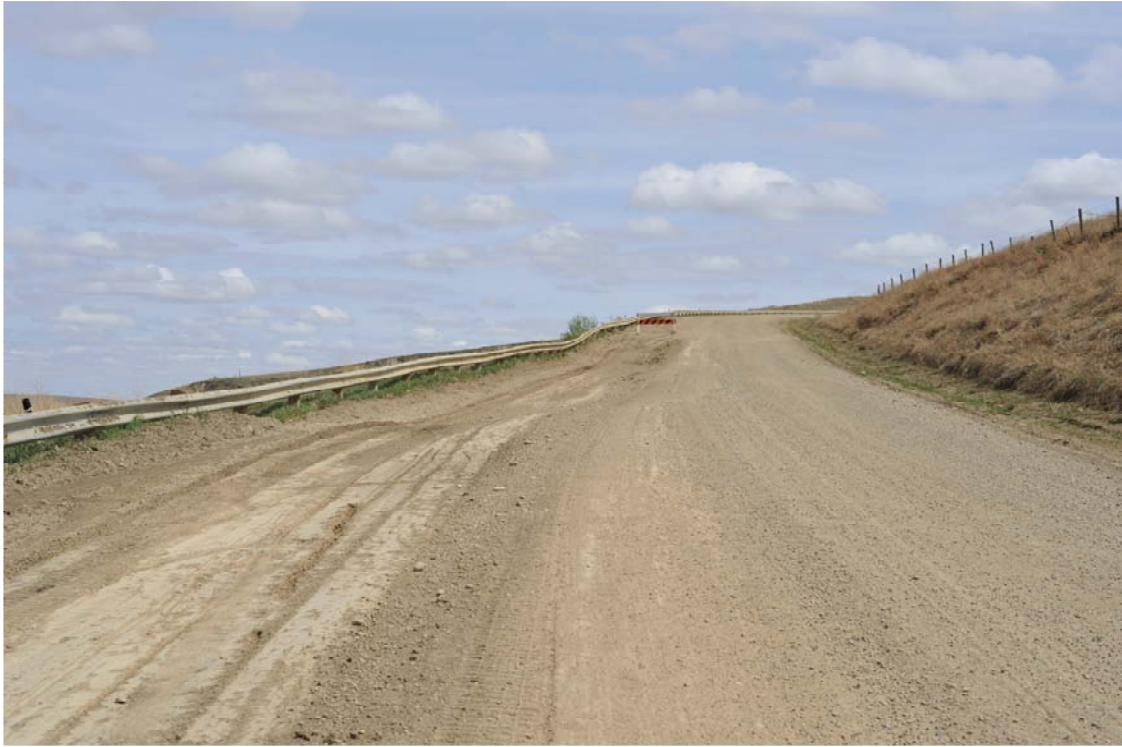
The site has been monitored at least twice per year since the 2007/2008 construction. Cracking and settlement over the original 70 m long section of highway at the crest of the slide has continued and has essentially returned to the condition observed in 2007 as shown in Photos 1 and 2 below. As shown, the guardrail indicates a lateral displacement at the edge of the highway. A barricade has been provided at the north end to direct traffic away from the settled zone.

Photo 1 Site Conditions May 13, 2011 (looking northeast)

It is considered that the highway is located at the crest of a major slide system in the coulee. Movements appear to be limited to the 70 m length originally observed in 2007 with the edge of the highway slowly displaced by the larger slide movement below. No signs of movement were observed beyond the settled zone on the highway. However, the current level of movement has effectively closed half the highway.

The slide was likely reactivated by ground saturation from the high regional precipitation levels in previous years. The observations indicate that this is a relatively deep slide in weak bedrock material and the attempts to stabilize the top of the slide have not been successful. It is considered that the creep movements will continue at a slow rate. A rapid failure, in particular due the remedial works installed below the highway, is considered a low probability.

Based on the risk level criteria provided by Alberta Transportation relating to safety, a risk rating of 54 was assigned to this site. This is based on a probability factor of 9 for an instability feature, and a consequence factor of 6 due to the partial closure of the highway.

In the interim, it is recommended to move the guardrail to the edge of the movement area, as shown on Figure 1. Approximately 200 m of guardrail will require realignment. It is recommended that new steel posts be installed along the new alignment and the existing guardrail be simply moved from the old posts to the new posts, leaving the old timber posts in place. An additional 30 m of new guardrail is required at the southwest end.

The realignment will reduce the highway width from about 12 m to about 8 m wide. Although this width is considered adequate for the low volume of traffic on the highway, it is recommended that a 10 m wide road be adopted due to the combined hill and curve. To achieve a 10 m wide road, surfacing gravel should be placed and compacted over the existing geo-cell protected ditch. The geo-cell will reinforce the subgrade and provide protection against erosion. A minimum 1 m wide ditch should be maintained on the backslope side of the road. Local trimming of the toe of the slope (no steeper than 1H:1V) should be undertaken to obtain the required width. Any exposed slope should be protected with the "Green Armor" slope seeding system. The base of the ditch should be protected with a layer of road gravel.

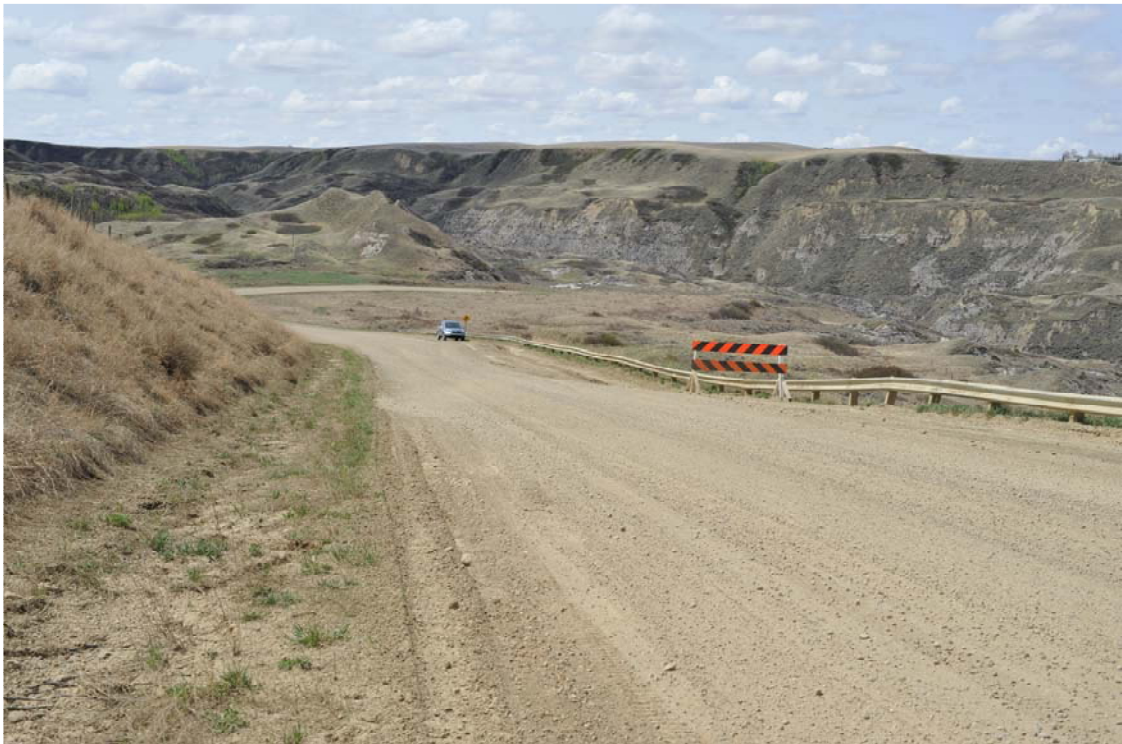
Photo 2 Site Conditions May 13, 2011 (looking southwest)
