August 14, 2013

Alberta Transportation  
Central Region  
#401, 4902 – 51 Street  
Red Deer, Alberta  
T4N 6K8

**Central Region Geohazard Assessment  
Site C42 H579:02 West of Water Valley  
2013 Site Inspection & Instrumentation Monitoring Report**

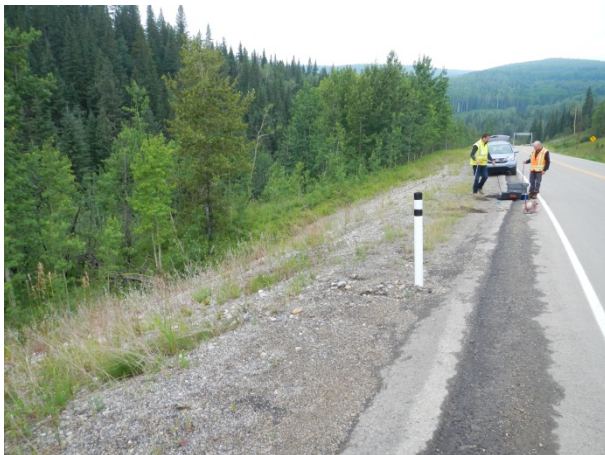
*Inclinometer 2005-7 being read*

Slope indicator 2005-7 is located at the crest of the highway embankment as shown on Figure 1. The August 2013 inclinometer readings indicated a total downslope movement of approximately 23 mm, at a depth of about 5 m below the road surface since October 2005 and about 4 mm of movement in the past year.

Instrumentation monitoring should continue at this site on an annual basis or following heavy rainfall events. If movement rates at SI 2005-7 increase again in the spring of 2014, it is recommended that the instruments be read again in the fall of 2014.

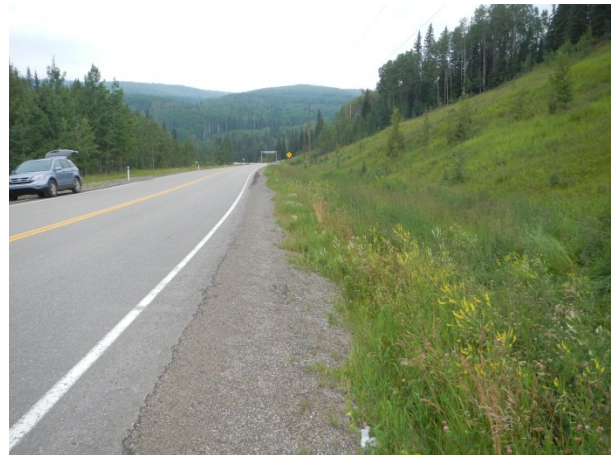
- The highway asphalt surfacing was reinstated in the summer of 2008, realigning the highway closer to its original configuration. The centre and shoulder lines were painted in 2009. The highway was in the process of being upgraded and repaved in June 2011. The highway alignment in the area of the slide remains unchanged from its 2008 configuration. No guardrail has been installed; however, an asphalt curb has been recently installed to reduce the runoff flow eroding the gravel.
- No cracking, settlement or other signs of movement in the highway surface or the gravel slope were observed.
- Erosion control matting was installed along the north ditch during the summer of 2011; the area is now well vegetated; however, SI 2005-5 could not be located.

*North ditch*

Slope indicator 2005-5 is located on the north (backslope) side of the highway as shown on Figure 1. No discernible movement has occurred at this location since September 2006. This instrument could not be located in the dense vegetation at the time of the August 2013 inspection.

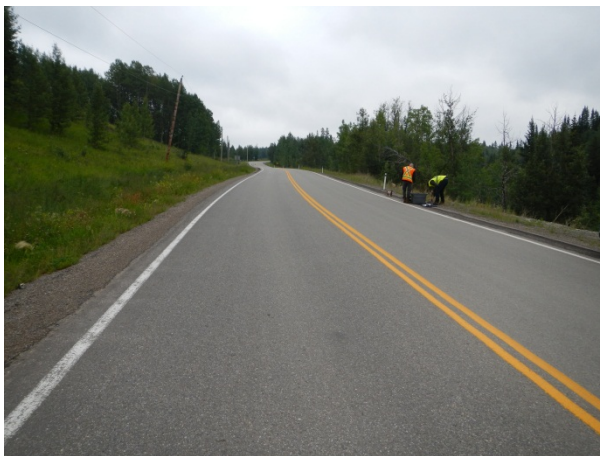
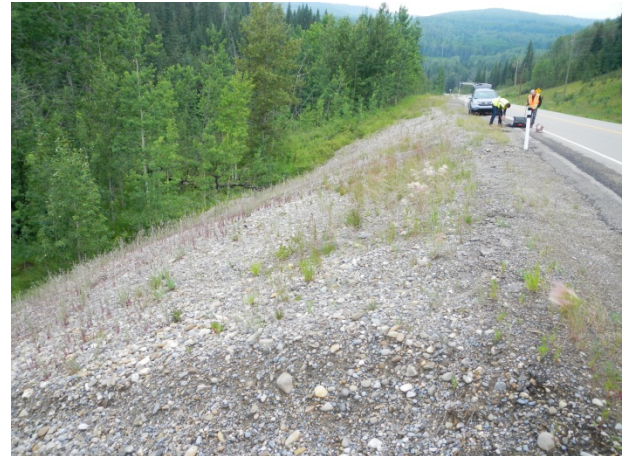
*No cracking, settlement or other signs of movement in the highway or gravel slope observed*
