June 25, 2001

Central Region Landslide Assessment Site C7
H16:30 Kenilworth Lake Slide
2001 Annual Inspection Report

This report was prepared by Klohn Crippen Consultants Ltd. for Alberta Transportation Central Region under Contract No. CE053/2000.

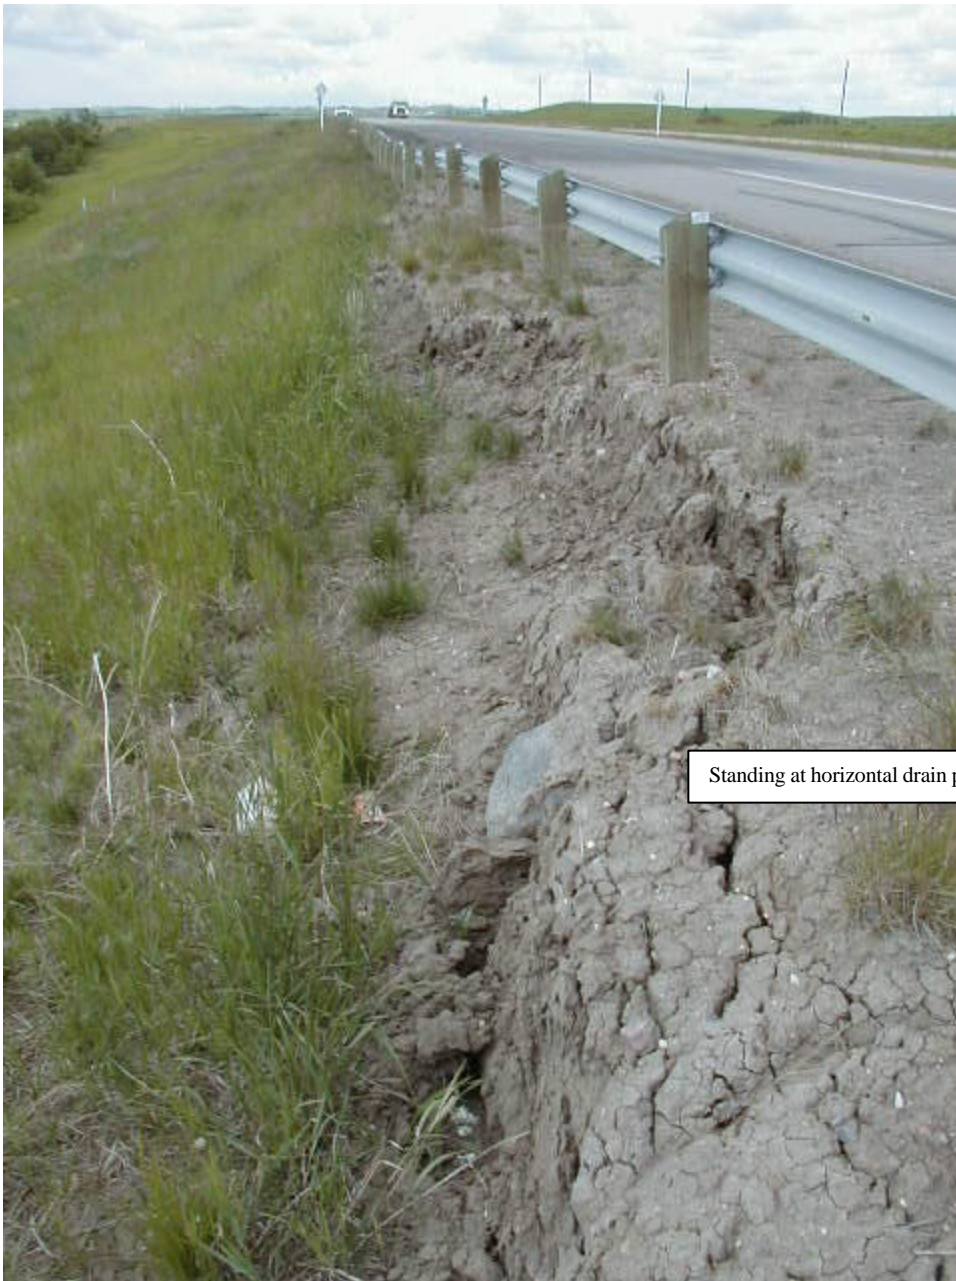
Standing at horizontal drain pipe location

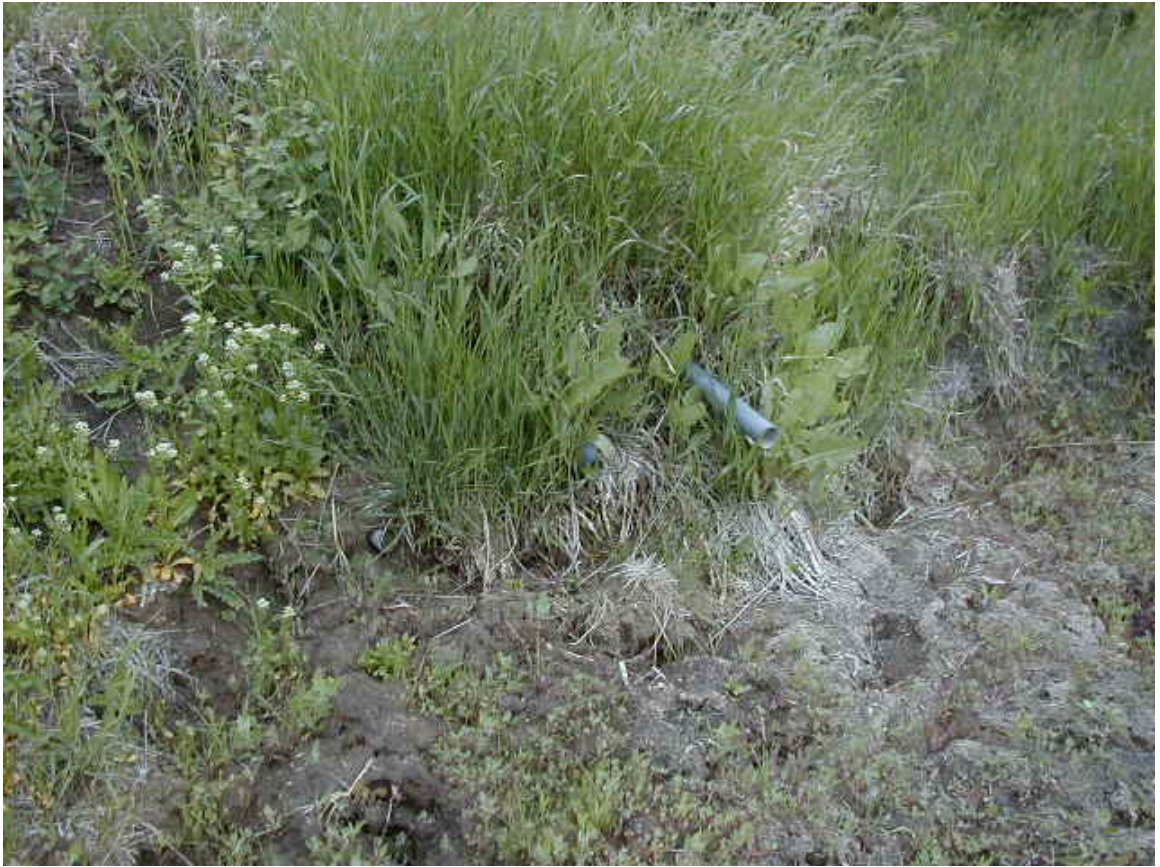
- A 30 m long patched section of the highway containing 2 distinct longitudinal cracks.
- A 25 m longitudinal crack in the centre of the shoulder about 20 m east of the patched area. To the south of this crack, cracks are also present in the slope adjacent to the guardrail and extend some distance down the slope.
- A slight deflection of the guardrail was observed.
- The horizontal drains daylighting at the toe of the slope were located and were observed to be dry.

No flow from drains
