Central Region Landslide Assessment Site C7
H16:30 Kenilworth Lake Slide
2002 Annual Inspection Report

This report was prepared by Klohn Crippen Consultants Ltd. for Alberta Transportation Central Region under Contract No. CE053/2000.

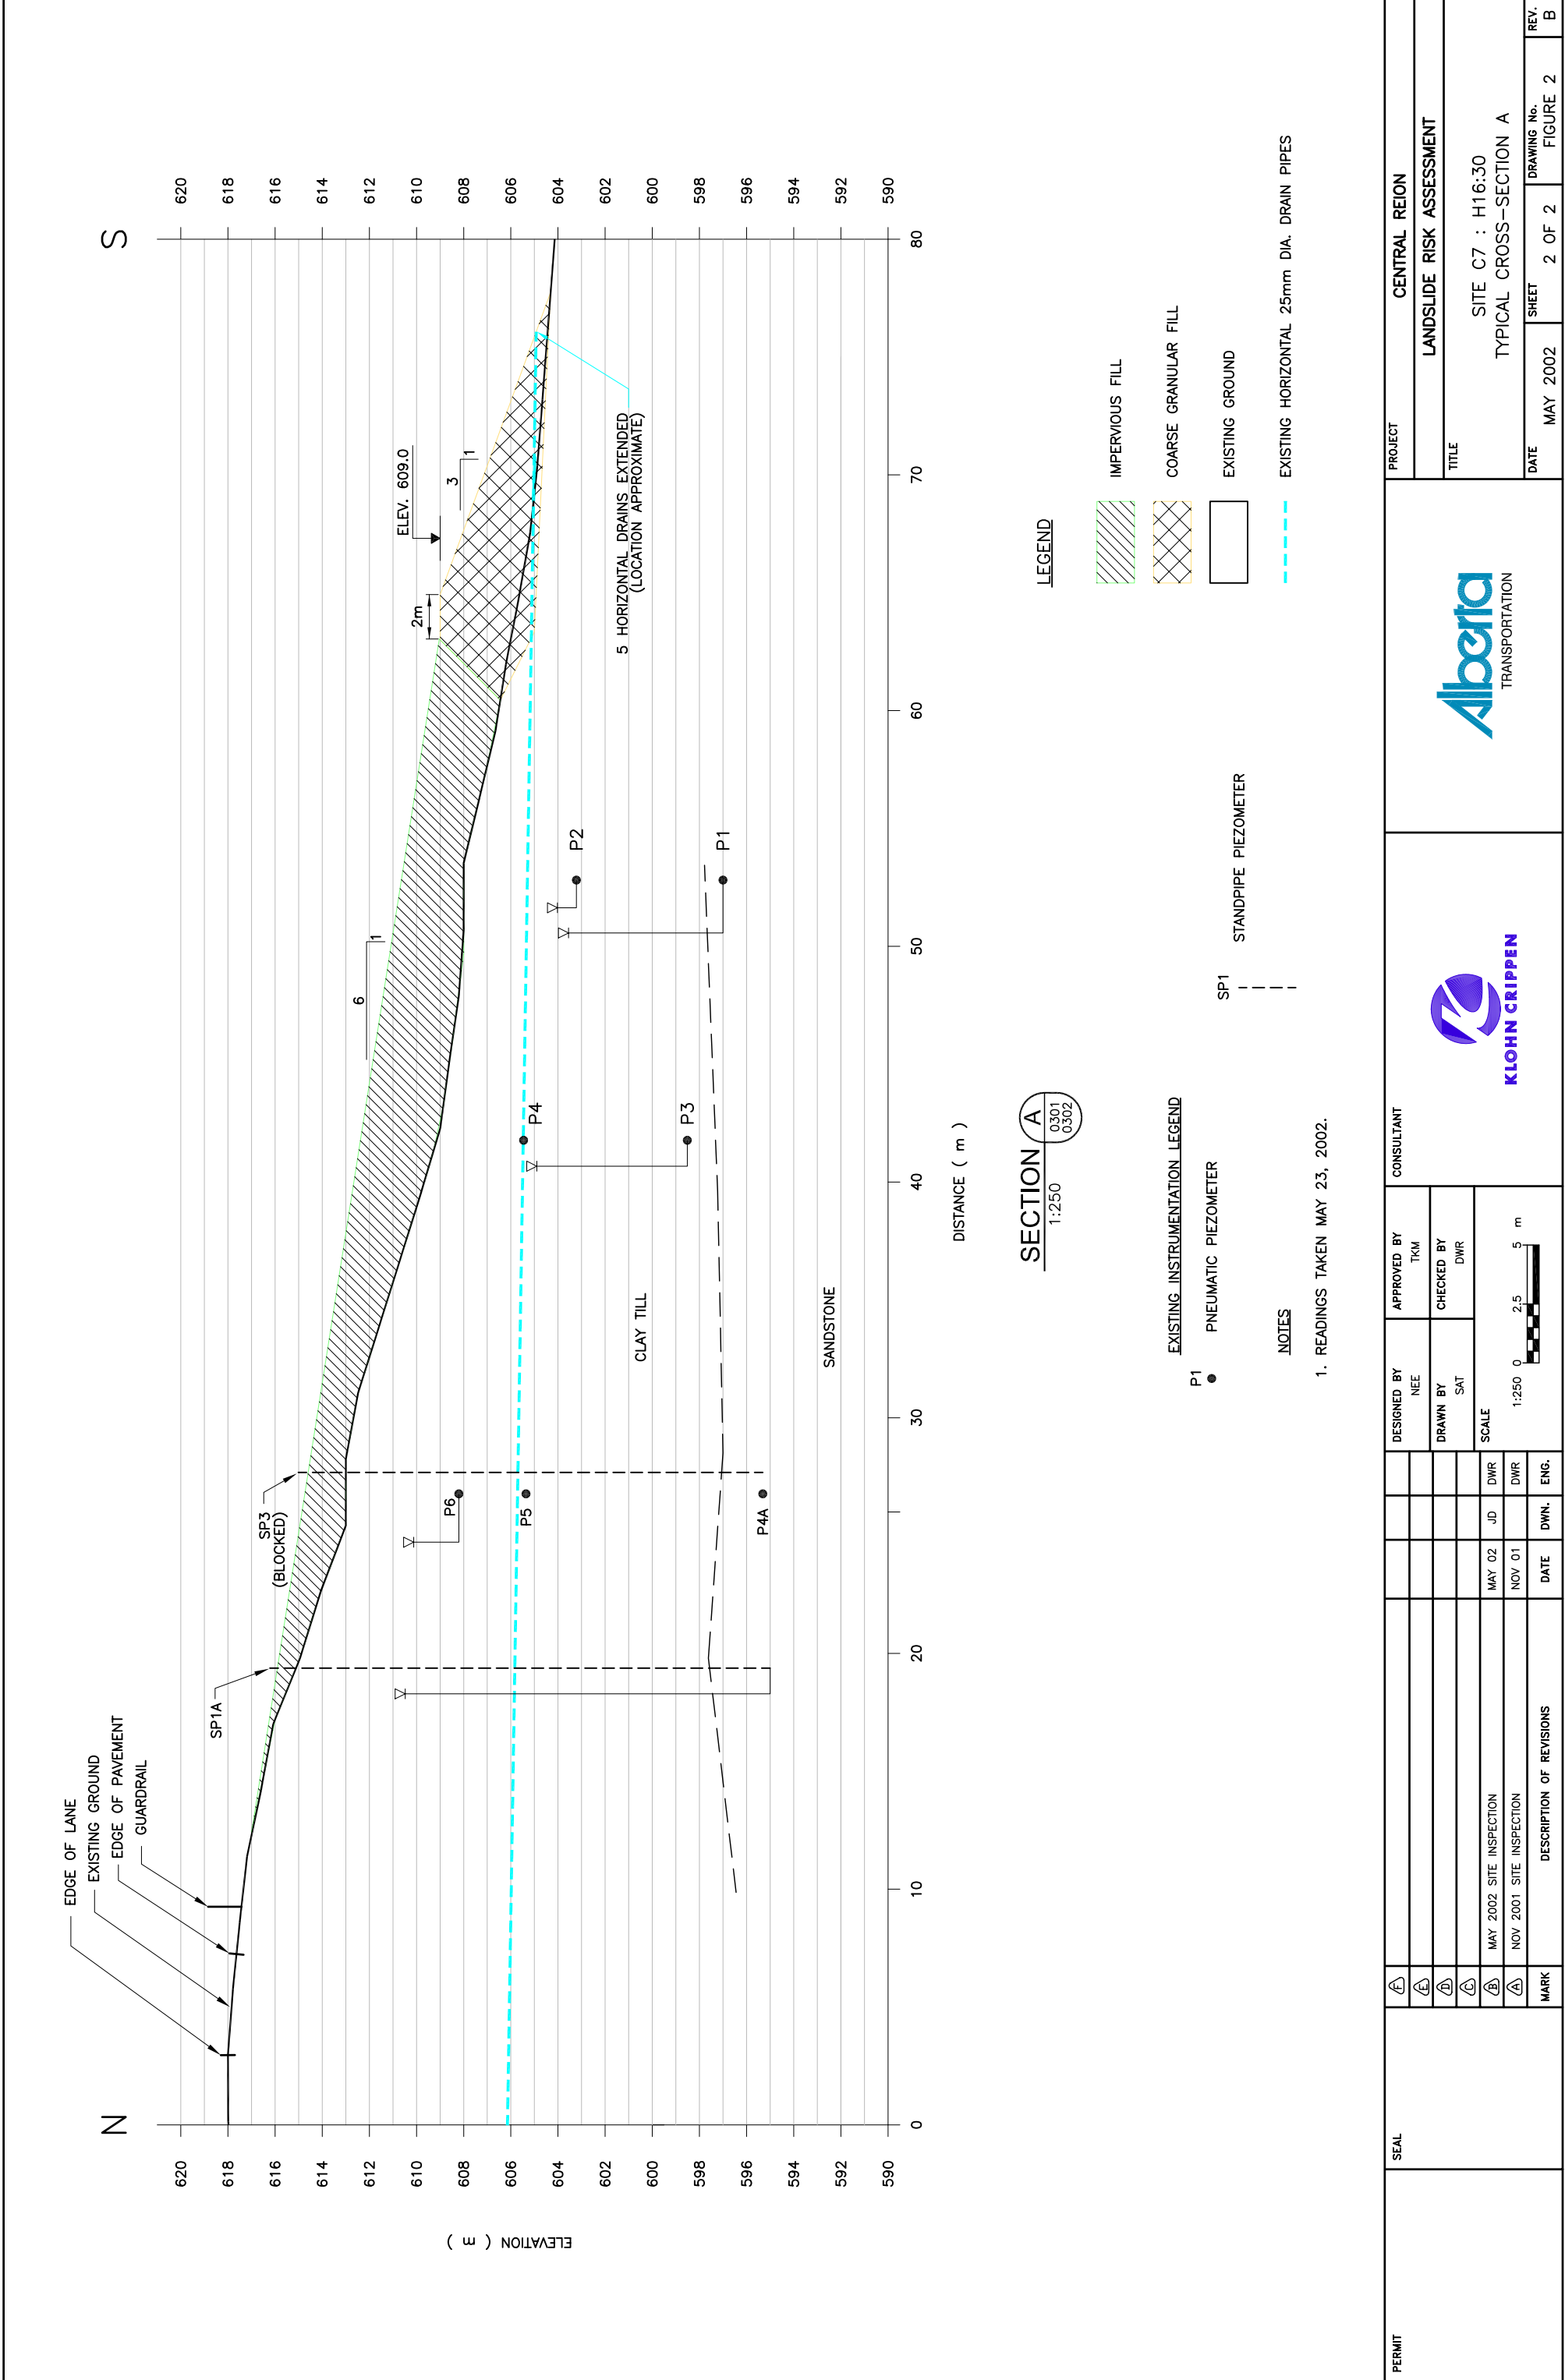
The slide location, site plan, instrument locations and cross-section are illustrated on Figures 1 and 2. The site features are also illustrated in the attached photographs.
