Photo 1
Looking south upgrade (towards Grande Cache) from about 150m south from Cutbank River bridge
 - Subsurface drains along backslope ditch (right side of photo)
 - Rosebud Creek (tributary to Cutbank River) at toe of sideslope (left side of photo) flowing north to join Cutbank River

Note: Photos taken on June 2007

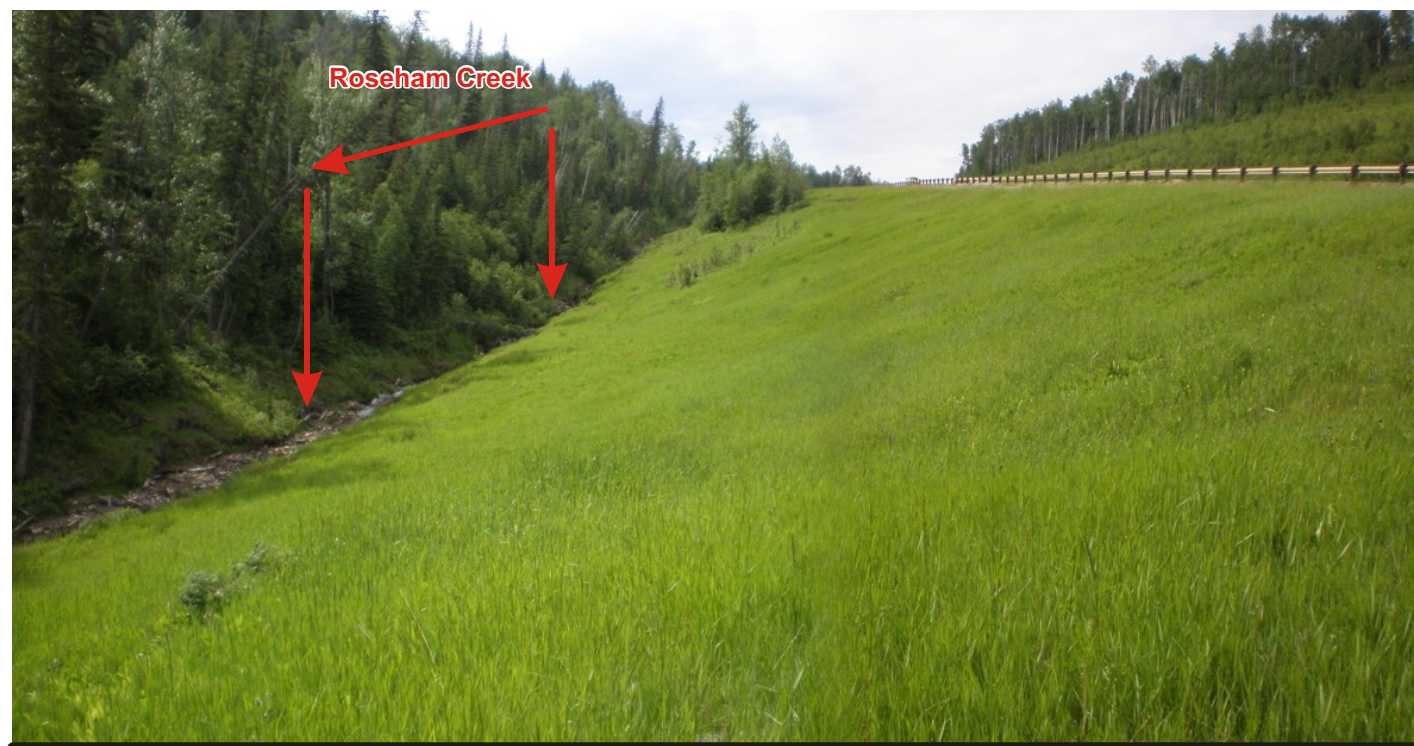
Photo 2
Looking south upgrade (towards Grande Cache) along mid-height of Cutbank River valley slope
 - About 400m of sidehill alignment (approach to Cutbank River) runs parallel to Rosebud Creek (tributary to Cutbank River)
 - Rosebud Creek is a straight channel and downcutting along a steep (7%) gradeline
 - Slumping of creek banks along Rosebud Creek at toe of highway sideslope (see photo #13 to 14 for bank slumping movements) deteriorating and starting to destabilize effect on this sidehill highway alignment. (See photos# 8, 11 to 13 for development of tension cracks)

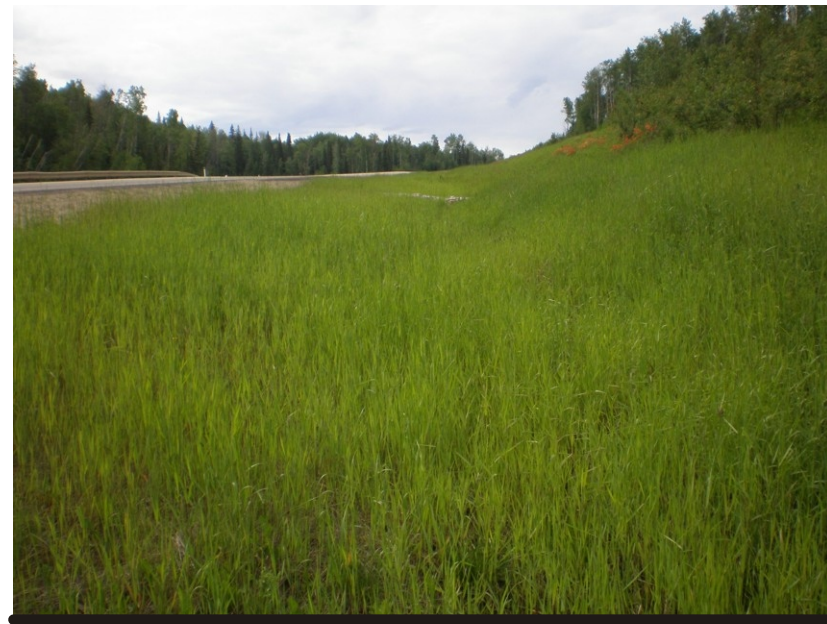
Photo 3

Looking south upgrade (towards Grande Cache) along backslope ditch
- Well grassed ditch as surface erosion protection
- A subsurface drain installed at 4m below ditch surface

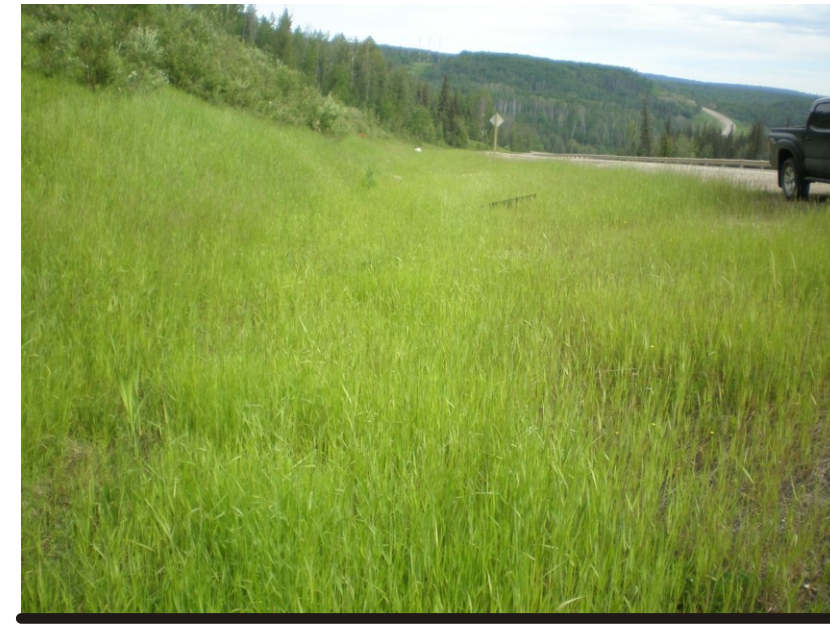
Photo 4

Looking north downgrade (towards Grande Grande) along backslope ditch
- A subsurface drain installed at 4m below ditch surface
- Outlet of subsurface at downgrade (foreground)

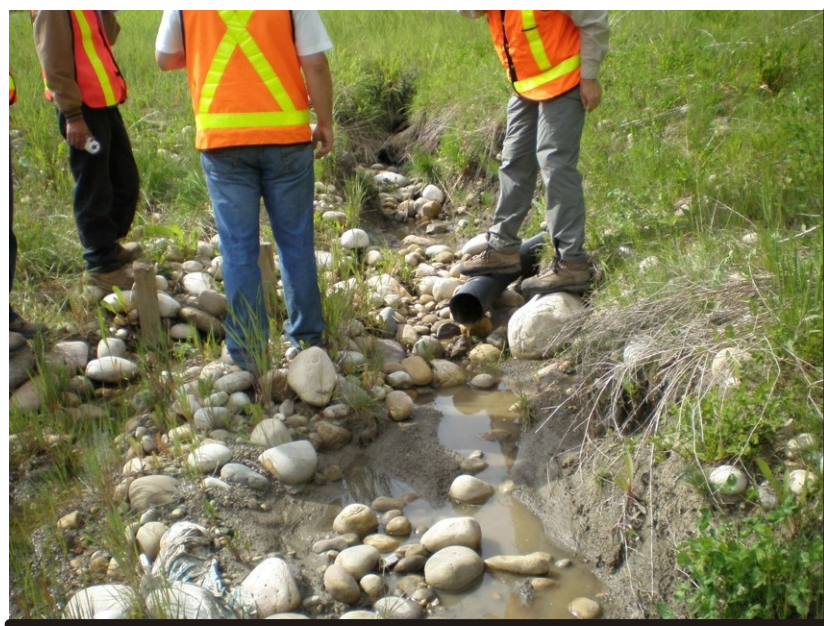
Photo 5

Outlet of subsurface drain was buried and blocked and it was opened up to flow (at this June 07 inspection)
- This outlet section of subdrain was damaged and needs repair.
Sub-excavation and replacement of damaged outlet section is advised.

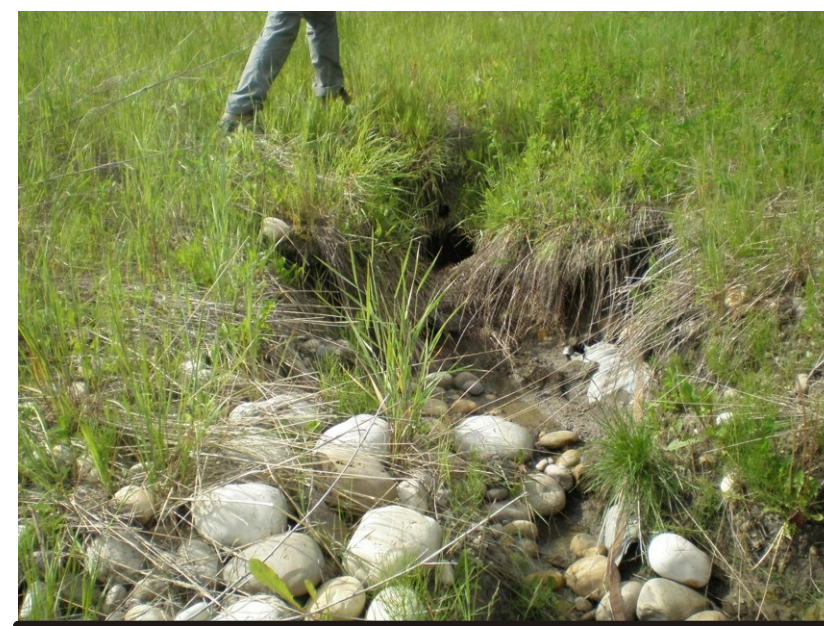
Photo 6

Outlet of subsurface drain was buried and needs to be repaired. Thereafter, yearly cleanout of outlet blockage siltation is advised.

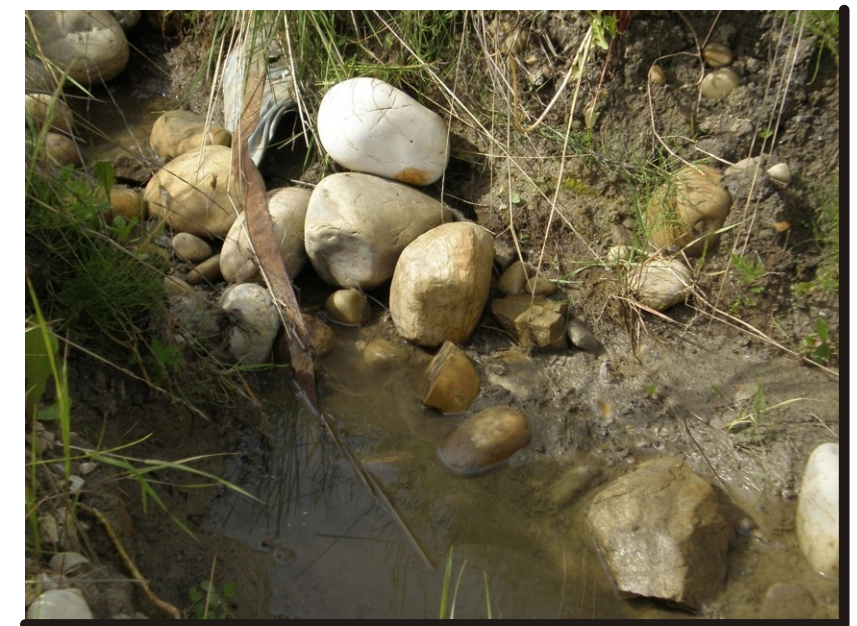
Photo 7

Another view of the buried outlet of subdrain.

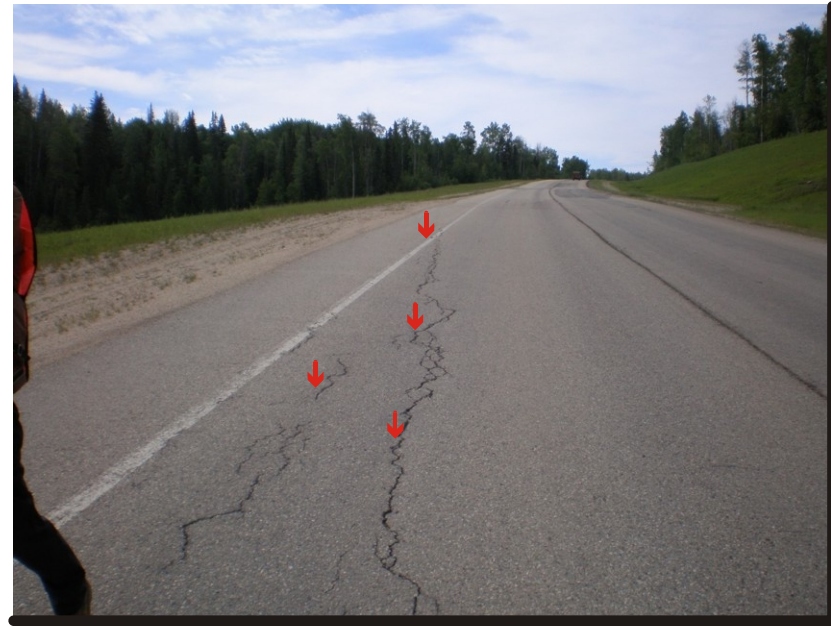
Photo 8

Looking south upgrade (from about 300m distance south of bridge abutment) along mid-height of River valley.

- Tension cracks of about 100m length along southbound lanes of pavement. It is apparent that these are not wheel track rutting cracks. Tension cracks just recently developed or reactivated in year 2006/2007.
- Apparently, there is an impending instability under-development along this sidehill roadway mostly probably due to vertical degradation of creek along the toes (left of photo) of this sidehill alignment.

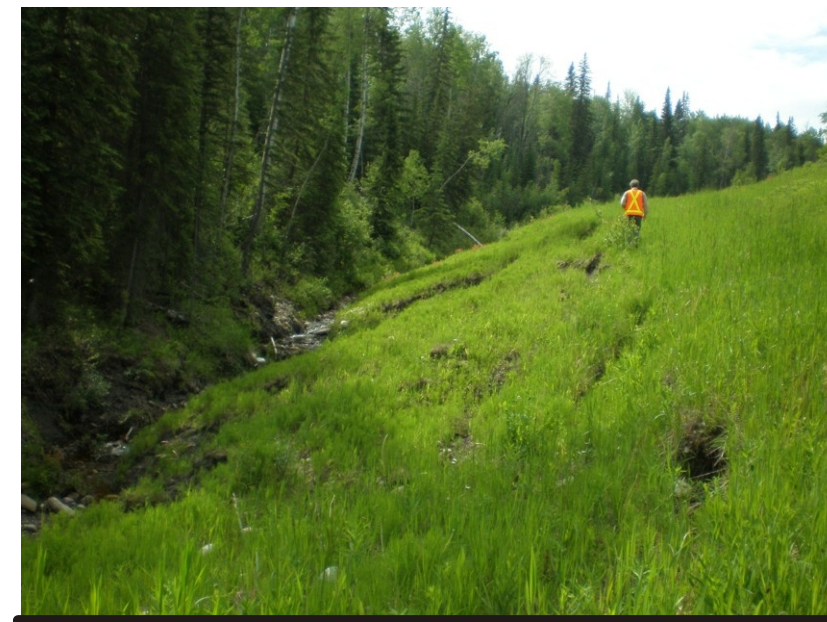
Photo 9

Looking south along the creek bank (highway to right of photo)

- Slumping of creep bank slopes at toe of sidehill highway alignment
- This slumping of creek bank slope extends about 100-150m

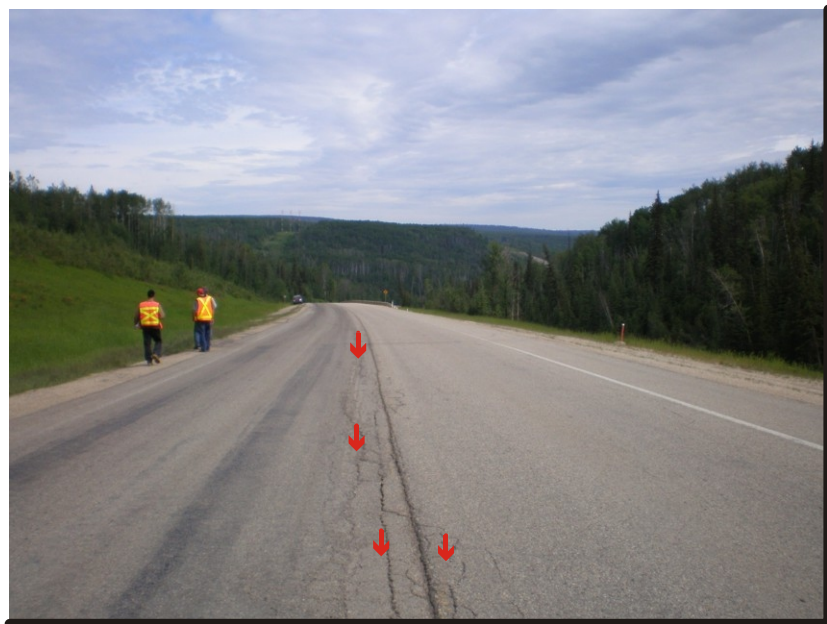
Photo 11

Looking north downgrade towards bridge

- Another views of tension crack propagation and reflecting along the roadway pavement
- Roseham Creek and toe of sideslope to right of photo

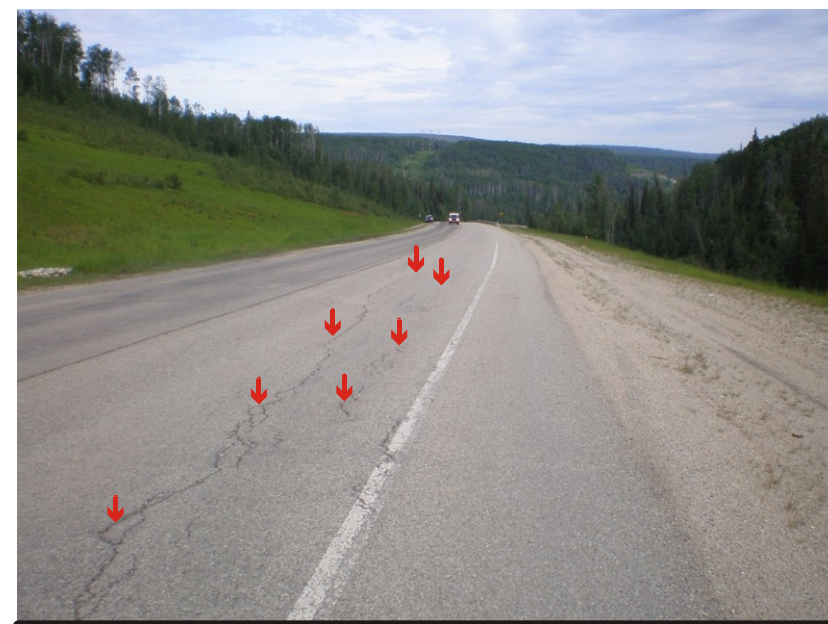
Photo 12

Looking north downgrade towards bridge

- Another views of tension crack propagation and reflecting along the roadway pavement
- Roseham Creek and toe of sideslope to right of photo

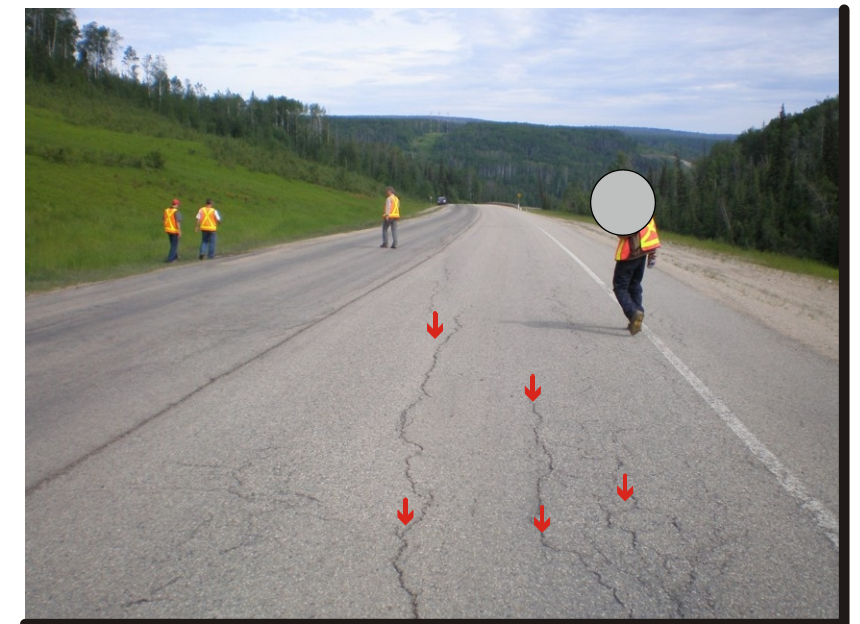
Photo 13

Looking north downgrade towards bridge

- Another views of tension crack propagation and reflecting along the roadway pavement
- Roseham Creek and toe of sideslope to right of photo

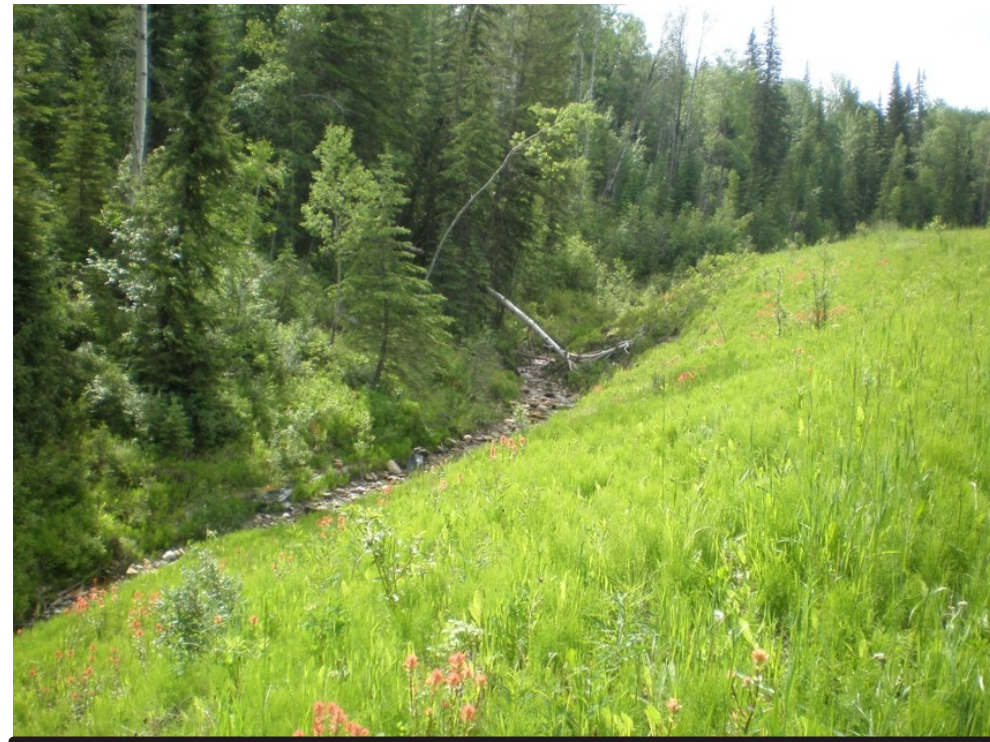
Photo 14

Slumping of creek banks on both sides of the creek

- the natural valley slope (left of photo) also exhibits instability (tilting trees) and slumping movement in same manner as highway sideslope (right of photo)

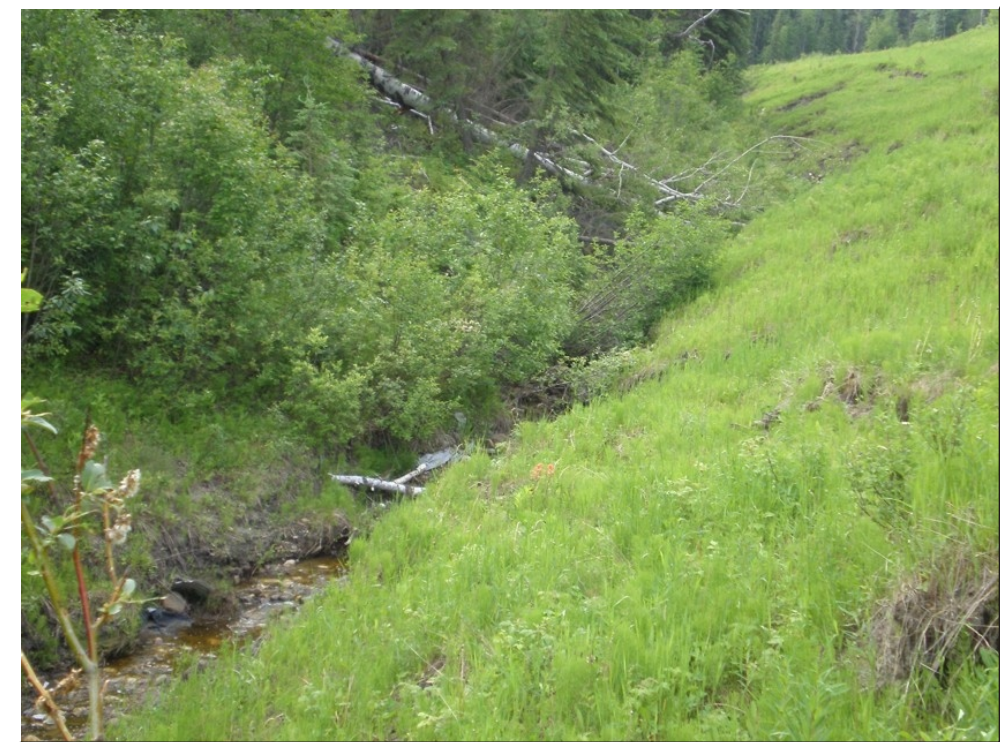
Photo 15

Slumping of creek banks on both sides of the creek

- the natural valley slope (left of photo) also exhibits instability (tilting trees) and slump movement in same manner as highway sideslope (right of photo)

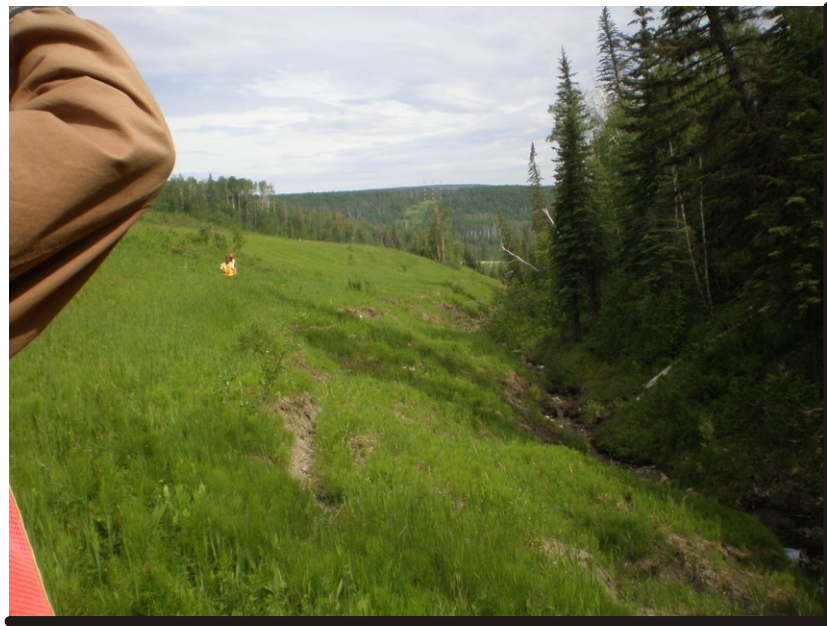
Photo 16

Looking north (towards bridge) downstream along creek bank
- Slumping of creek banks
- Gradual loss of toe support for sidehill fill alignment

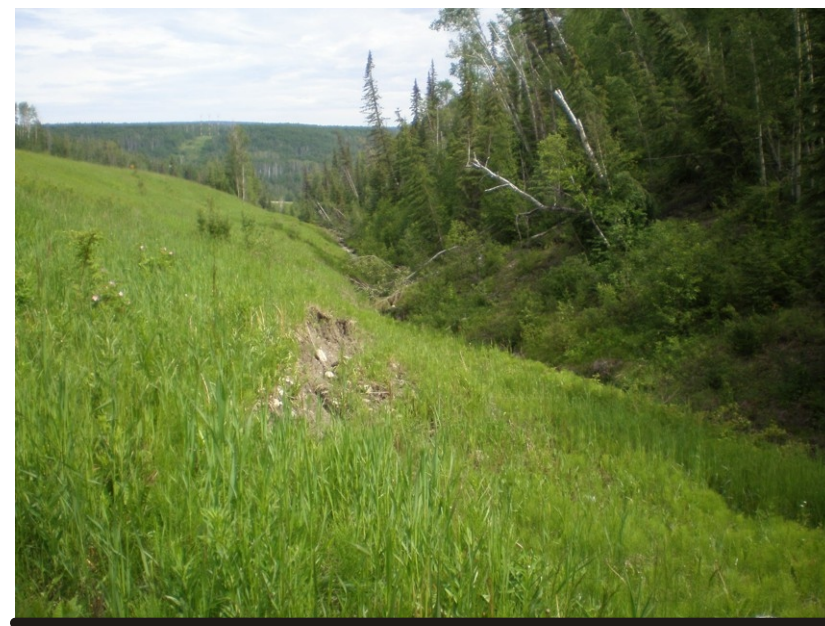
Photo 17

Looking north (towards bridge) downstream along creek bank
- Slumping of creek banks
- Gradual loss of toe support for sidehill fill alignment

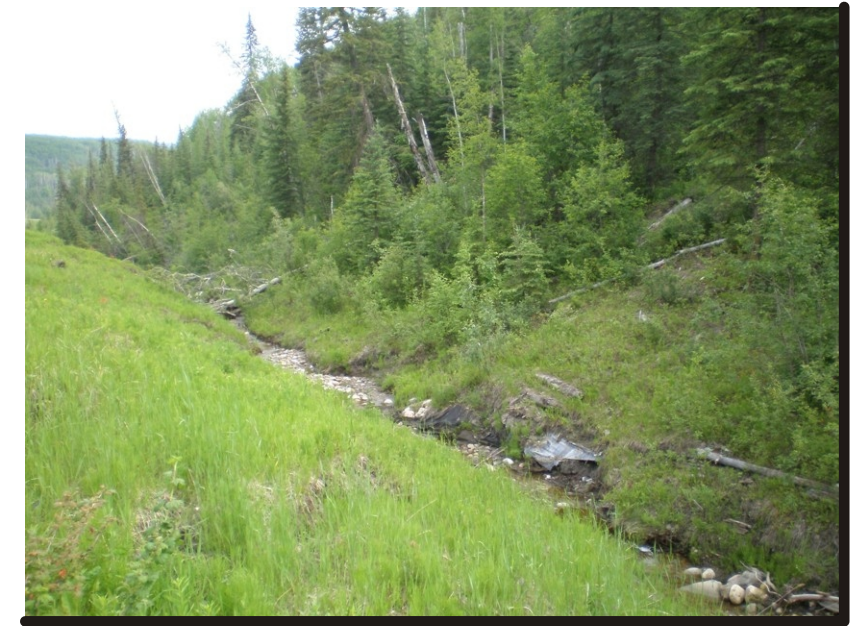
Photo 18

Looking north (towards bridge) downstream along creek bank
- Slumping of creek banks
- Gradual loss of toe support for sidehill fill alignment

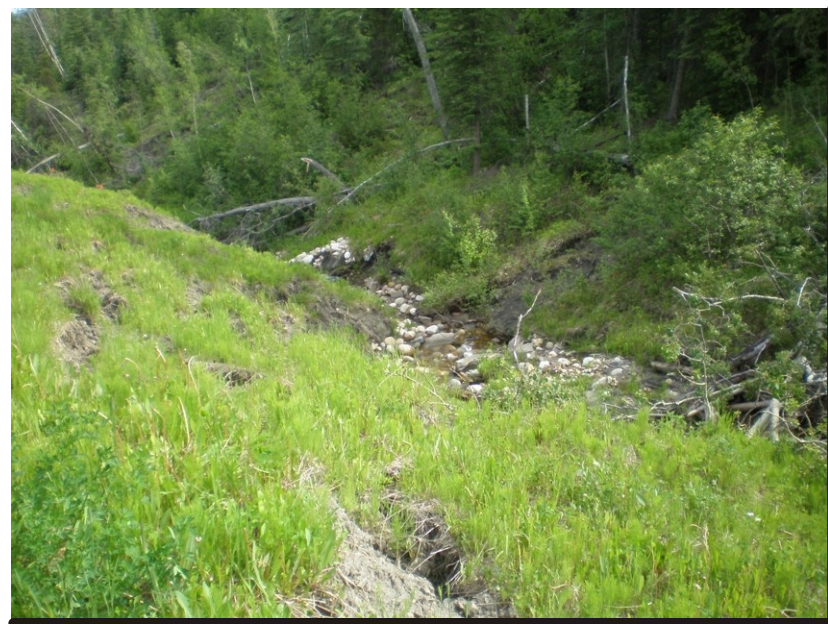
Photo 19

Previous rock checks eroded by high creek flow along this creek of about 7% grade.

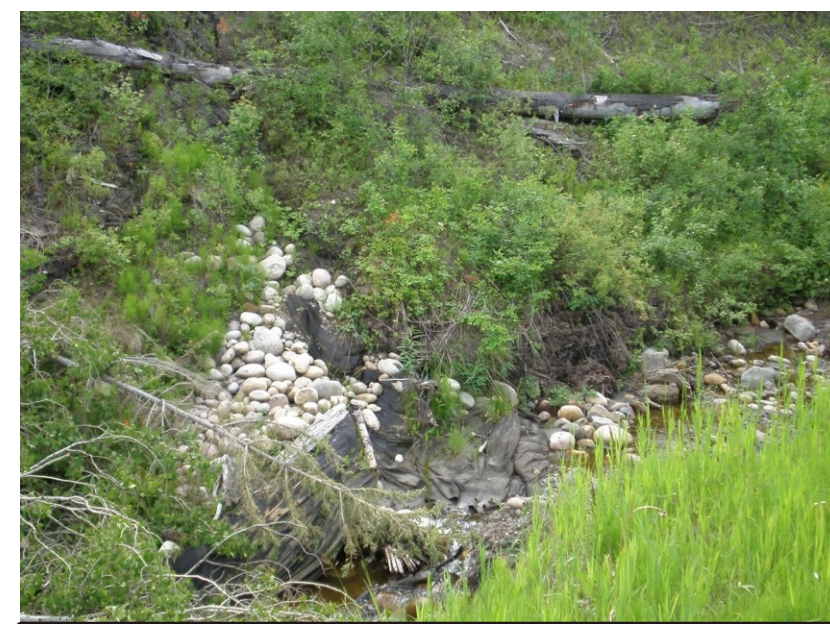
Photo 20

Previous rock checks eroded by high creek flow along this creek of about 7% grade.
