Slide Name: (GP 12) Hwy 49:04 Ksituan River
Inspection Date: June 11, 2001
Inspection By: Alberta Transportation Staff (see attached list of attendees)
EBA Staff (Karl Li and Tony Ruban)

Figure 1
Highway 49:04
Aerial Photo of Site

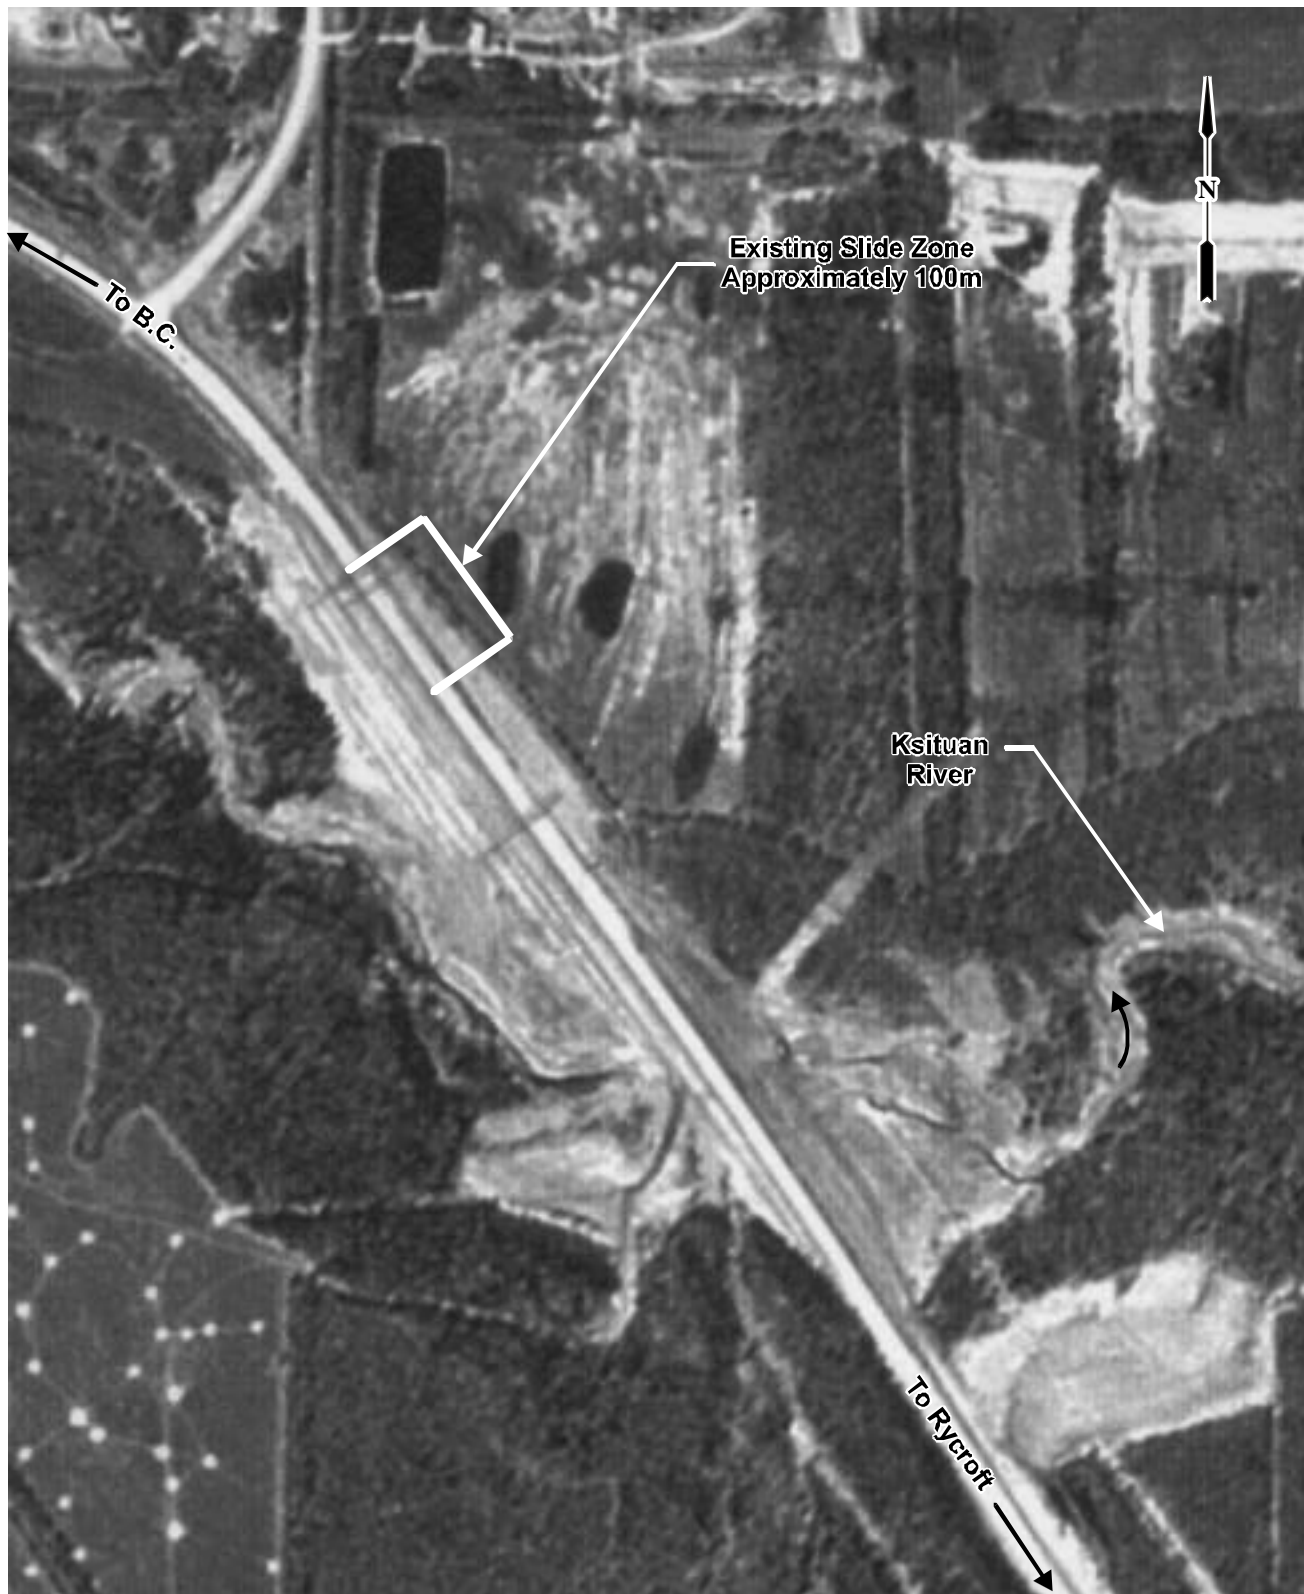
- The previous and current (June 2001) SI readings were reviewed to indicate that:
 - At the $\frac{3}{4}$ height of slope, movement was monitored at 8 m depth (SI#1).

- At the mid-height of slope, movement was monitored at 18 m depth (SI#2).
 - Shallow groundwater table was identified at both SI locations.
- A slide remediation design of toe berming was submitted in early Spring 2001 by EBA to Stantec Consultants as part of the highway widening design.

- In addition to the toe berm, the shifting of the alignment (with excavation of backslope) away from the slide and the lowering of grade was designed as part of the geometric improvement.

- Subsequent to the above site inspection, Karl Li visited the site in late July 2001 and observed that the remediation works were constructed.
 - The remediation construction will downgrade the risk rating because design parameters indicate that a higher factor of safety (F.S.=1.5) is achievable.

- Visual and instrumentation monitoring of this site should continue to monitor the performance of recent remediation.
