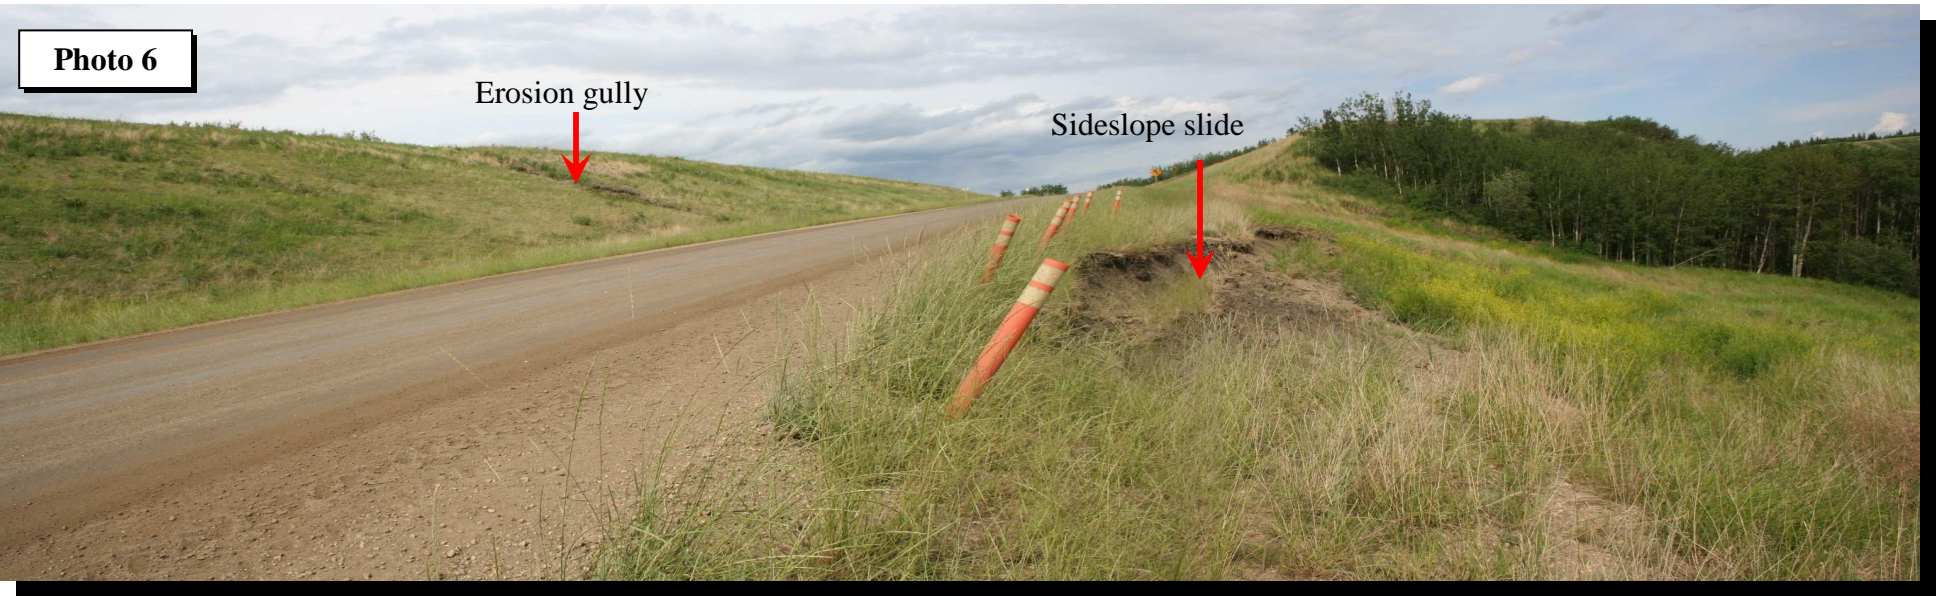
Looking upgrade north (away from Hwy. 49 Jct.)

- Sideslope slides (right) has encroached to shoulder of northbound lane
- Erosion gully formed at backslope (left) as a result of runoff from upland farm area

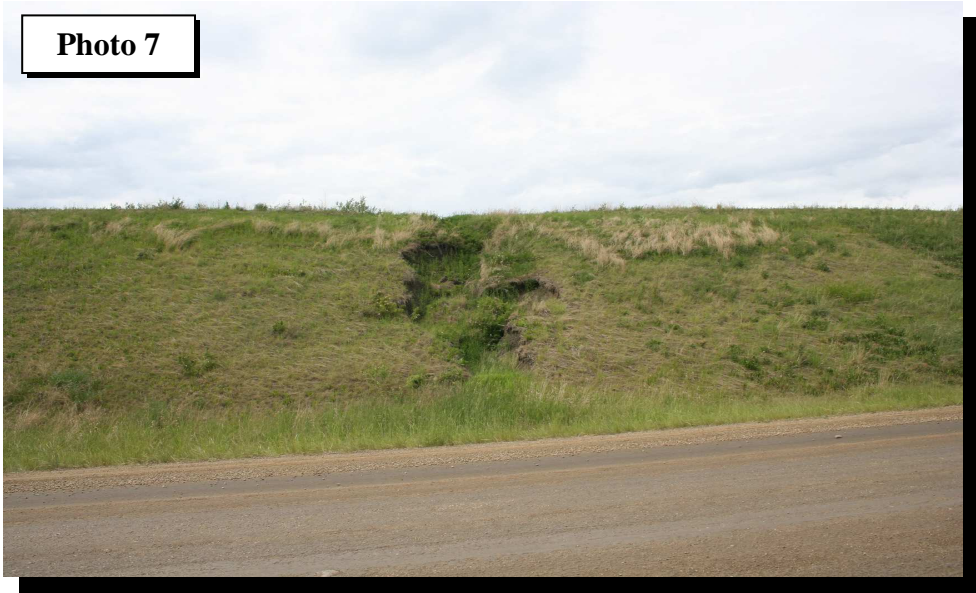
Looking west (another view)

- Erosion gully at backslope at upper portion of river valley

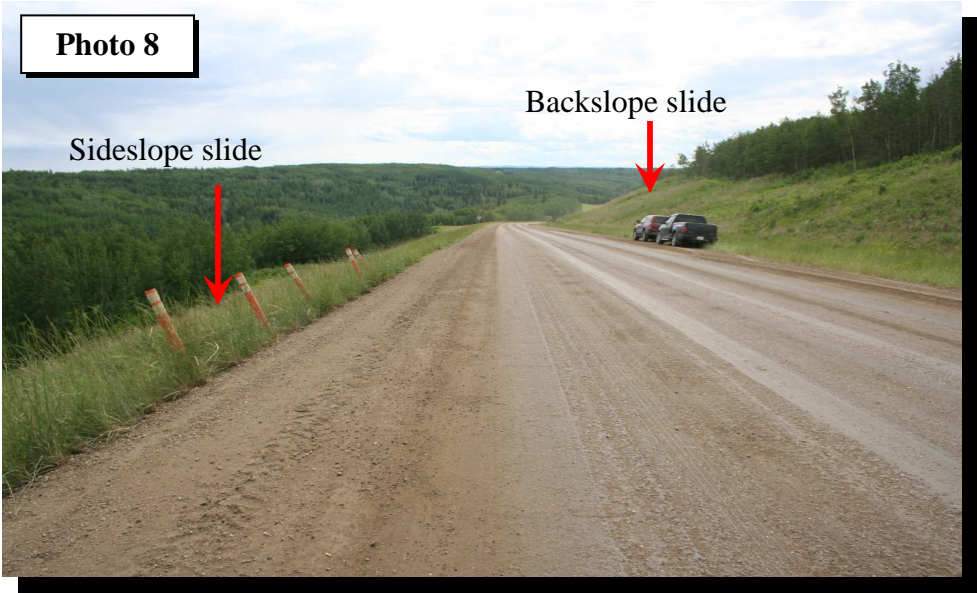
Looking downgrade south (toward Ksituan River)

- Sideslope slides to left of photo (no clearly visible from road elevation)
- Backslope slides on right started to develop
