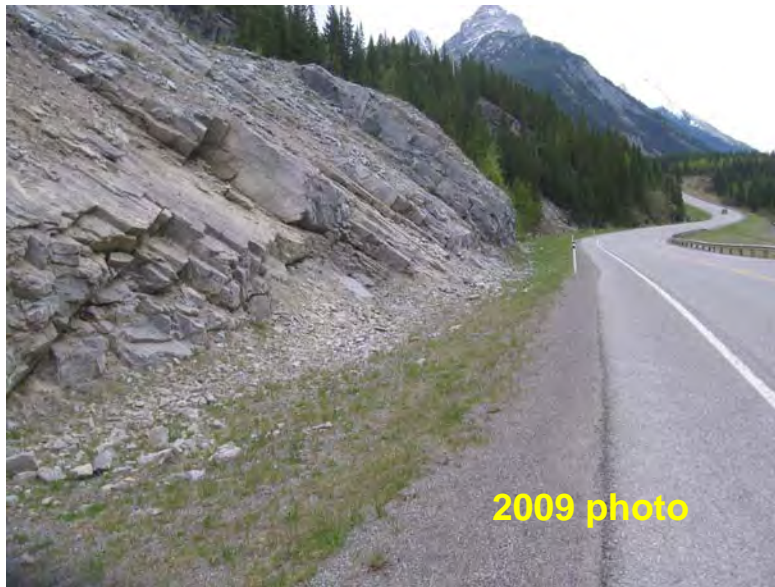
Photo 1 (top) – June 2009

Facing south along the east highway ditch adjacent to the cut slope. The rockfall debris from this cut slope is contained within the existing ditch.

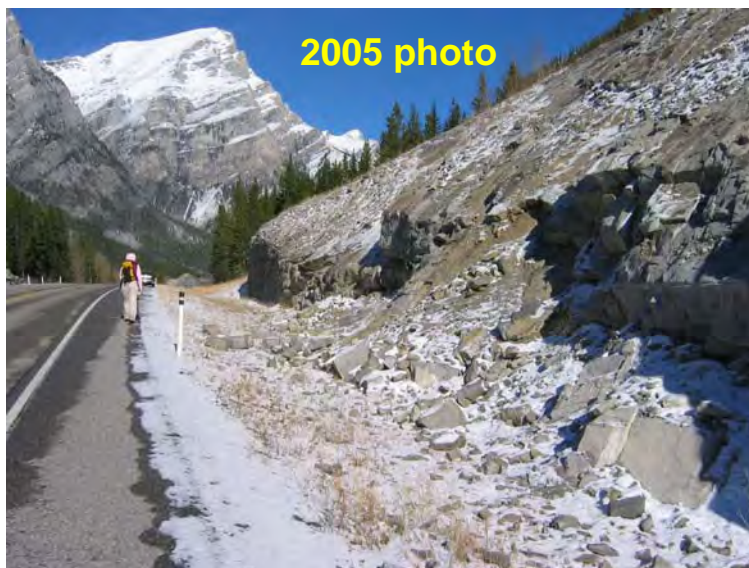
Photo 2 (bottom) – 2005

Facing north along the east highway ditch, across the same area shown in Photo 1. At the time of the 2005 inspection there was a significant accumulation of up to boulder-sized rockfall debris along the ditch.
