**Rocky Creek**

**Fortress Junction Road Cracking Site**

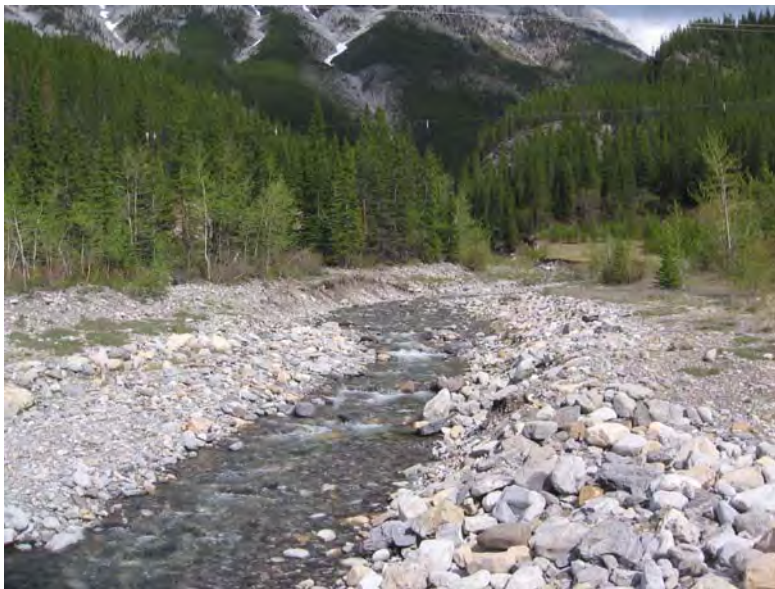
**Photo 2 (bottom) – June 2009**

Facing upstream along the creek channel from the Highway 40 bridge.

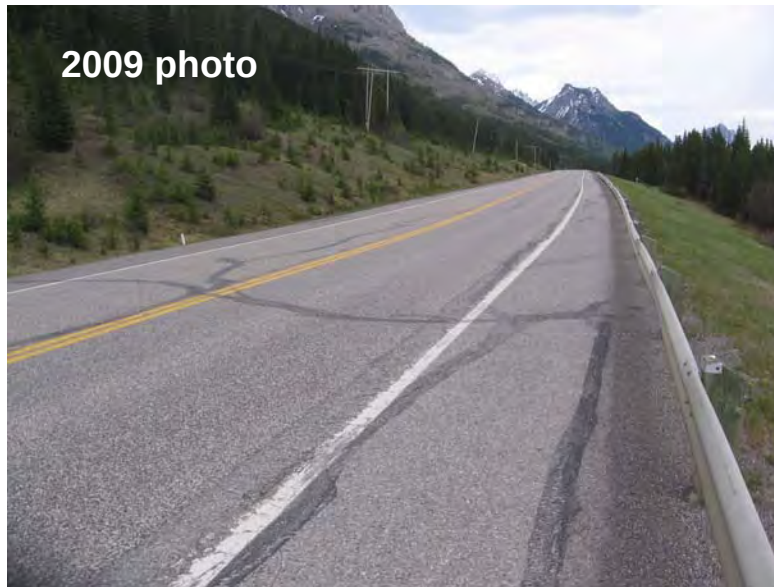
**Photo 3 (top) – June 2009**

Facing southbound across the settlement and cracking area in the southbound lane. The pattern of the cracking and downdrop is suggestive of slumping of a segment of the downslope lane, however when compared to Photo 4 from the 2005 inspection it does not appear that the damage to the road surface has worsened in recent years.

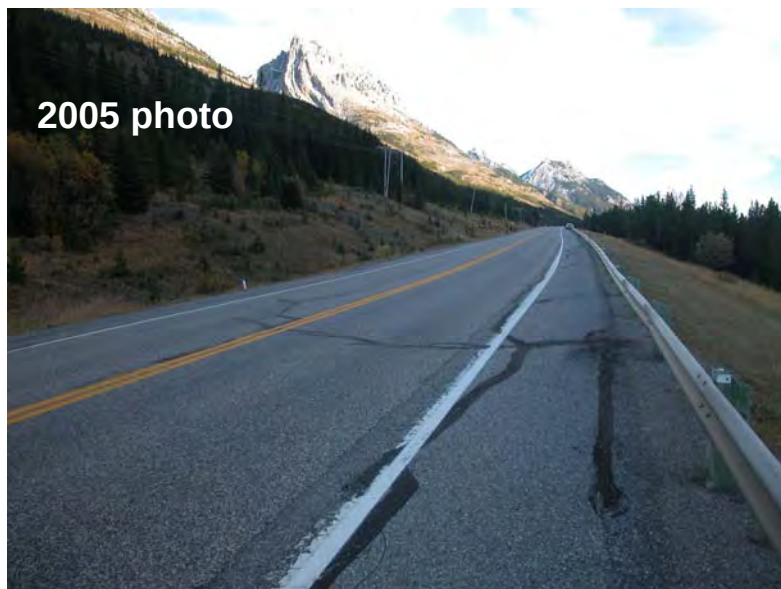
**Photo 4 (bottom) – 2005**

The same area as shown in Photo 3, as it appeared during the 2005 inspection.

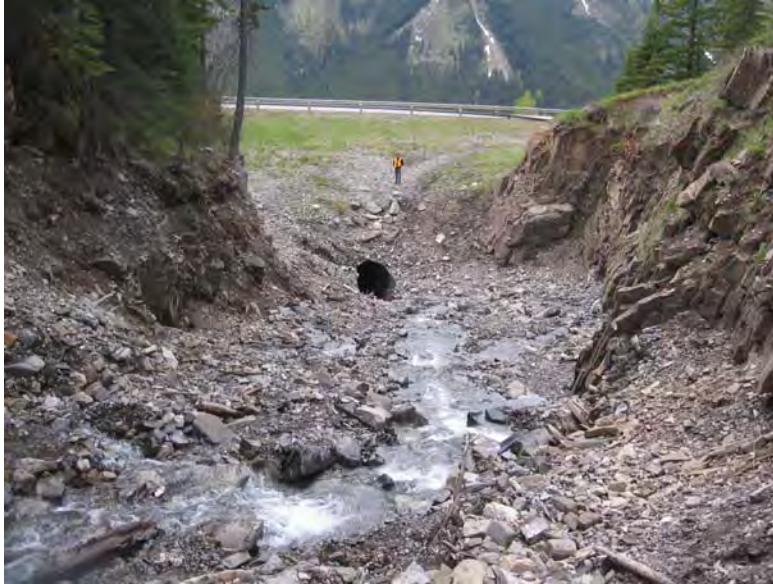
**Photo 5 (top) – June 2009**

Facing downstream towards the culvert inlet with Highway 40 visible in the background. A large volume of debris was excavated from this “basin” upstream of the culvert in 2005. It appears that relatively little additional debris has accumulated in this area since that time.

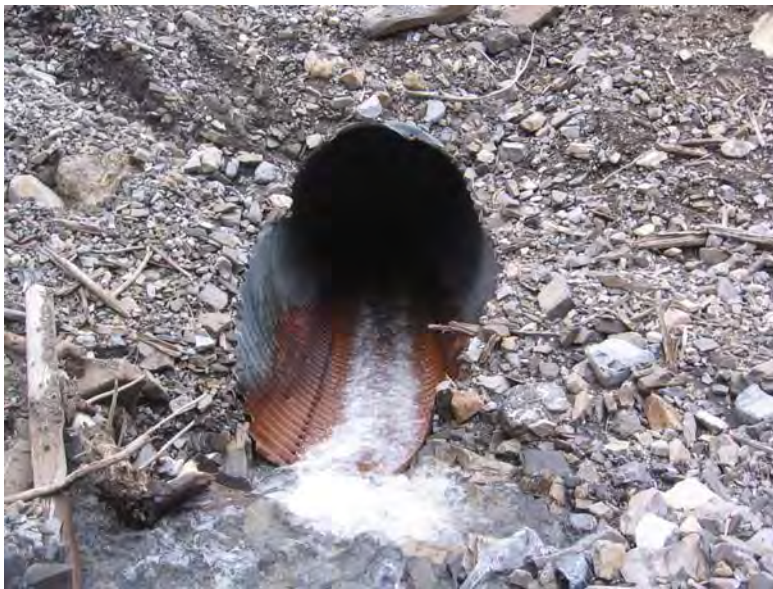
**Photo 6 (bottom) – June 2009**

Closer view of the culvert inlet, which was clear of debris at the time of the June 2009 inspection. The inlet was approximately 50% blocked with debris at the time of the 2005 inspection, with the culvert pipe completely filled with debris a few metres in from the inlet.
