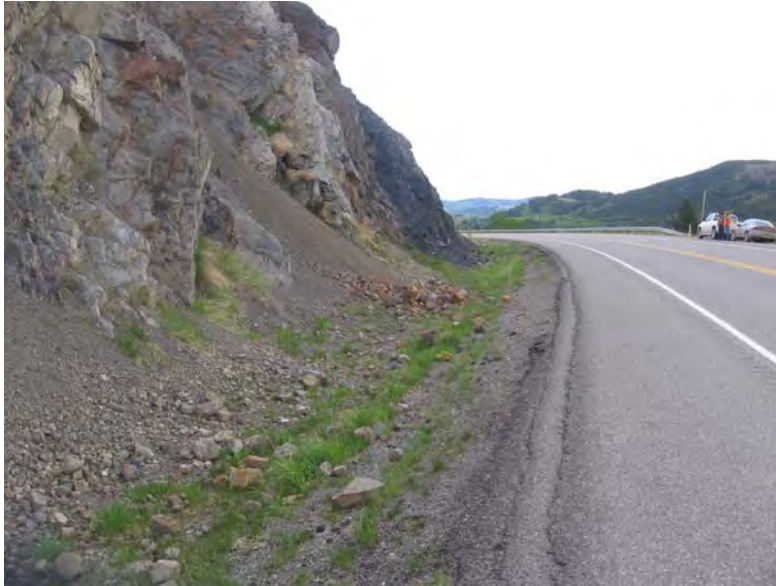
**Photo 3 (top) – June 2009**  
Facing eastbound along the north ditch, showing the accumulation of rockfall debris along the ditch.

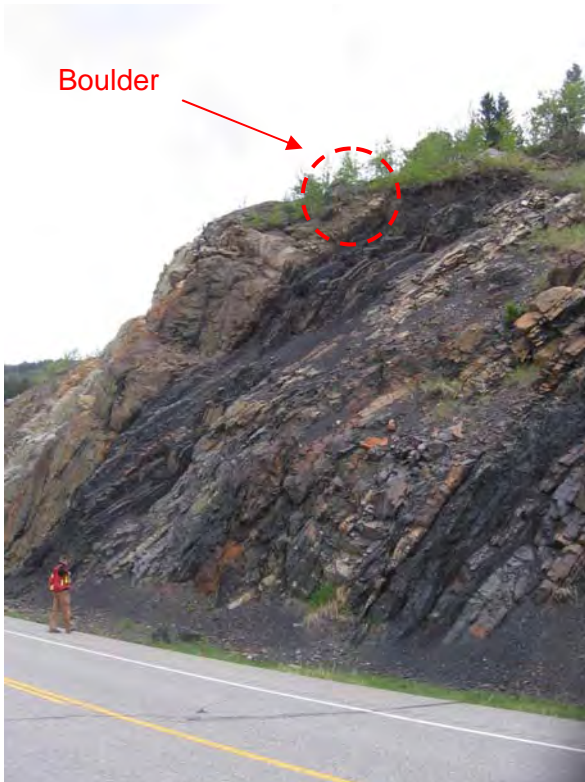
**Photo 4 (bottom) – June 2009**  
Another view of the cut slope. Note the boulder perched near the crest of the slope. If this boulder eventually comes loose from the slope it may roll onto the highway and/or break up upon impacting the ditch with debris spilling onto the highway.
