HWY 43:16 - WHITECOURT EAST HILL (NC1)
SELECTED PHOTOGRAPHS

DATE: JUNE 2, 2004
THURBER PROJECT #15-16-192

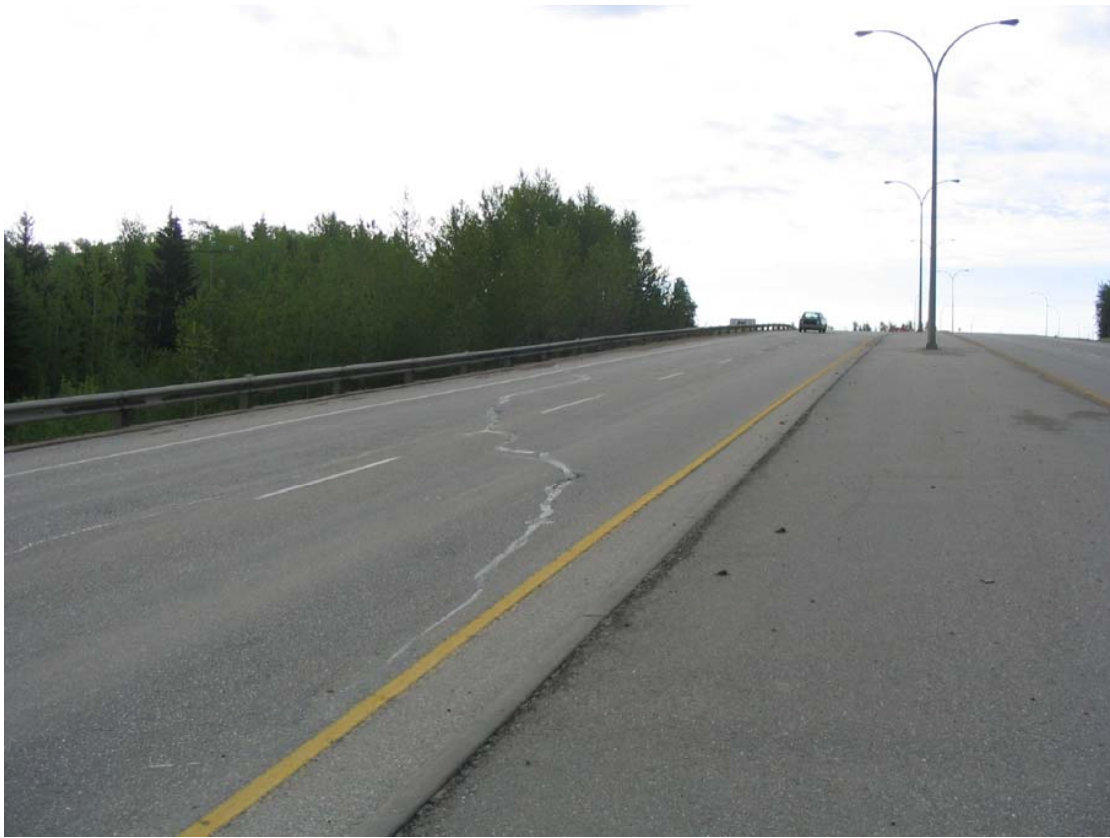
PHOTO 1 EAST CRACK LOOKING WEST

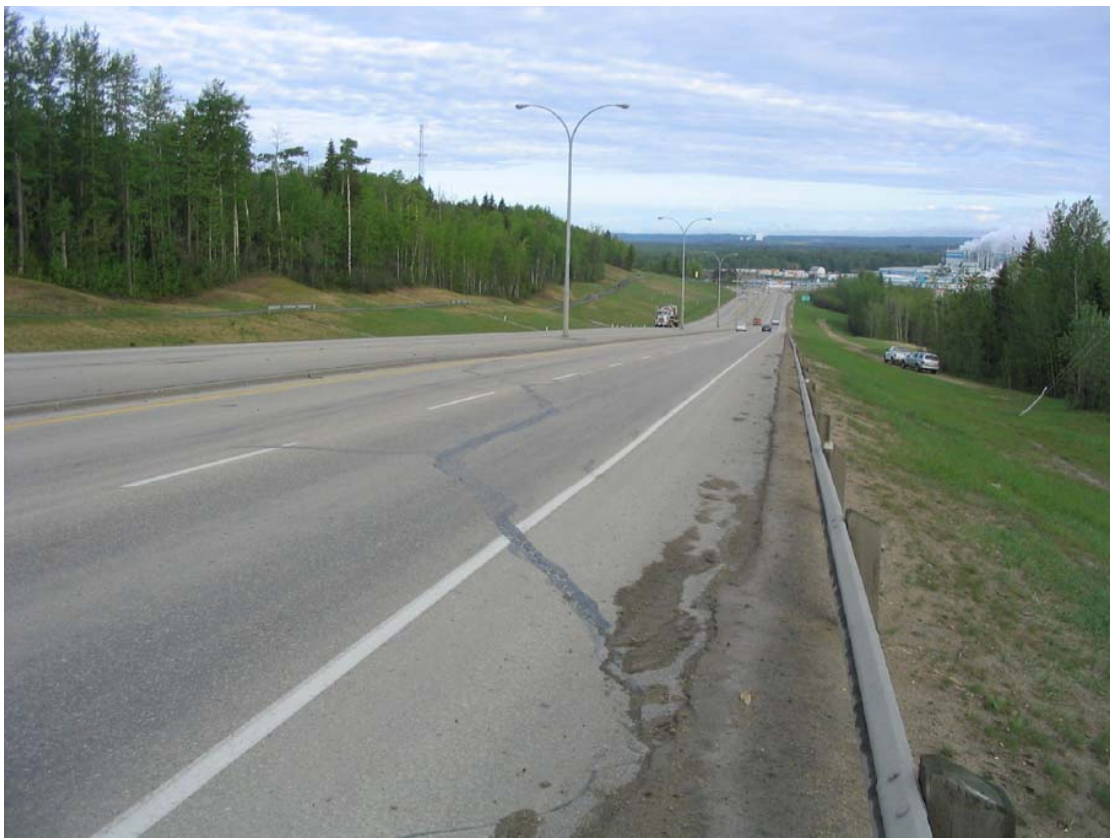
PHOTO 2 EAST CRACK LOOKING EAST

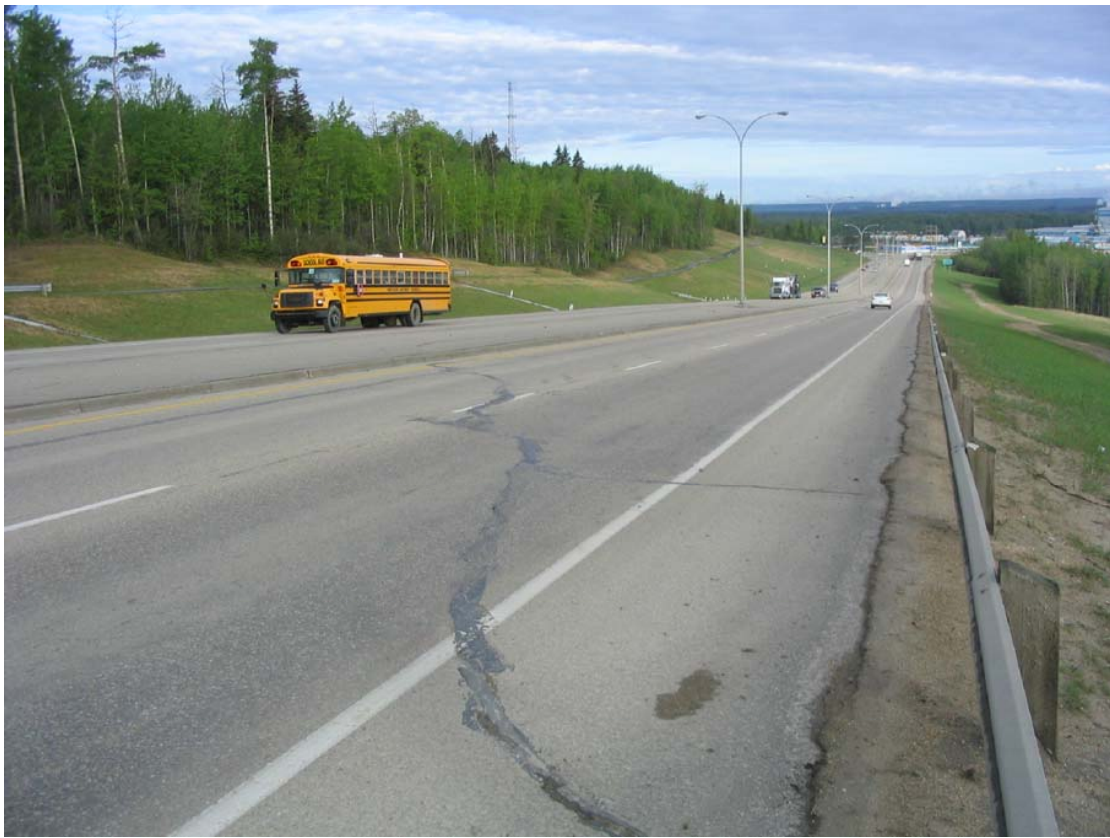
PHOTO 3 WEST CRACK LOOKING WEST

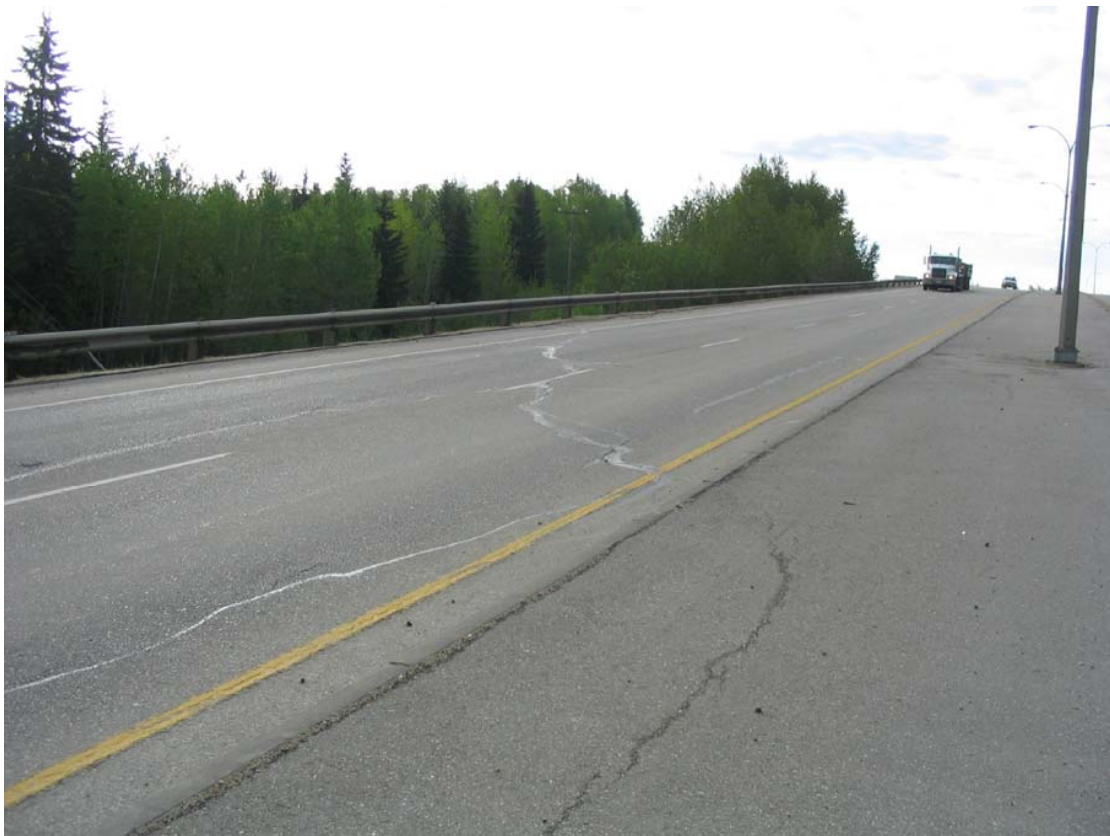
PHOTO 4 WEST CRACK LOOKING EAST

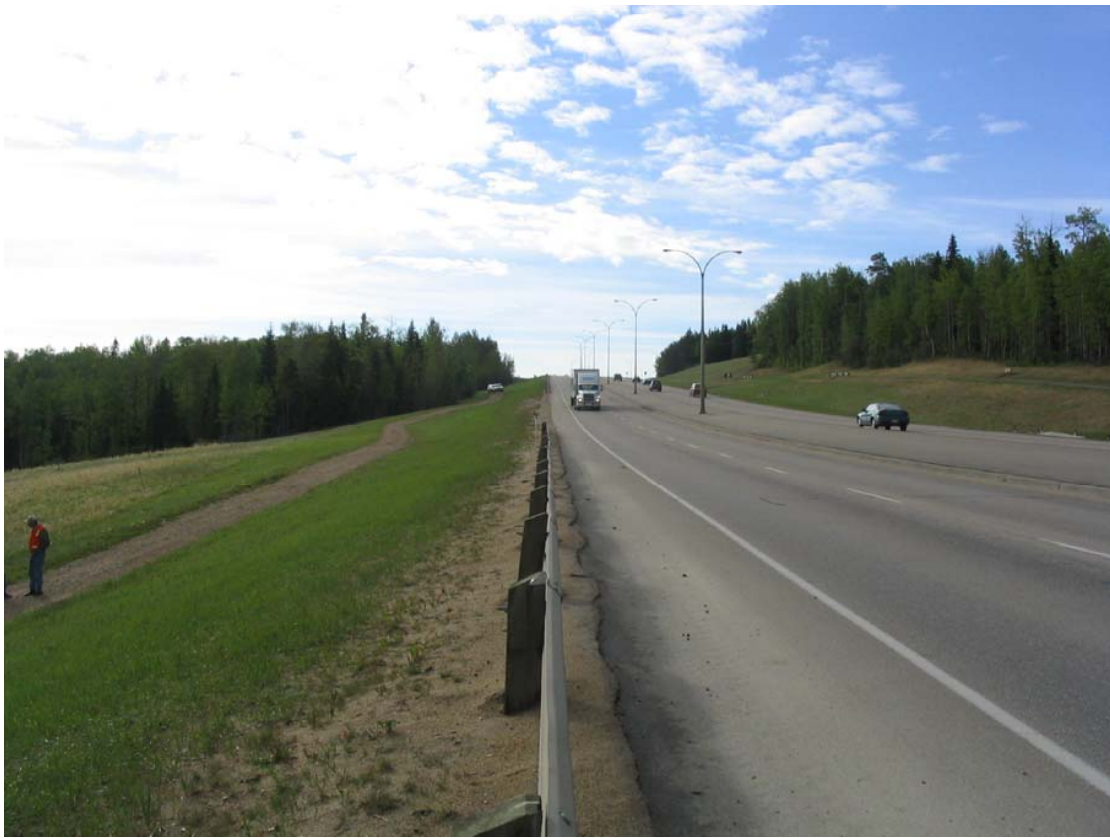
PHOTO 5 LOOKING EAST ALONG NORTH GUARDRAIL

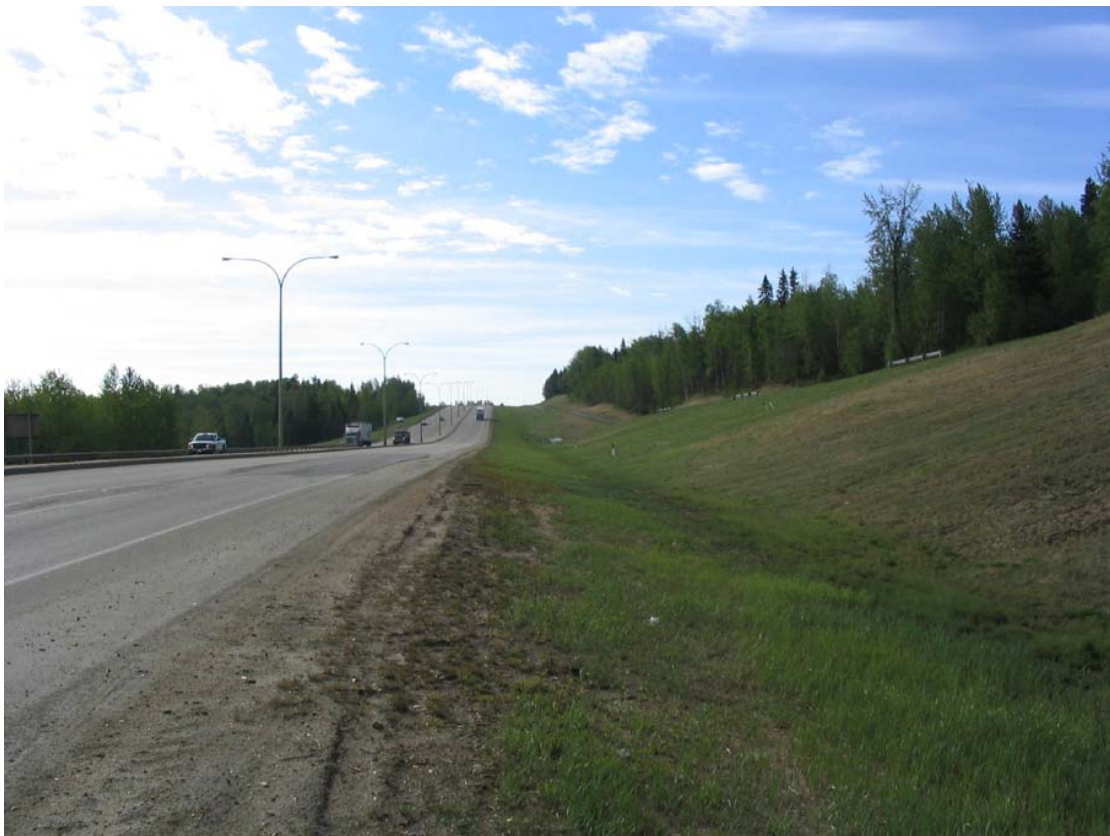
PHOTO 6 LOOKING EAST ALONG SOUTH SHOULDER

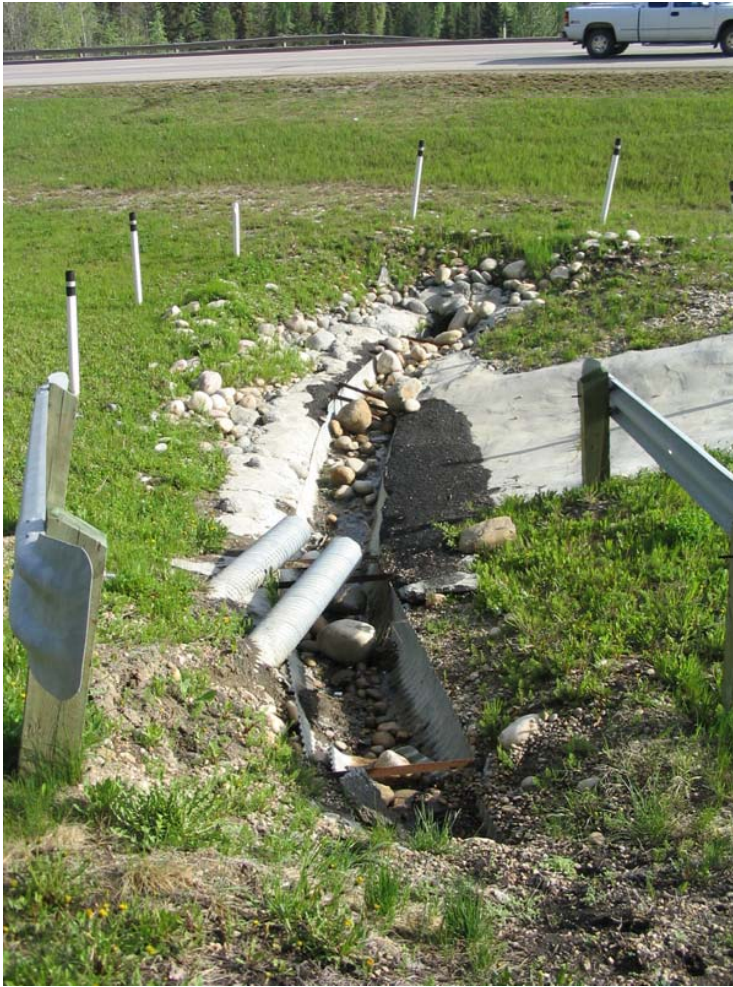
PHOTO 7 SUBDRAIN AND CULVERT
OUTLETS NEAR STATION 1+680
(SOUTH OF HIGHWAY)

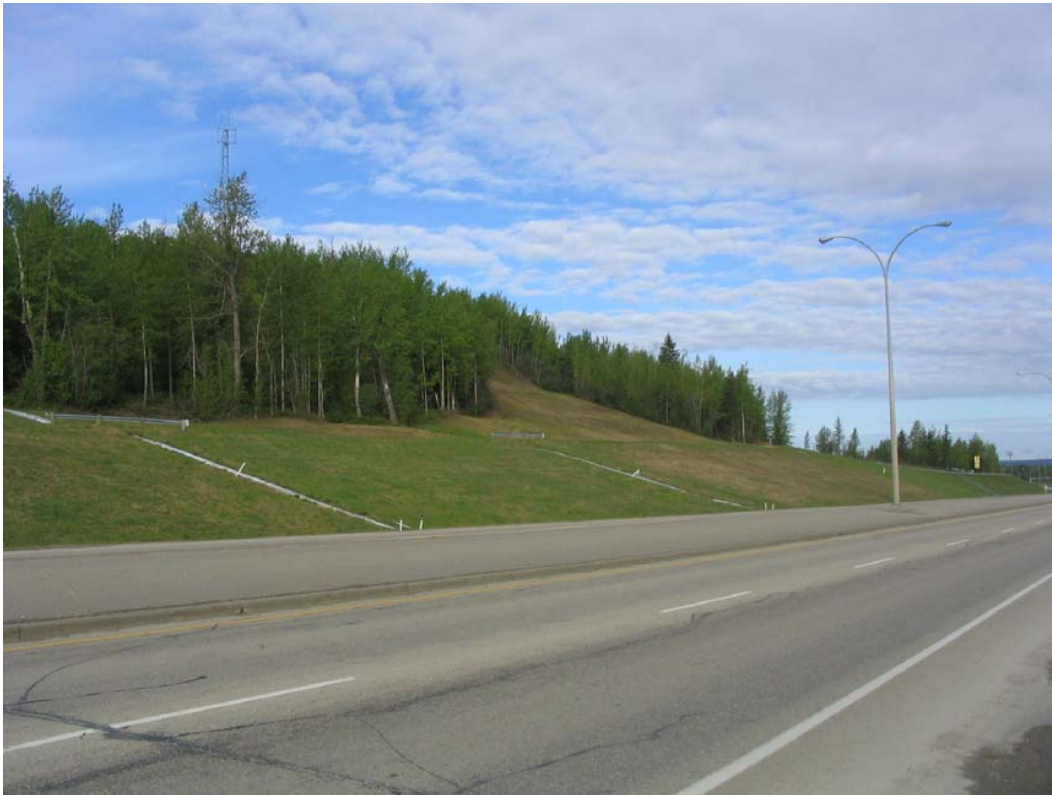
PHOTO 8 AREA OF PREVIOUS BACKSLOPE REPAIR (LOOKING SOUTHWEST)

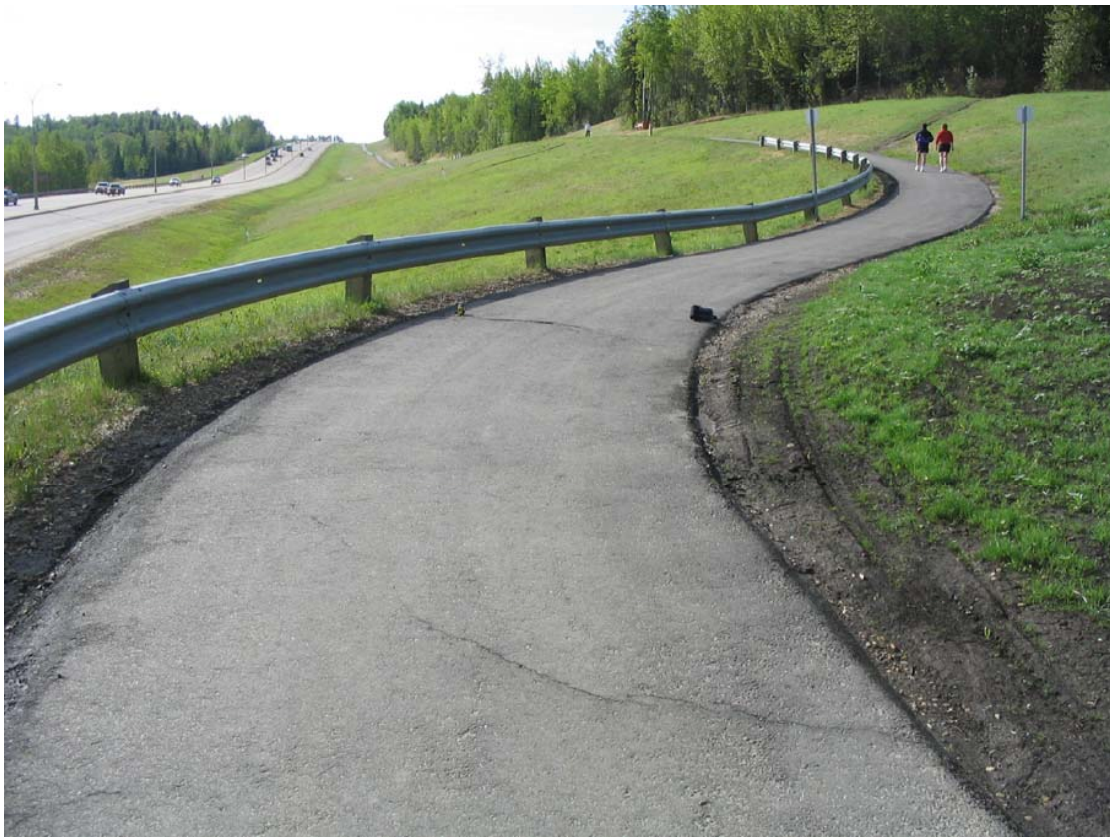
PHOTO 9 TWO EASTERN CRACKS IN NEW ASPHALT TRAIL (LOOKING EAST)

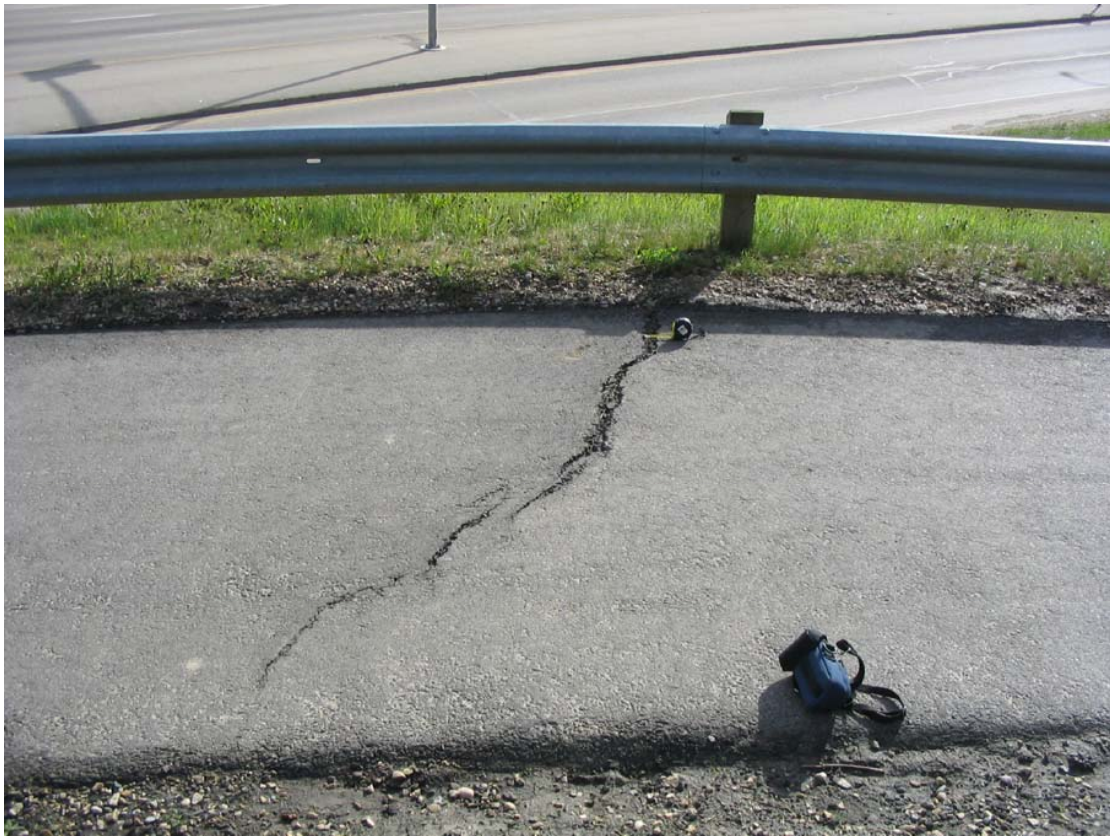
PHOTO 10 EASTERNMOST CRACK IN NEW ASPHALT TRAIL (LOOKING NORTHEAST)

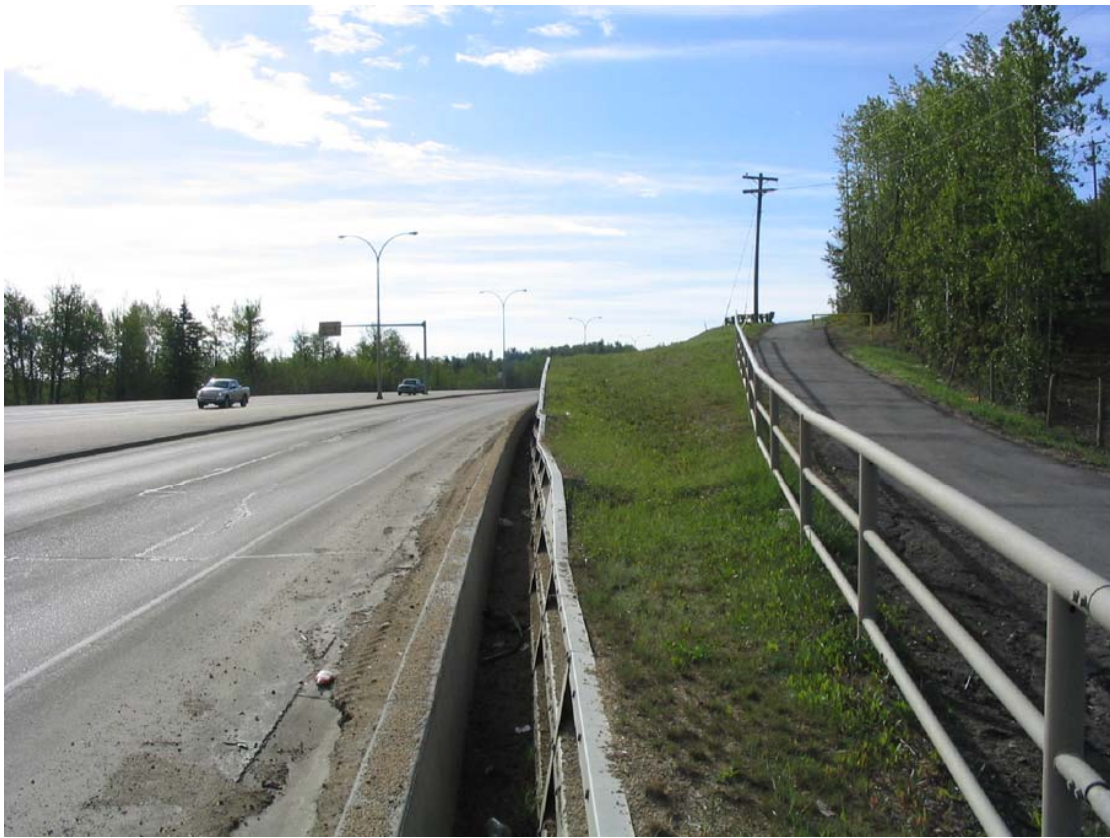
PHOTO 11 BIN WALL, STATION 1+200 LOOKING NORTHEAST

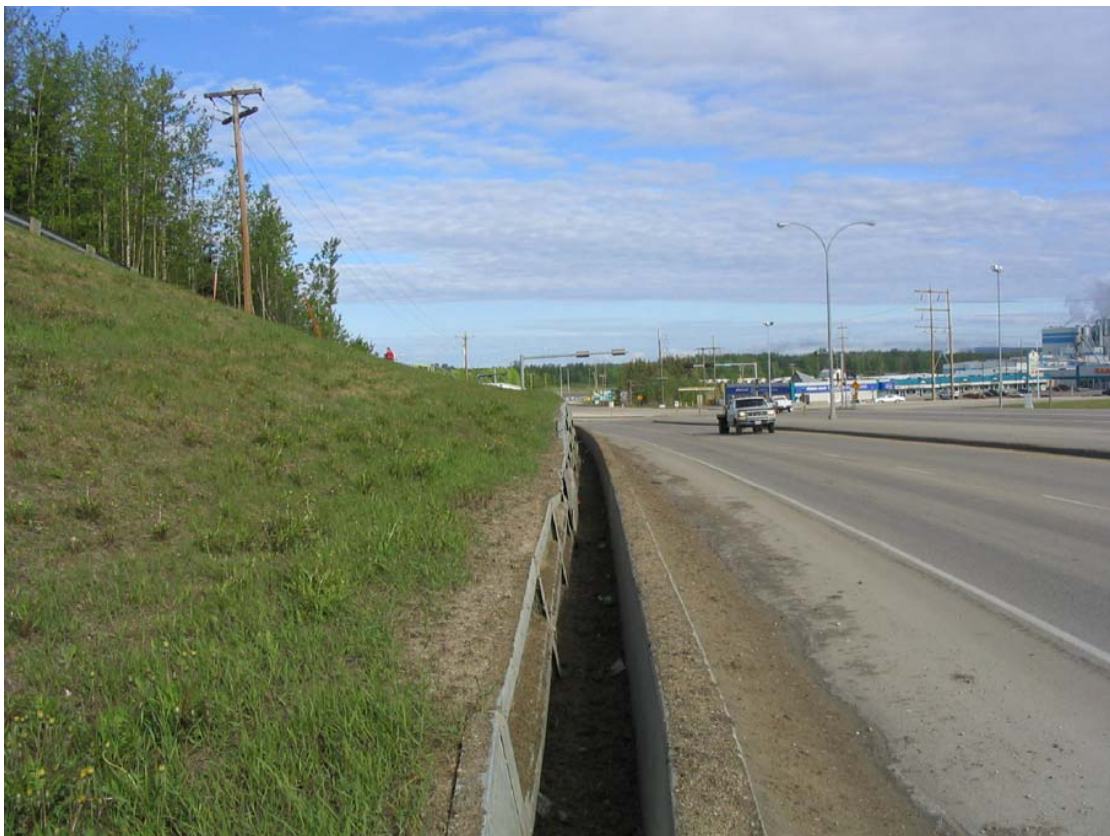
PHOTO 12 BIN WALL, STATION 1+200 LOOKING WEST
