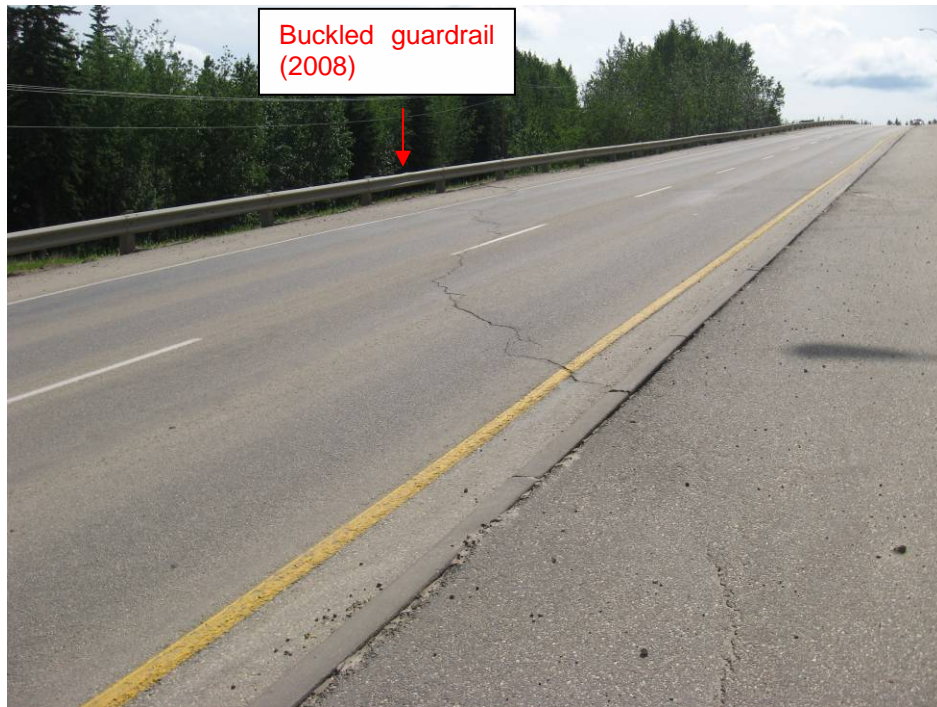
Photo 1 – Looking northeast at west crack, June 11, 2008.

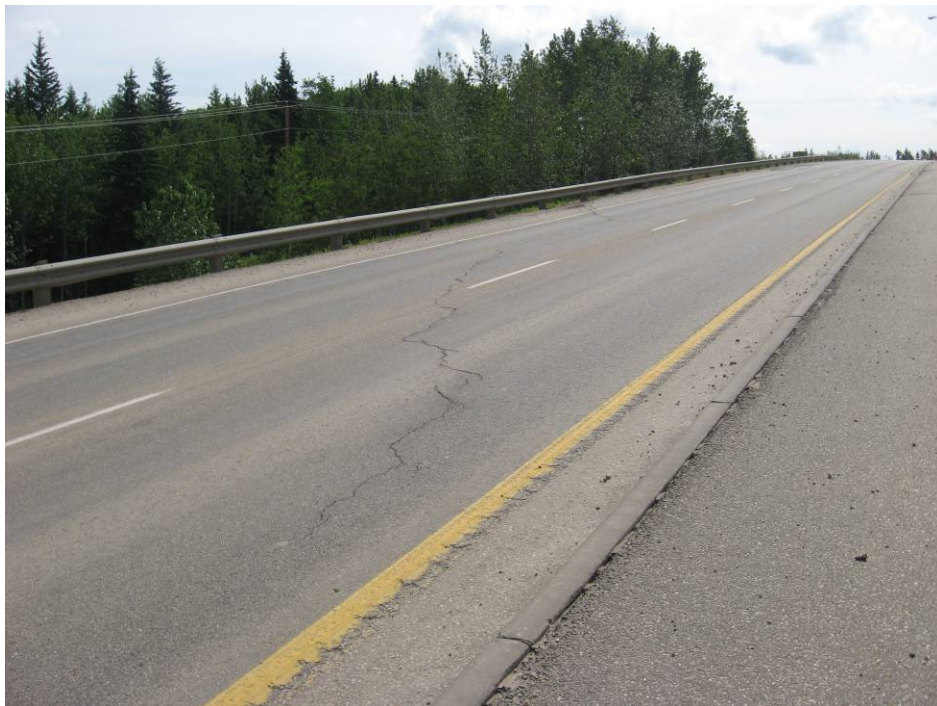
Photo 2 – Looking northeast at east crack, June 11, 2008.

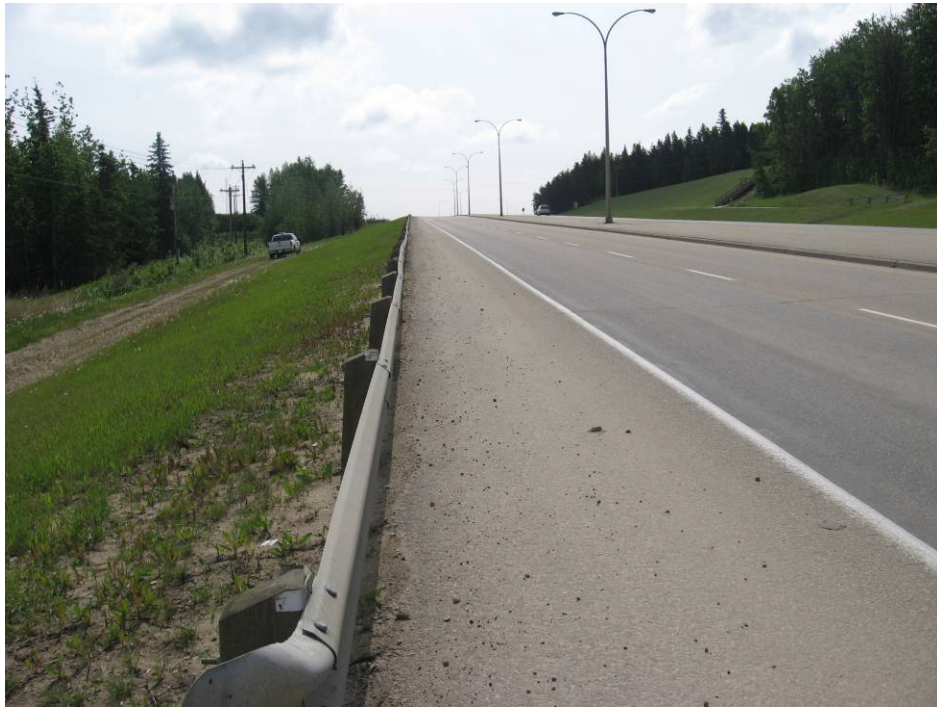
Photo 3 – Looking east along north guardrail, June 11, 2008.

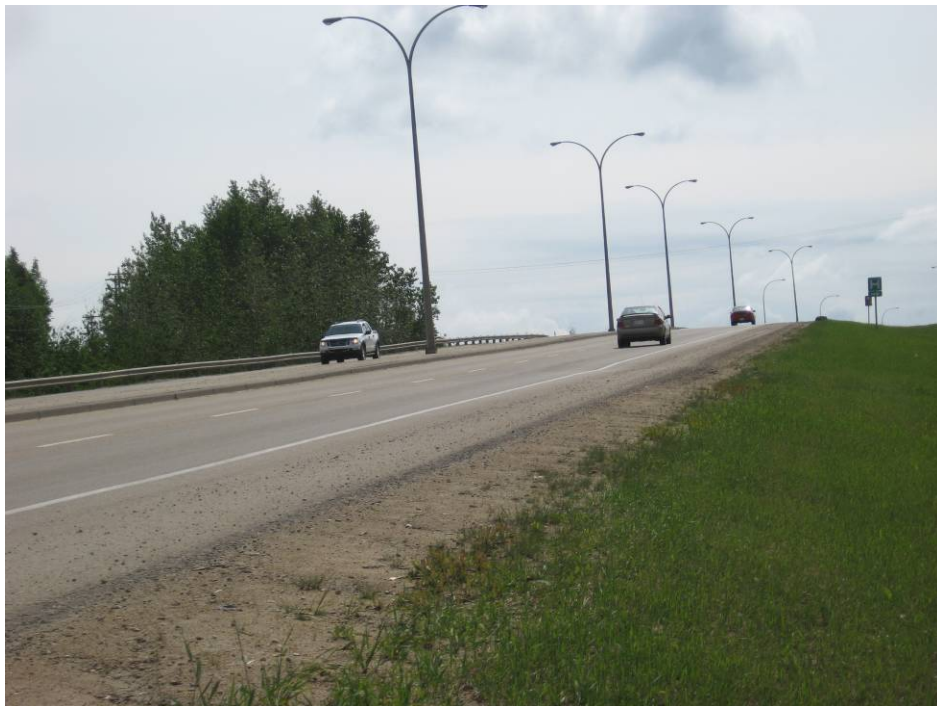
Photo 4 – Looking east at repaired shoulder and culvert dip (Station 1+770),
June 11, 2008.

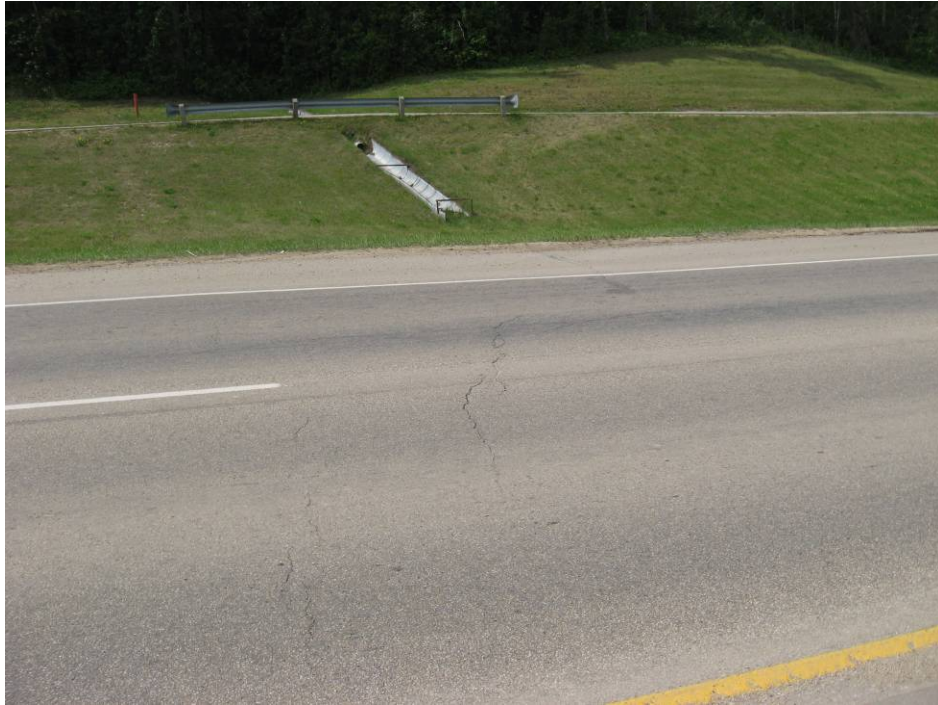
Photo 5 – Gentle dip and pavement crack at Station 1+770, June 11, 2008.

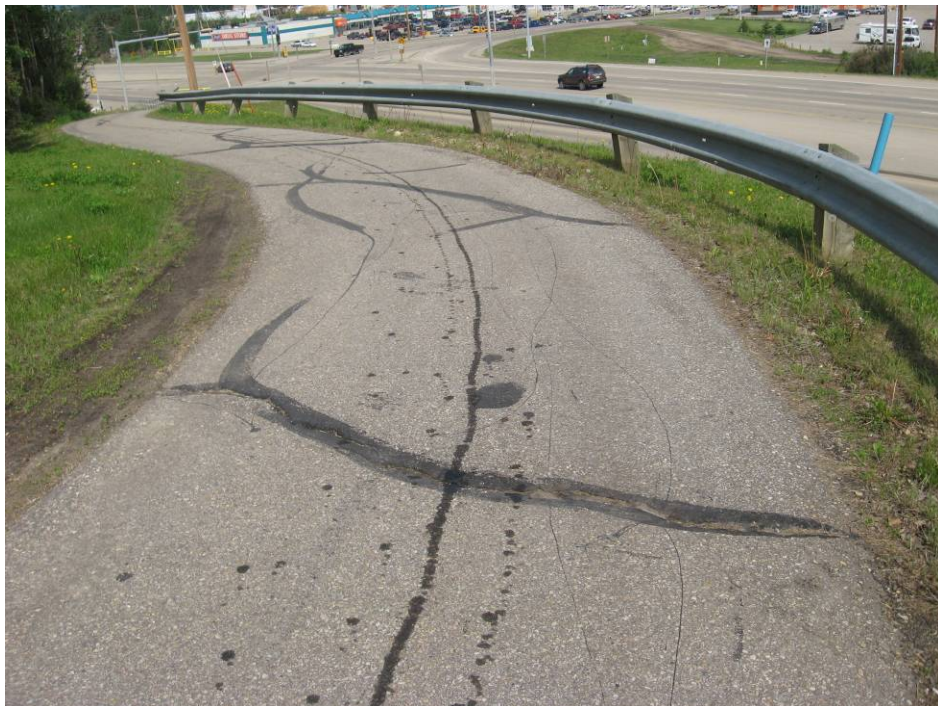
Photo 6 – Looking west at cracks above bin wall, June 11, 2008.

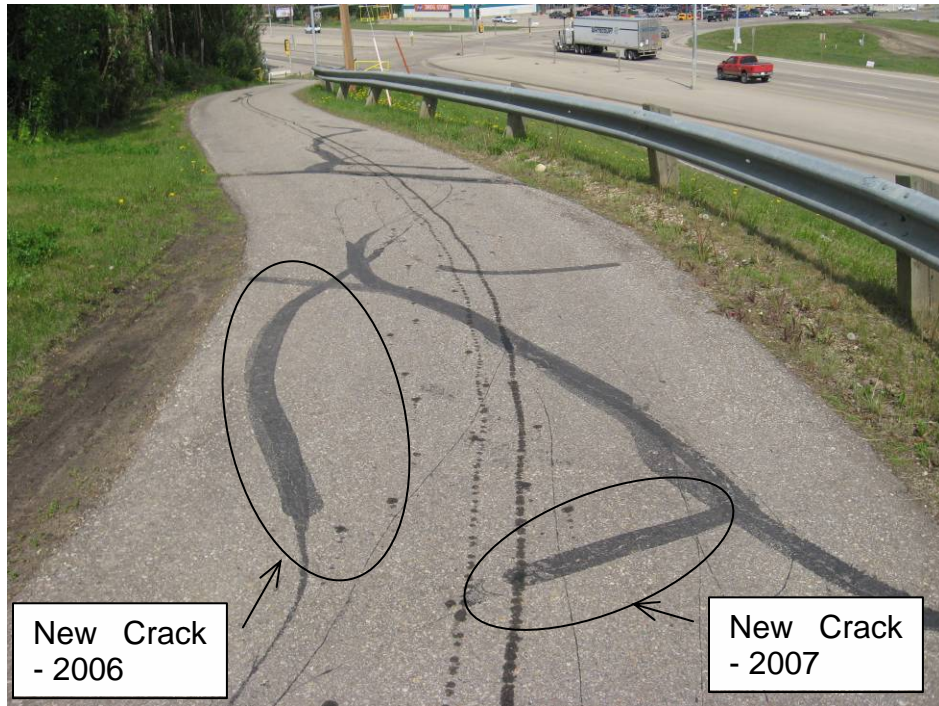
Photo 7 – Closer view of new crack to south of existing cracks, June 11, 2008.

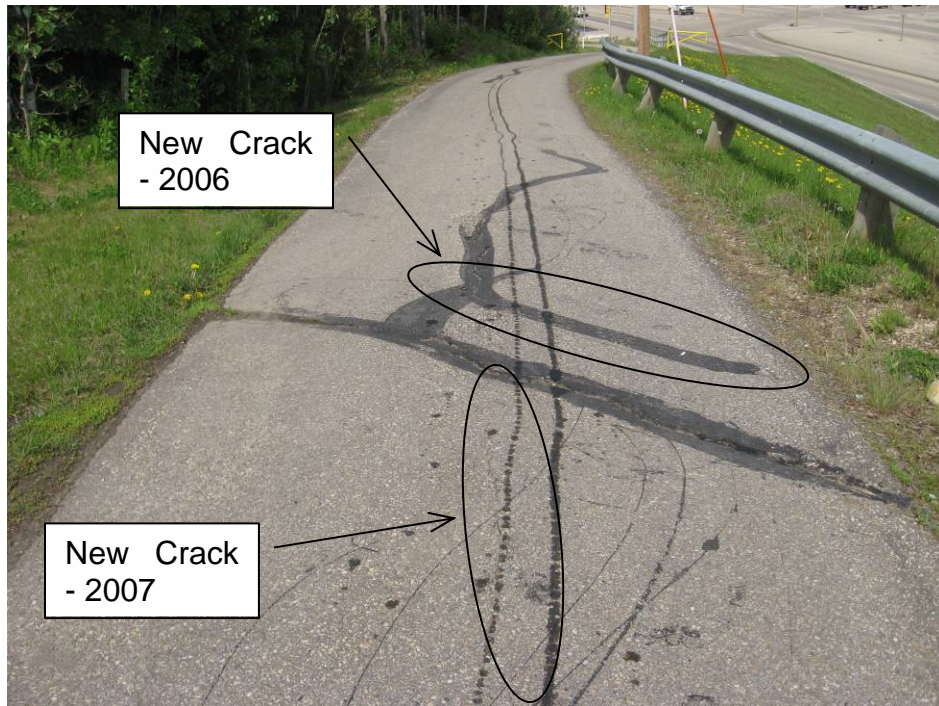
Photo 8 – Closer view of new crack to between existing cracks, June 11, 2008.

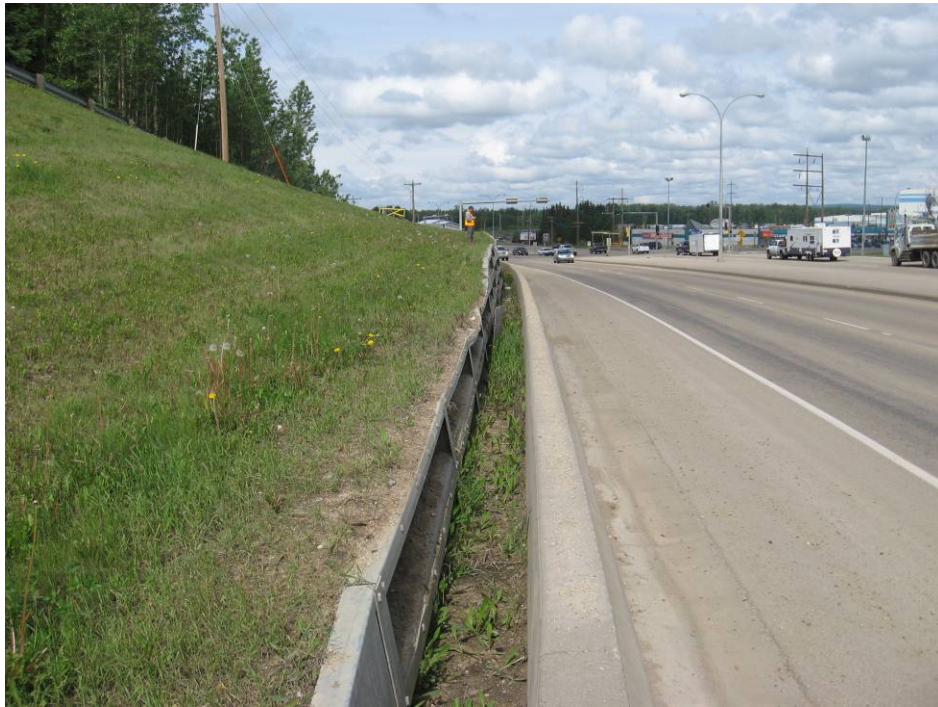
Photo 9 – Looking west at bin wall (Station 1+200), June 11, 2008.

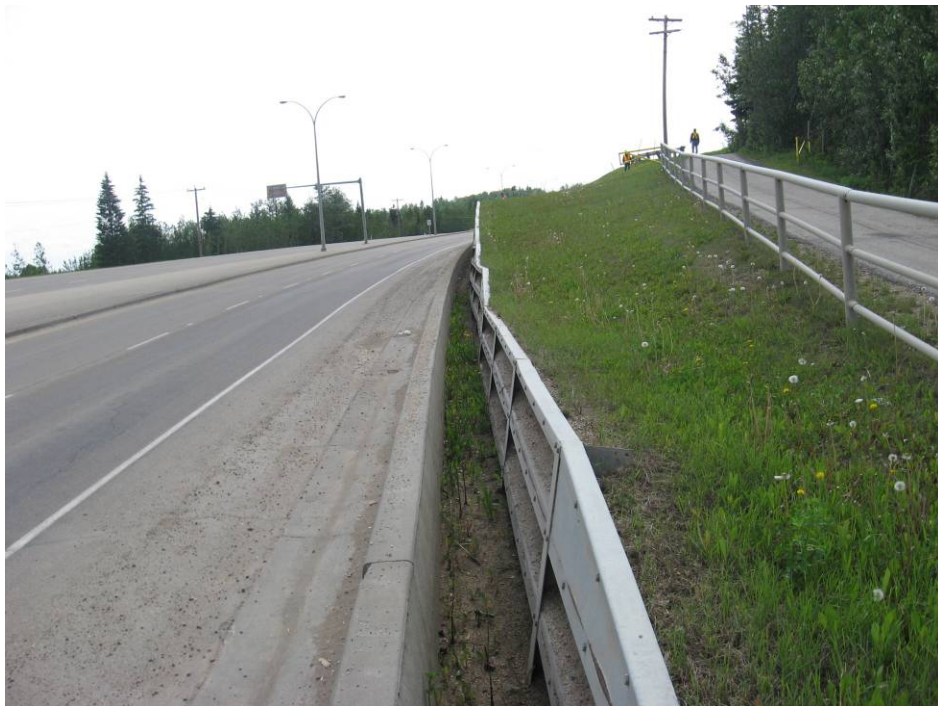
Photo 10 – Looking east at bin wall (Station 1+200), June 11, 2008.
