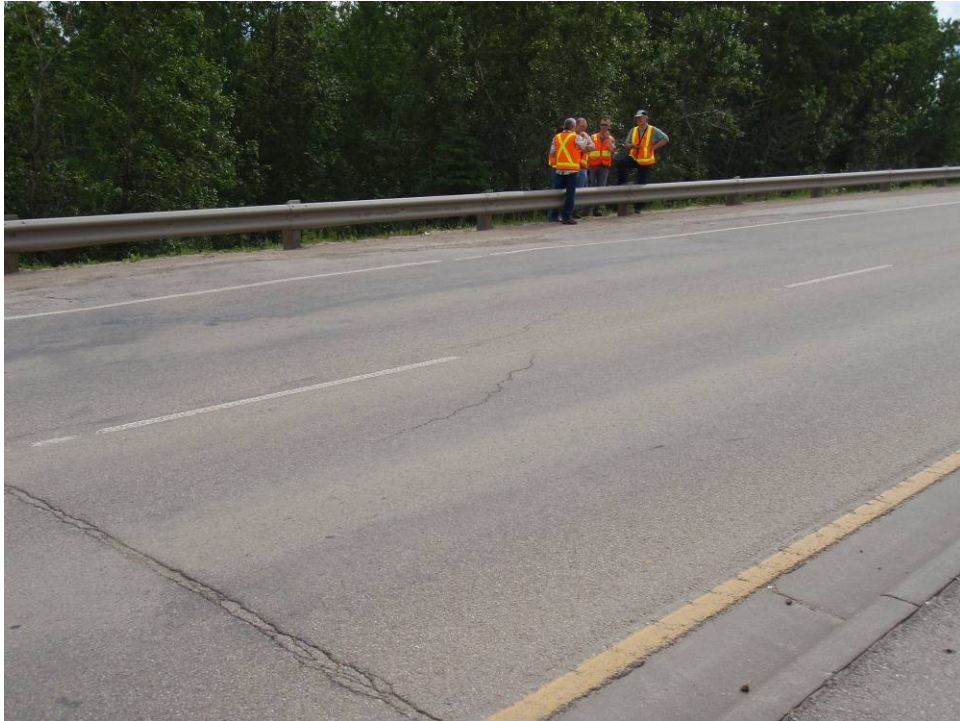
Photo 1 – Looking northeast at catch basin cracks (June 15, 2009).

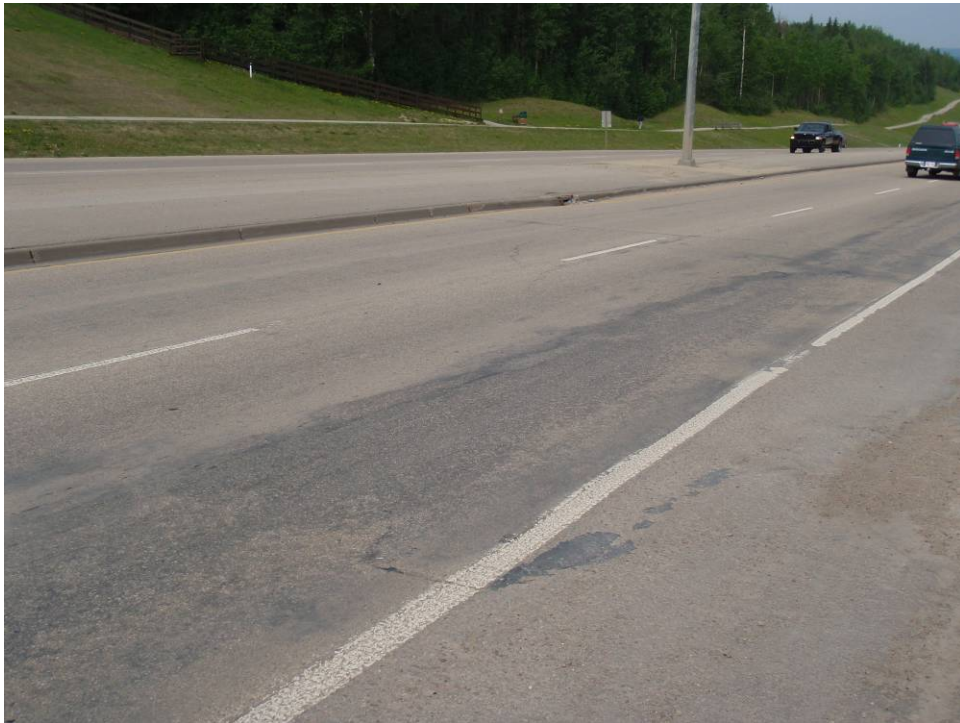
Photo 2 – Looking southwest at catch basin cracks (June 15, 2009).

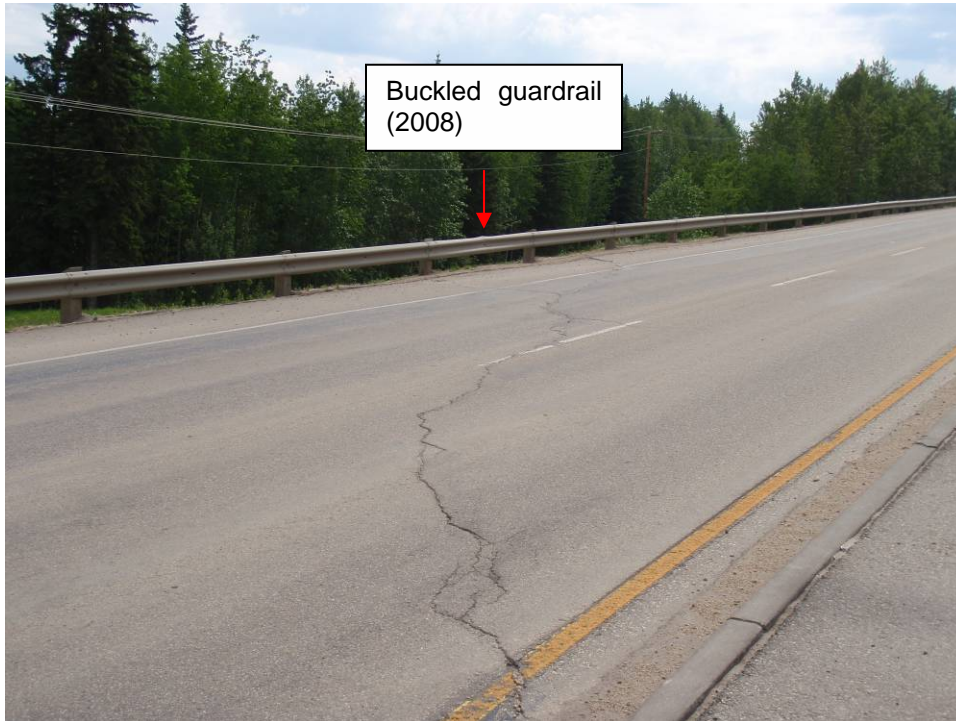
Photo 3 – Looking northeast at west crack (June 15, 2009).

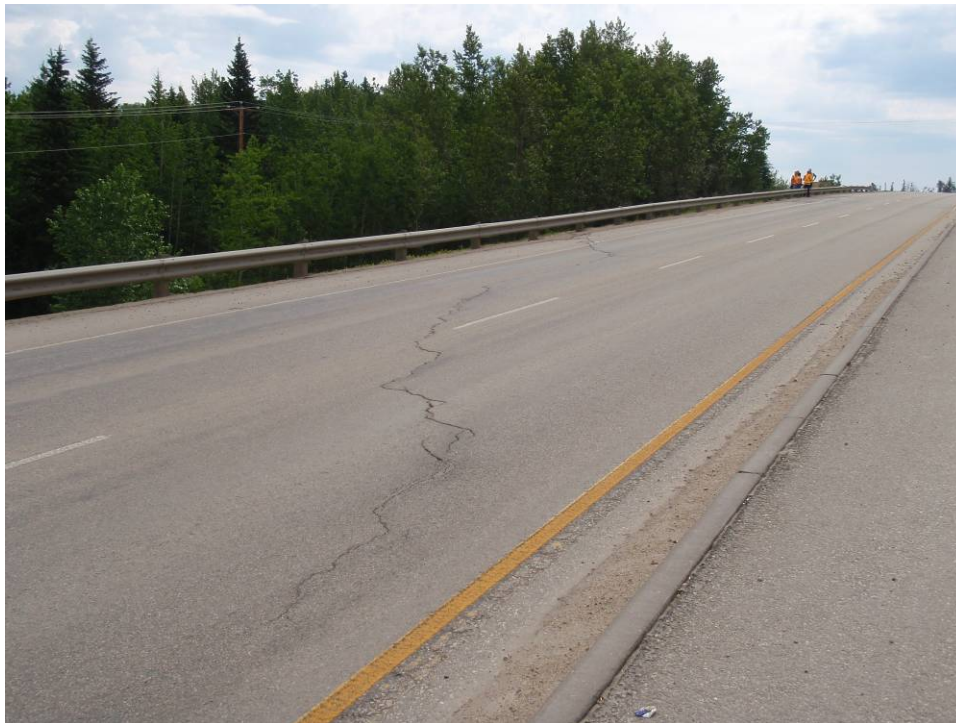
Photo 4 – Looking northeast at east crack (June 15, 2009).

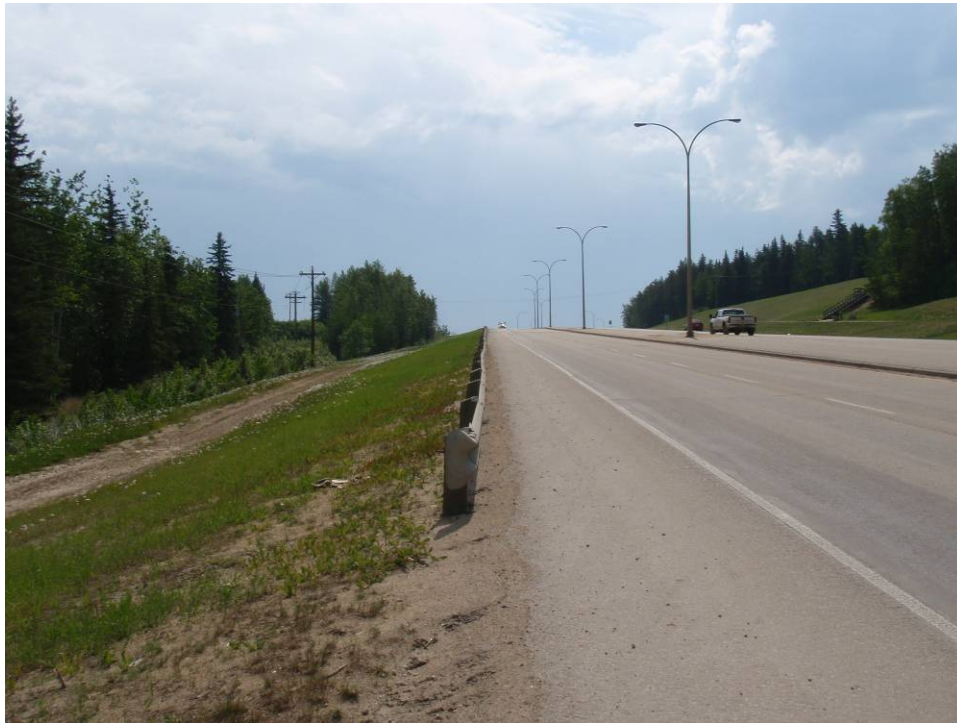
Photo 5 – Looking east along north guardrail (June 15, 2009).

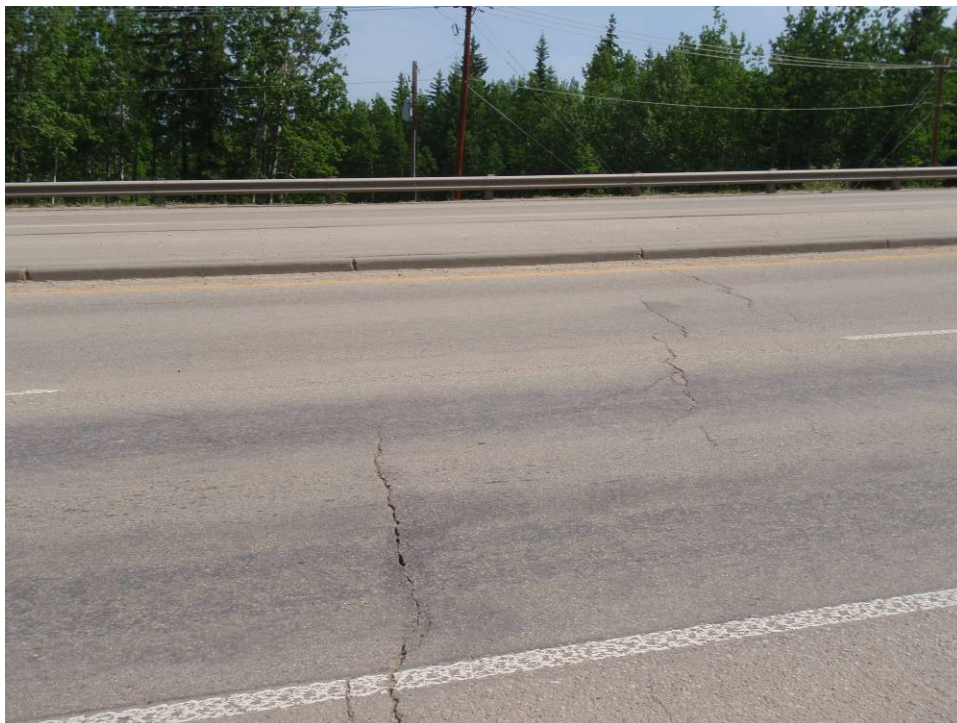
Photo 6 – Looking northeast at culvert dip at Station 1+850 (June 15, 2009).

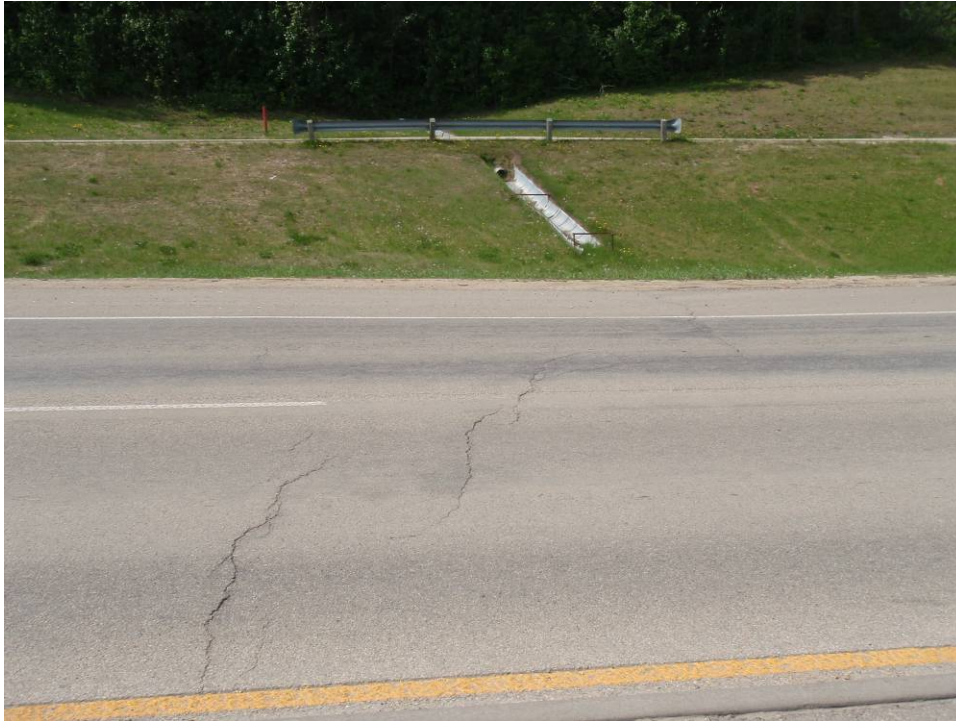
Photo 7 – Gentle dip and pavement crack at Station 1+850 (June 15, 2009).

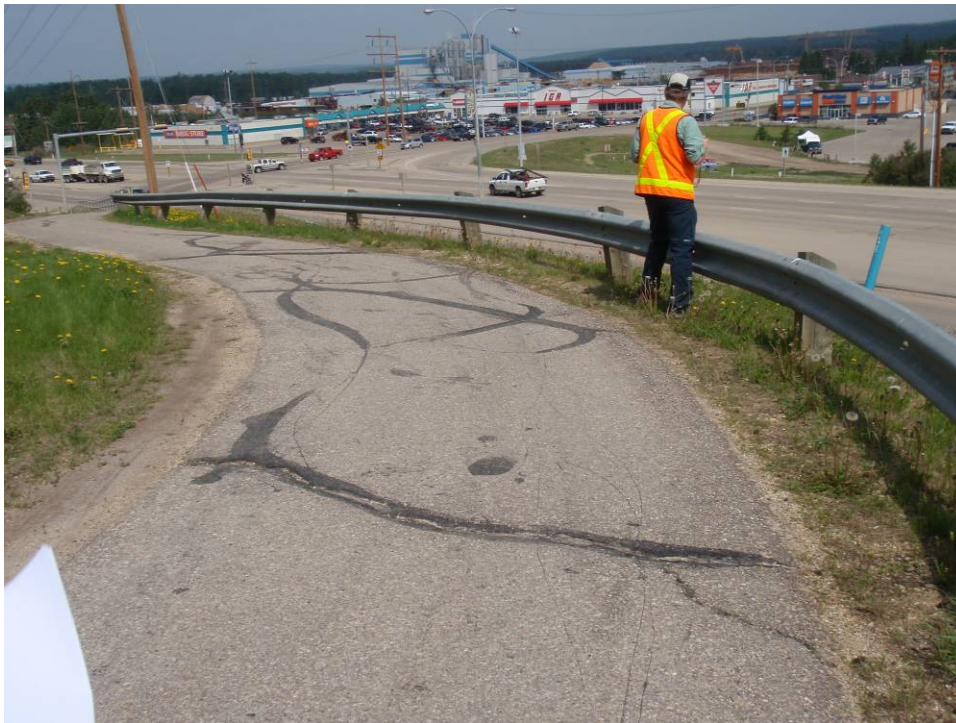
Photo 8 – Looking west at cracks above bin wall. Note tilt of SI30 casing just beyond guardrail (June 15, 2009).

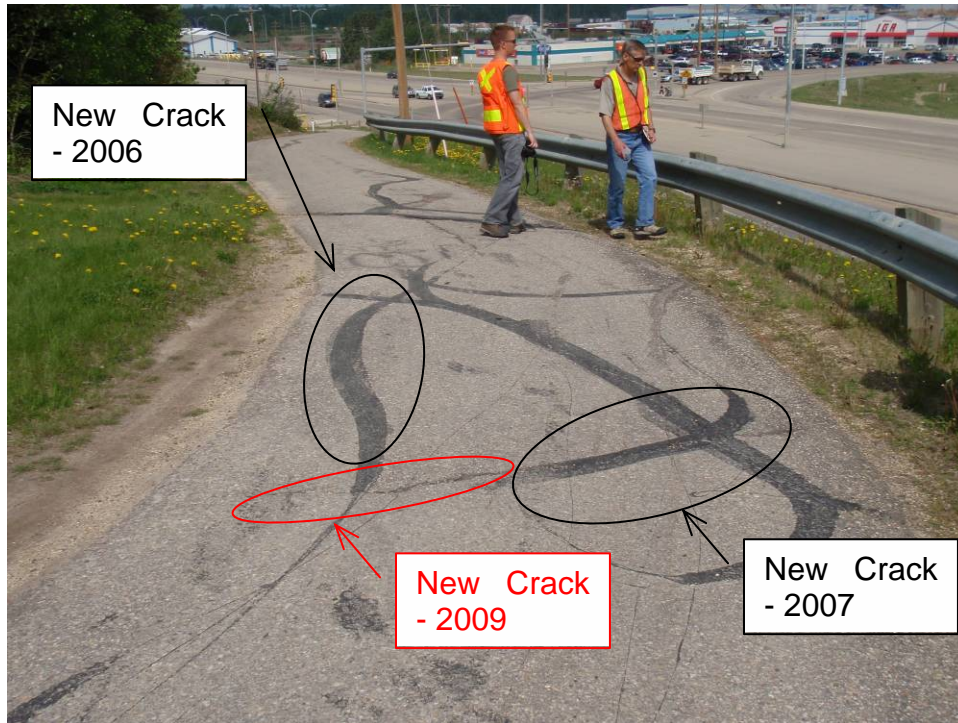
Photo 9 – Closer view of new crack to south of existing cracks (June 15, 2009).

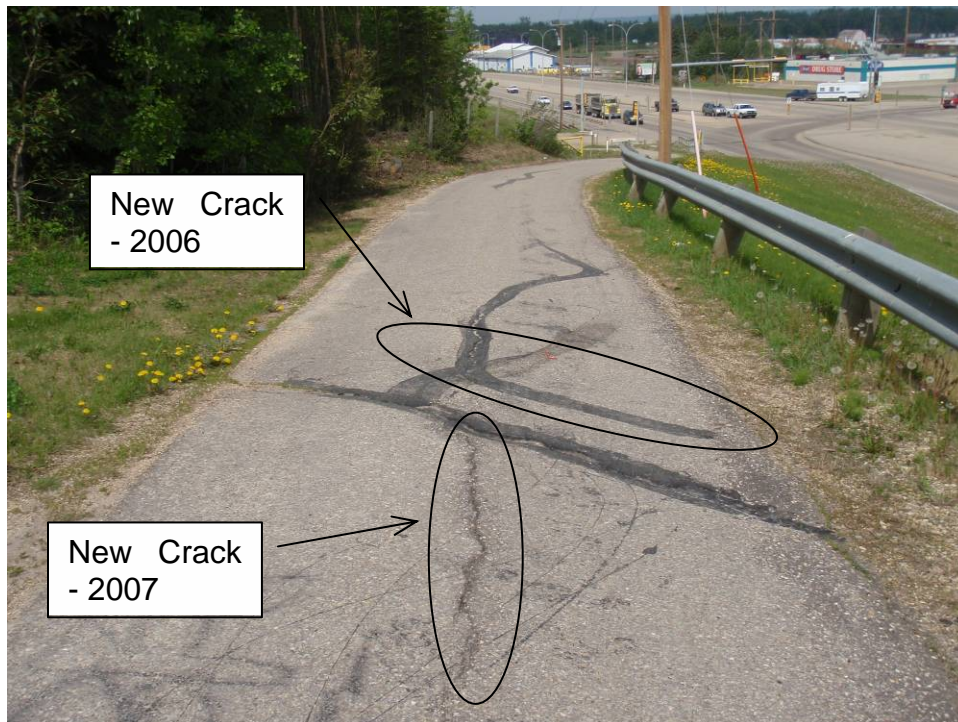
Photo 10 – Closer view of new crack to between existing cracks (June 15, 2009).

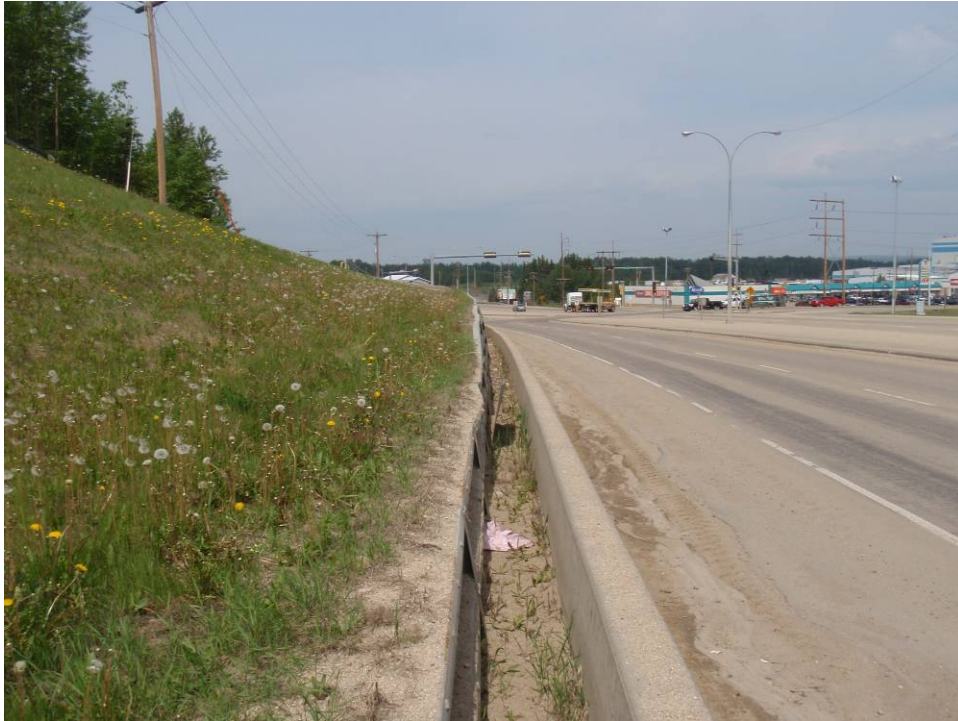
Photo 11 – Looking west at bin wall (Station 1+200) (June 15, 2009).

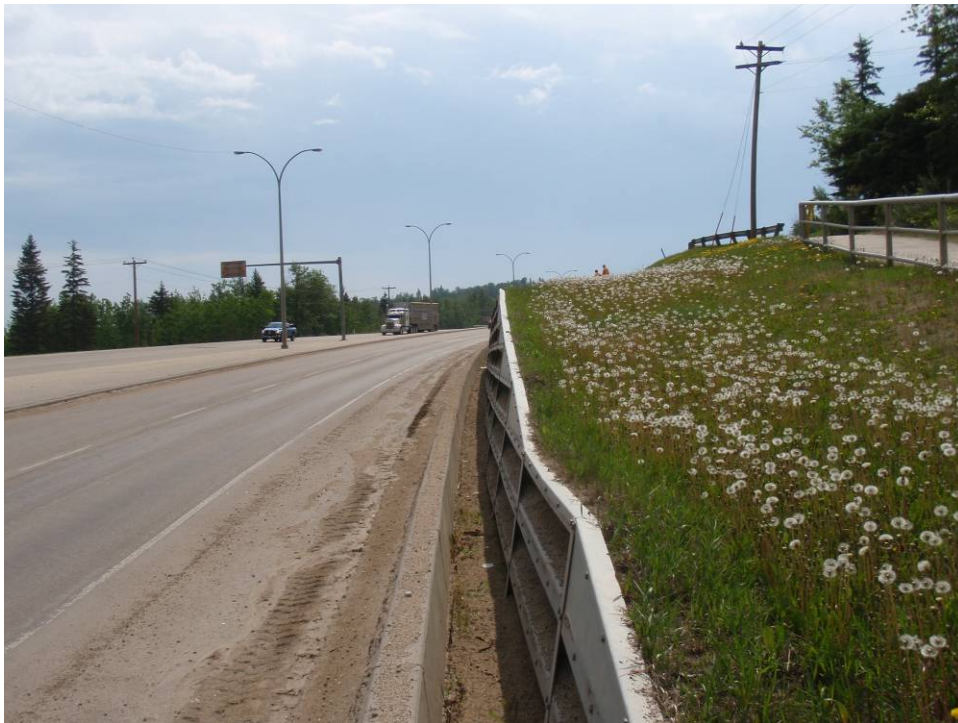
Photo 12 – Looking east at bin wall (Station 1+200) (June 15, 2009).
