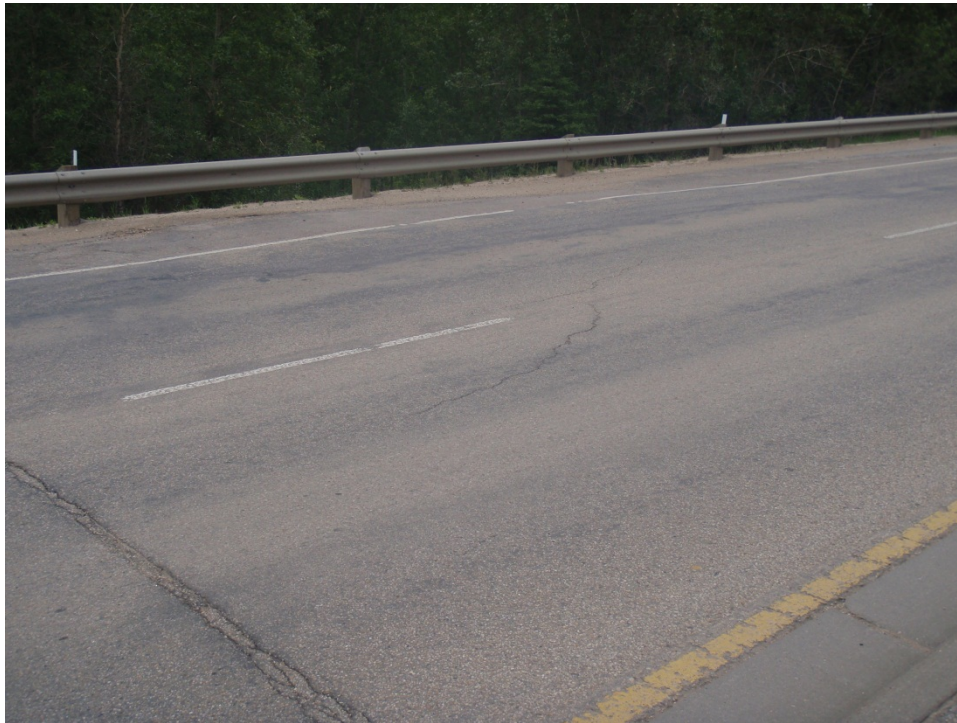
Photo 1 – Looking northeast at catch basin cracks (June 15, 2010).

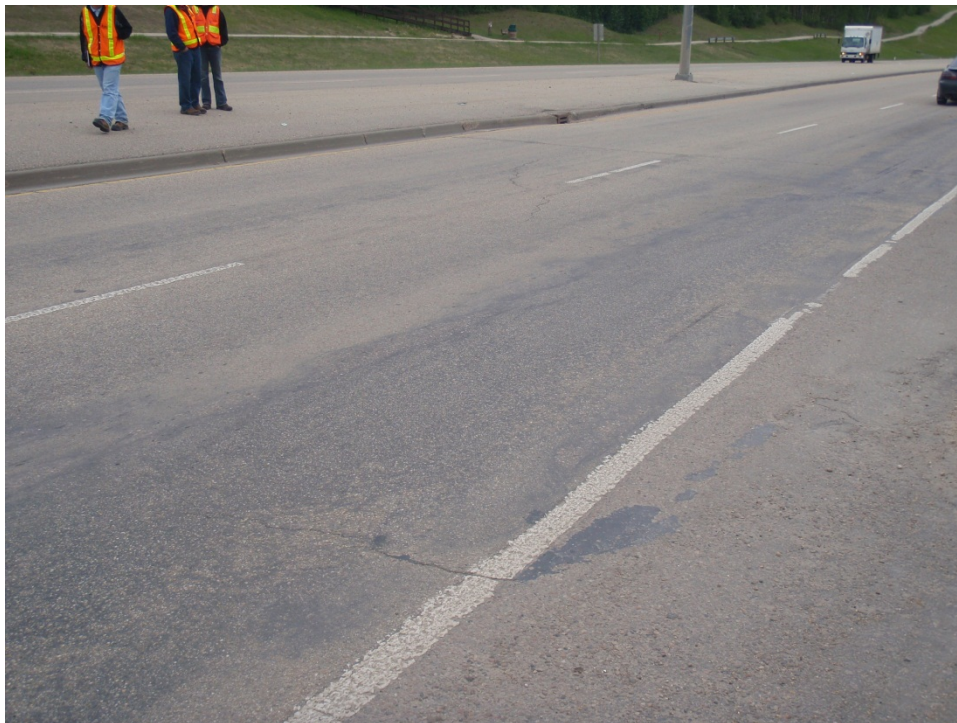
Photo 2 – Looking southwest at catch basin cracks (June 15, 2010).

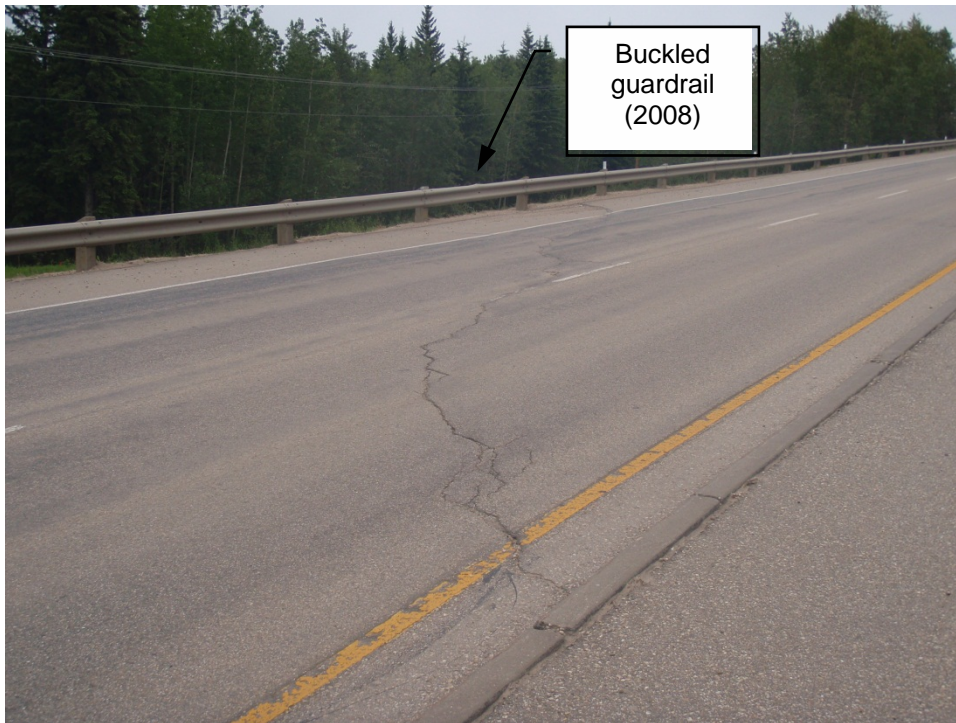
Photo 3 – Looking northeast at west crack (June 15, 2010).

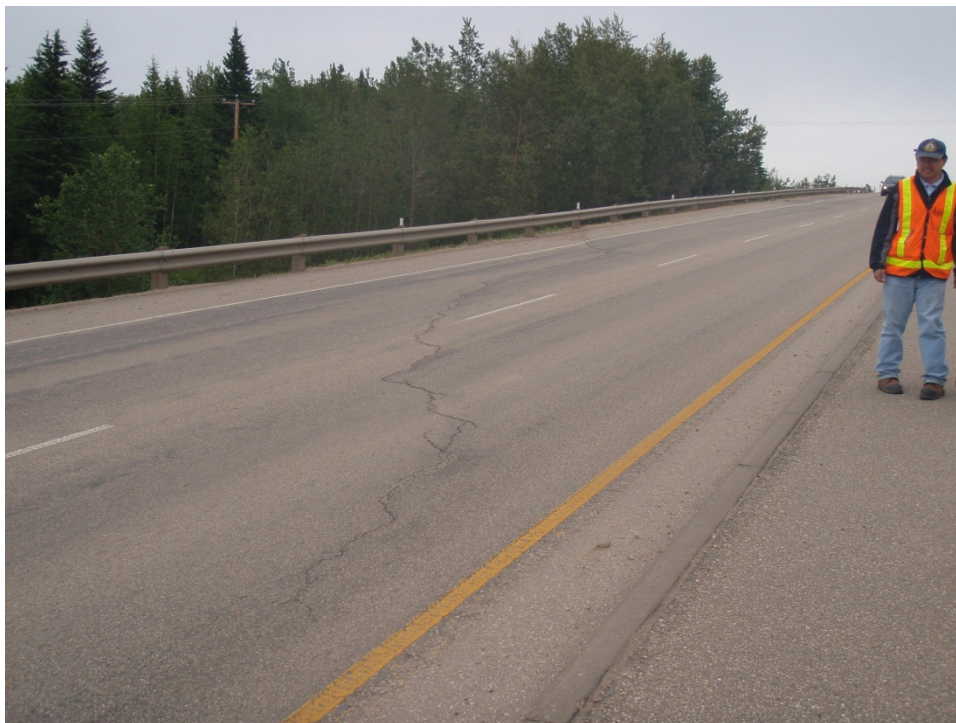
Photo 4 – Looking northeast at east crack (June 15, 2010).

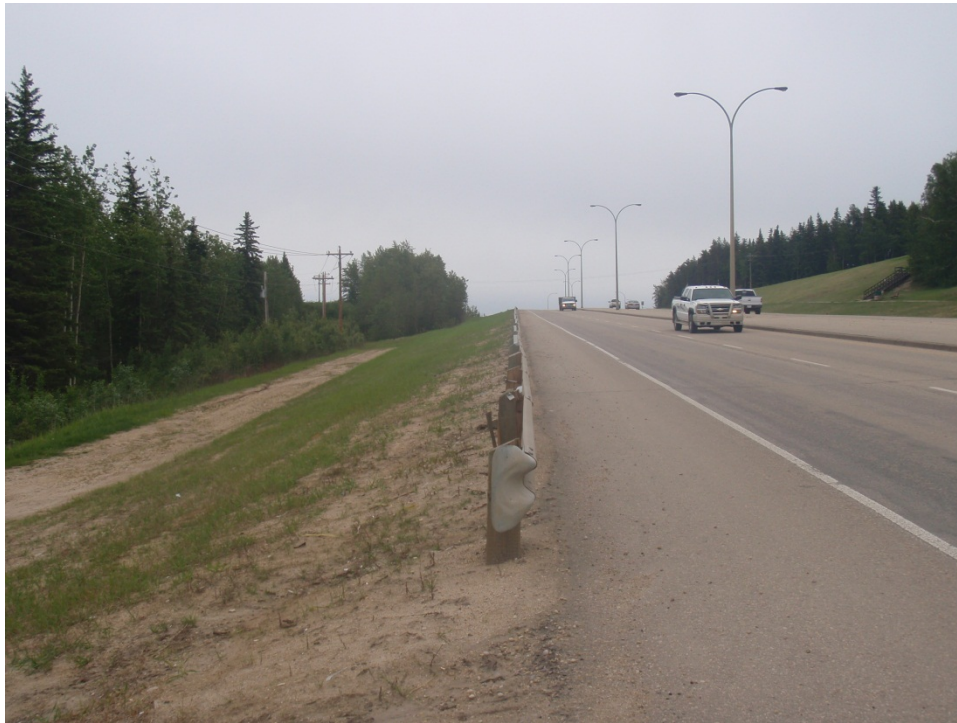
Photo 5 – Looking east along north guardrail (June 15, 2010).

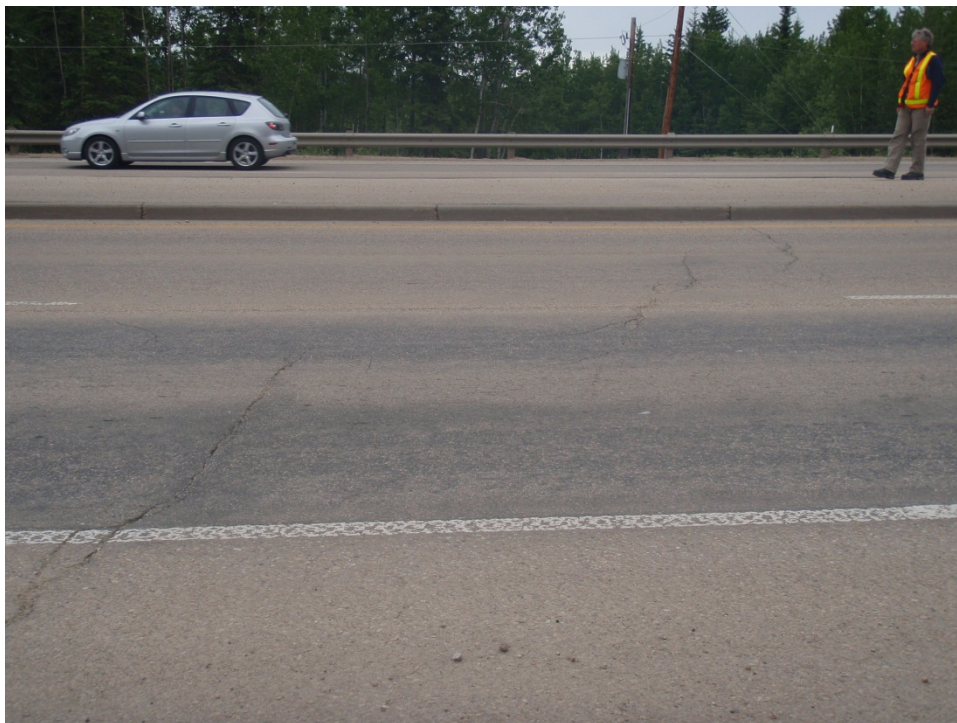
Photo 6 – Looking northeast at culvert dip at Station 1+850 (June 15, 2010).

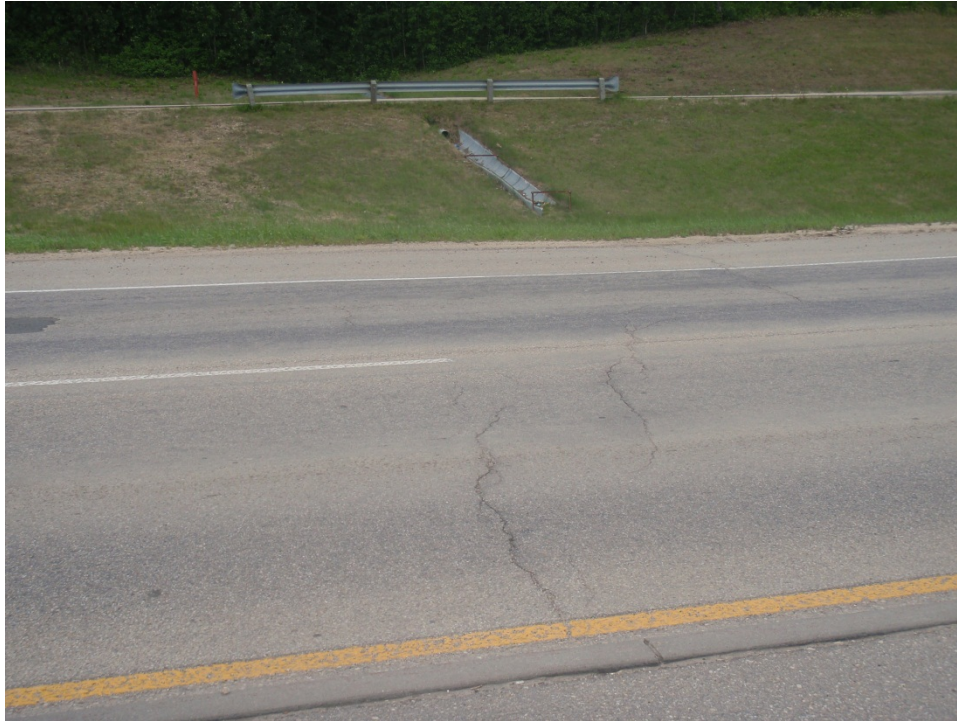
Photo 7 – Gentle dip and pavement crack at Station 1+850 (June 15, 2010).

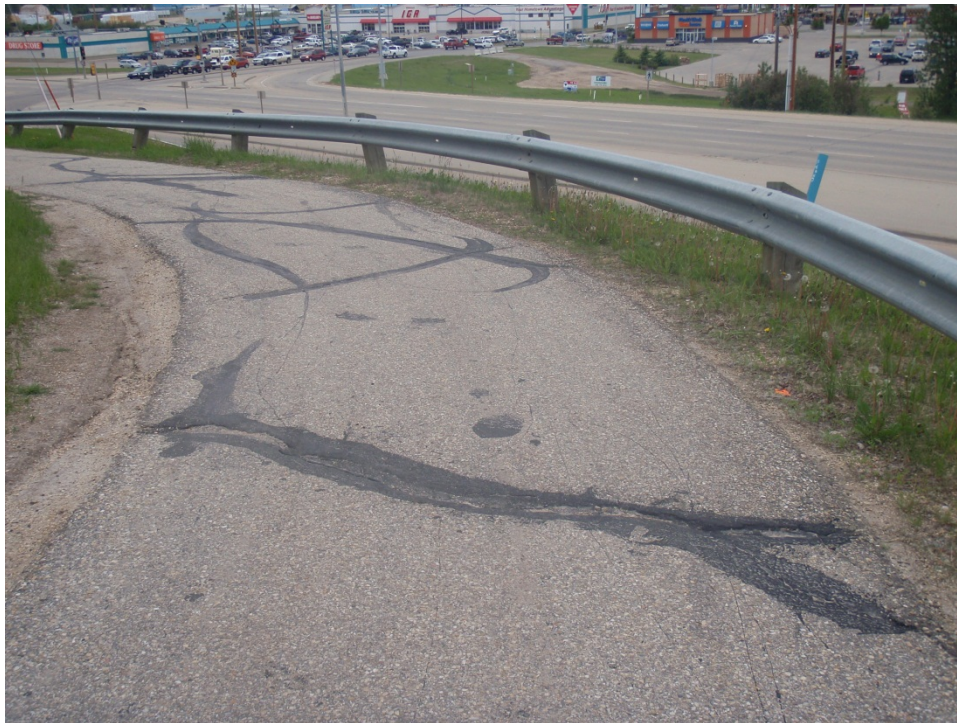
Photo 8 – Looking west at cracks above bin wall. Note tilt of SI30 casing just beyond guardrail (June 15, 2010).

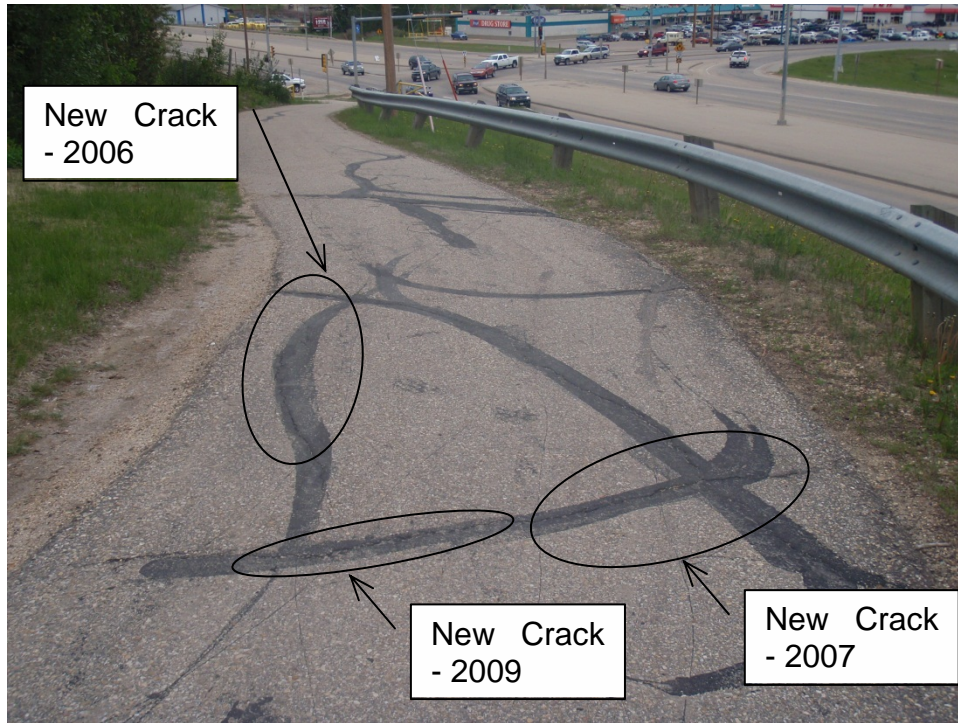
Photo 9 – Closer view of new crack to south of existing cracks (June 15, 2010).

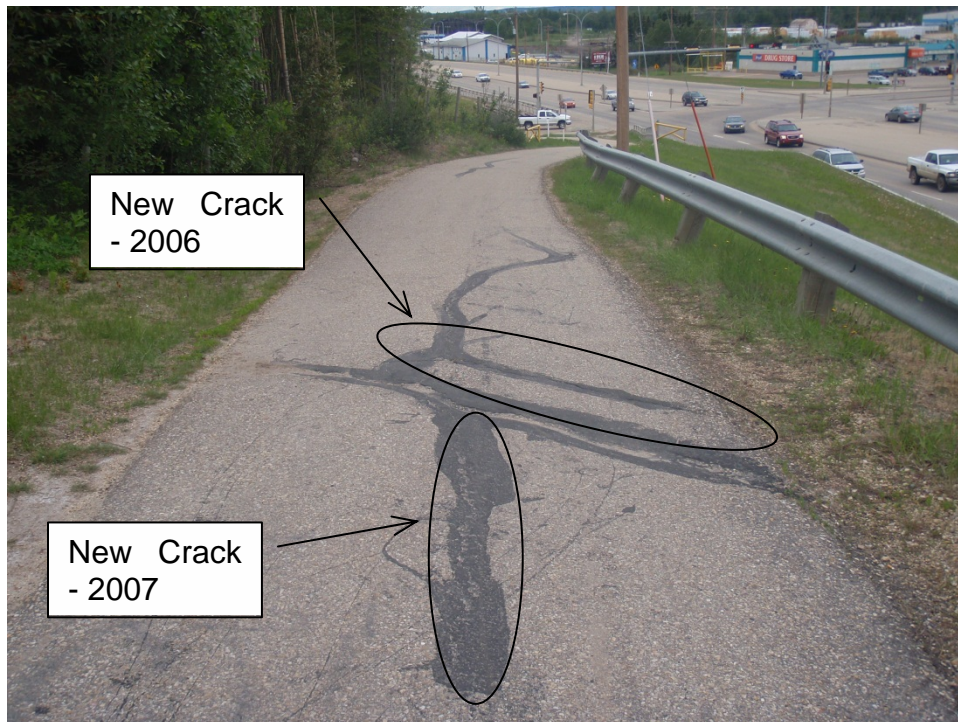
Photo 10 – Closer view of new crack to between existing cracks (June 15, 2010).

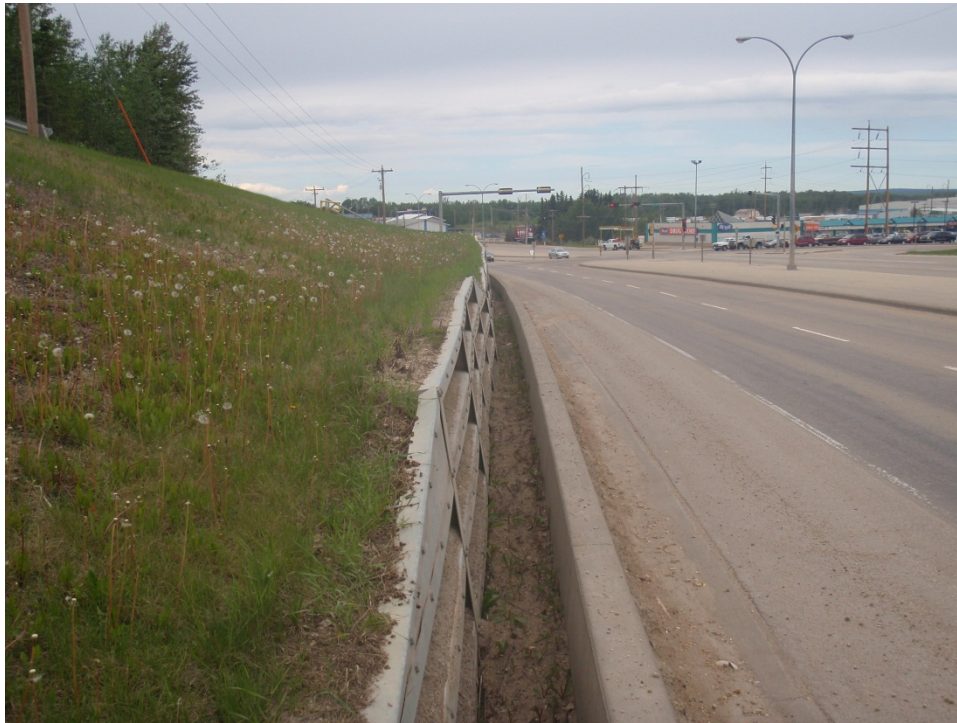
Photo 11 – Looking west at bin wall (Station 1+200) (June 15, 2010).

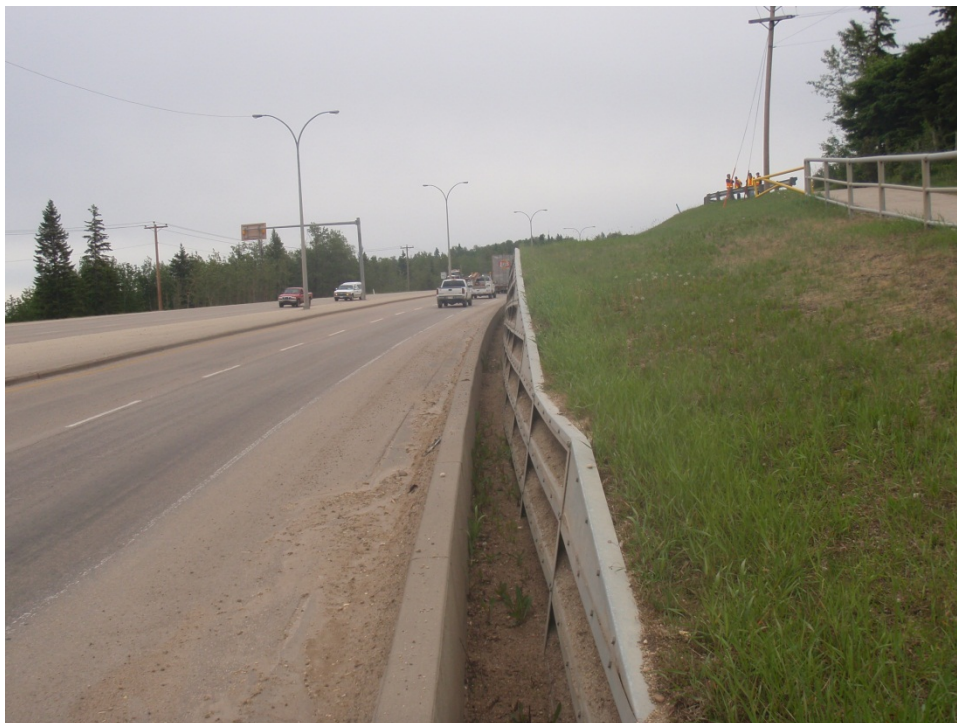
Photo 12 – Looking east at bin wall (Station 1+200) (June 15, 2010).
