NC1 - WHITECOURT EAST HILL
2013 Annual Inspection Photos

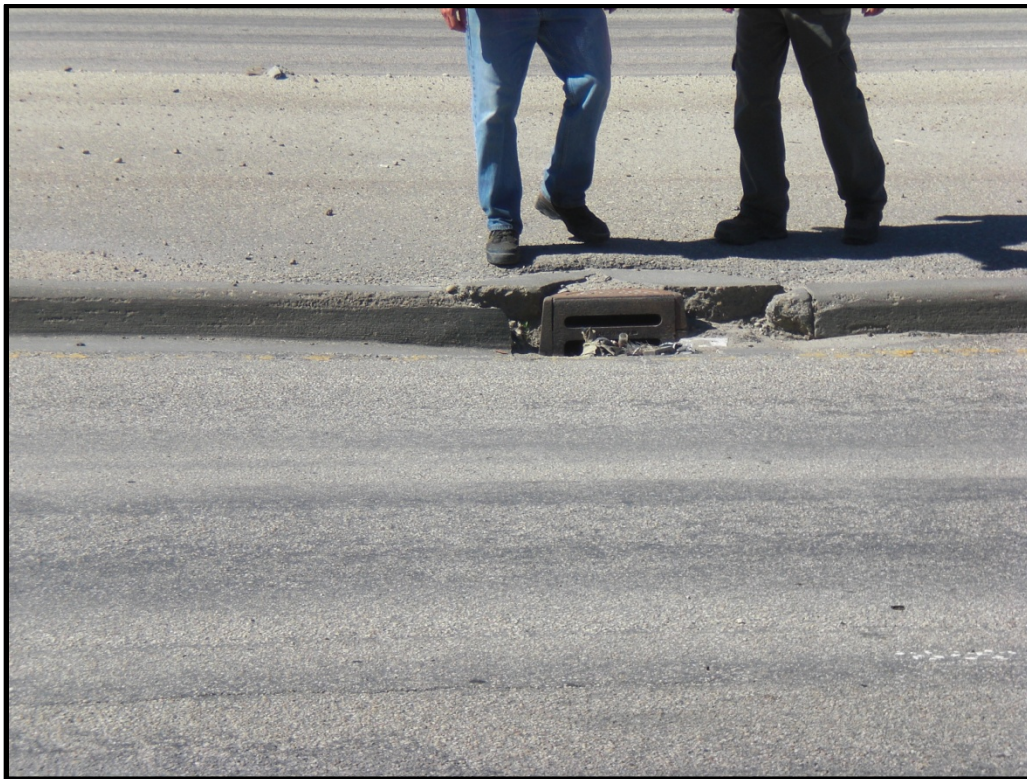
PHOTO 1: Dip in pavement at Catch Basin Cracks.

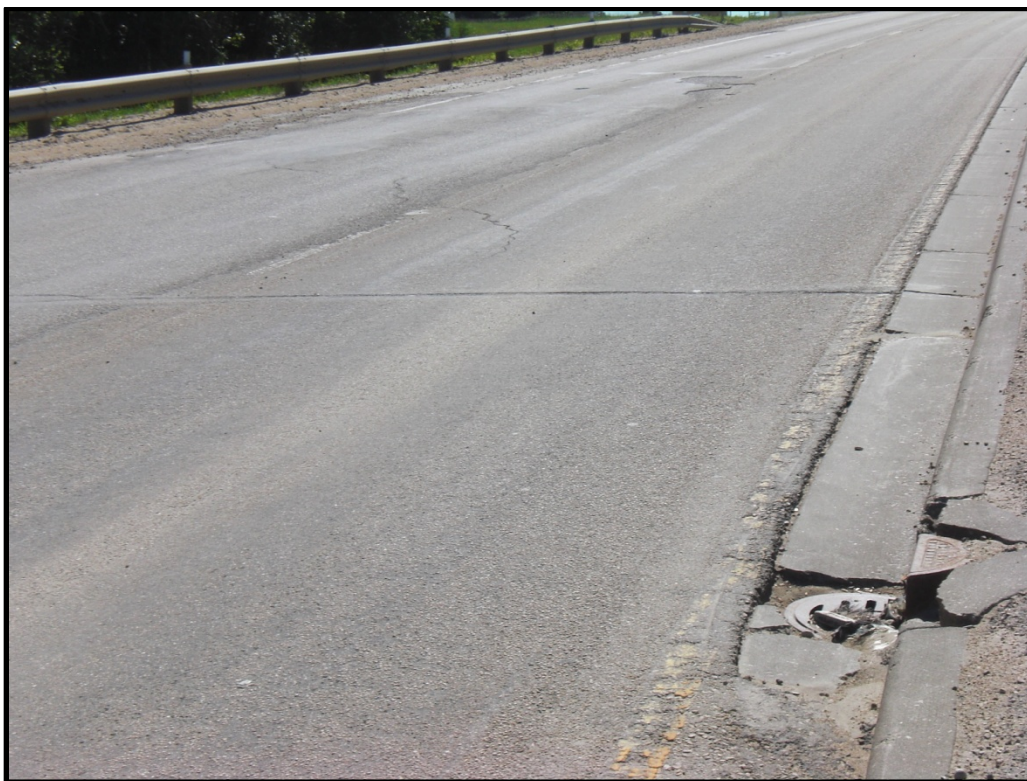
PHOTO 2: Catch Basin Cracks, facing East.

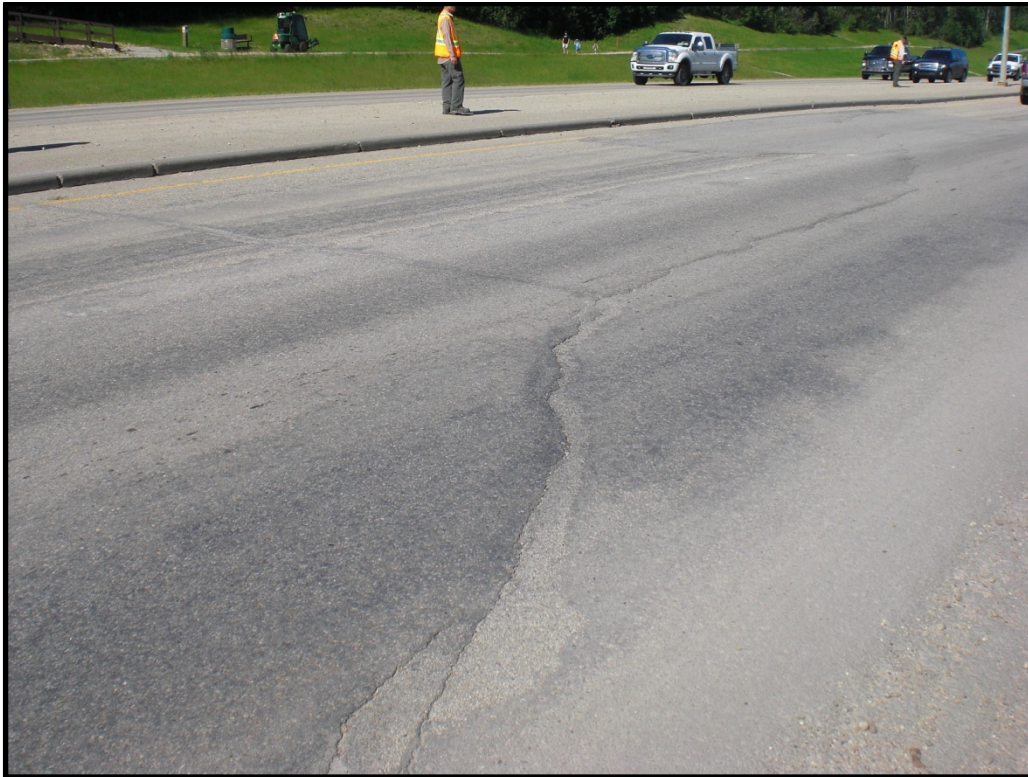
PHOTO 3: East Cracks, facing West.

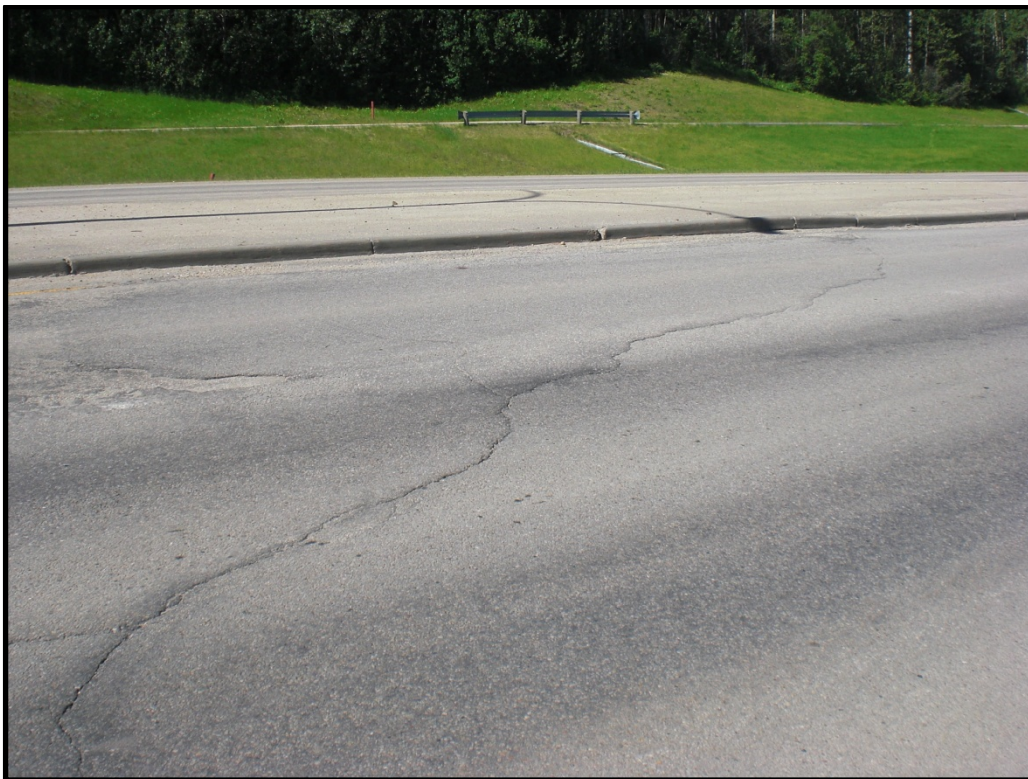
PHOTO 4: West Cracks, facing North.

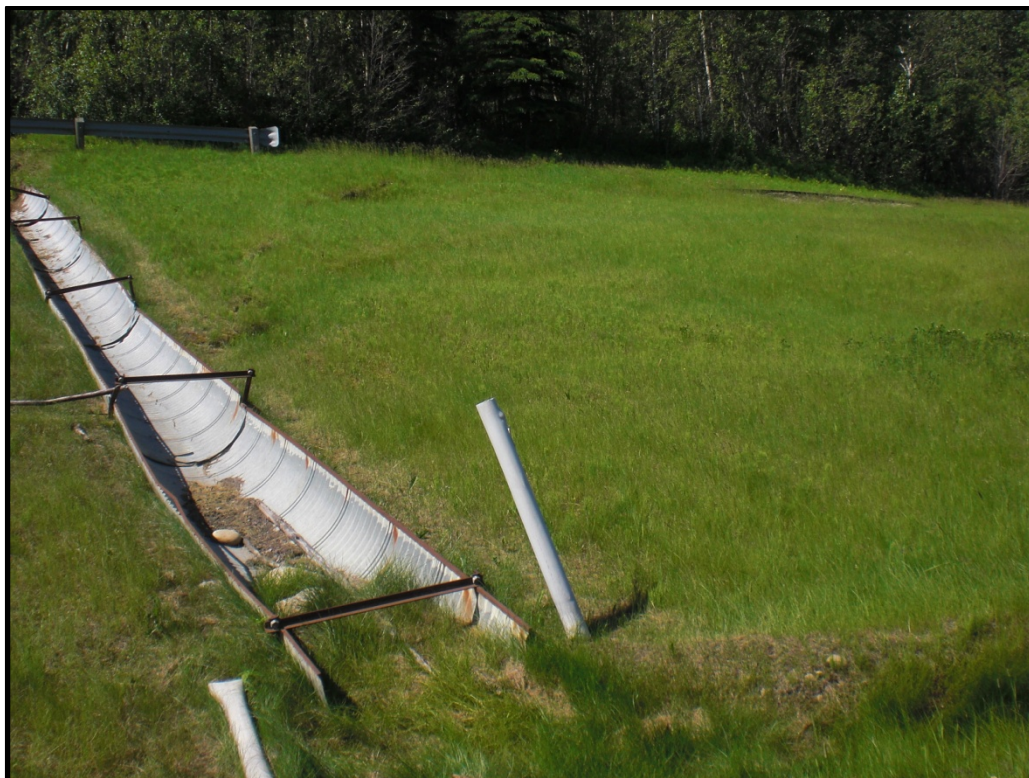
PHOTO 5: East end of surficial slope movement in Hwy 43 backslope (Approx. Sta. 1+600).

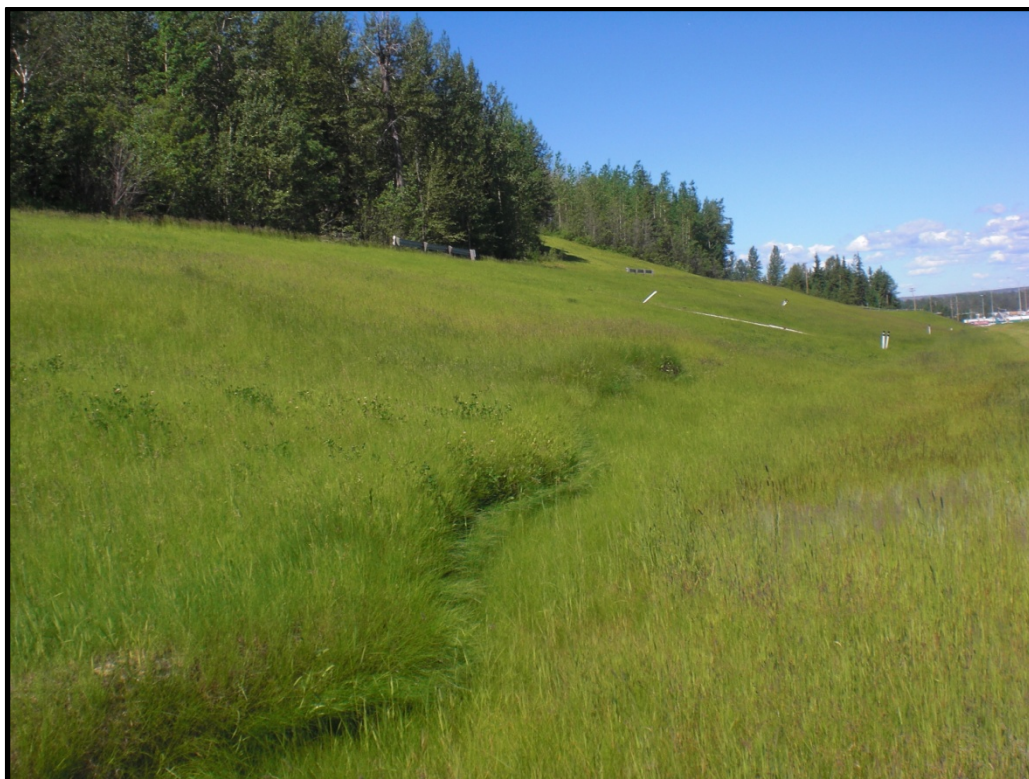
PHOTO 6: Toe bulge of surficial slope movement in Hwy 43 backslope (Approx. Sta. 1+600).

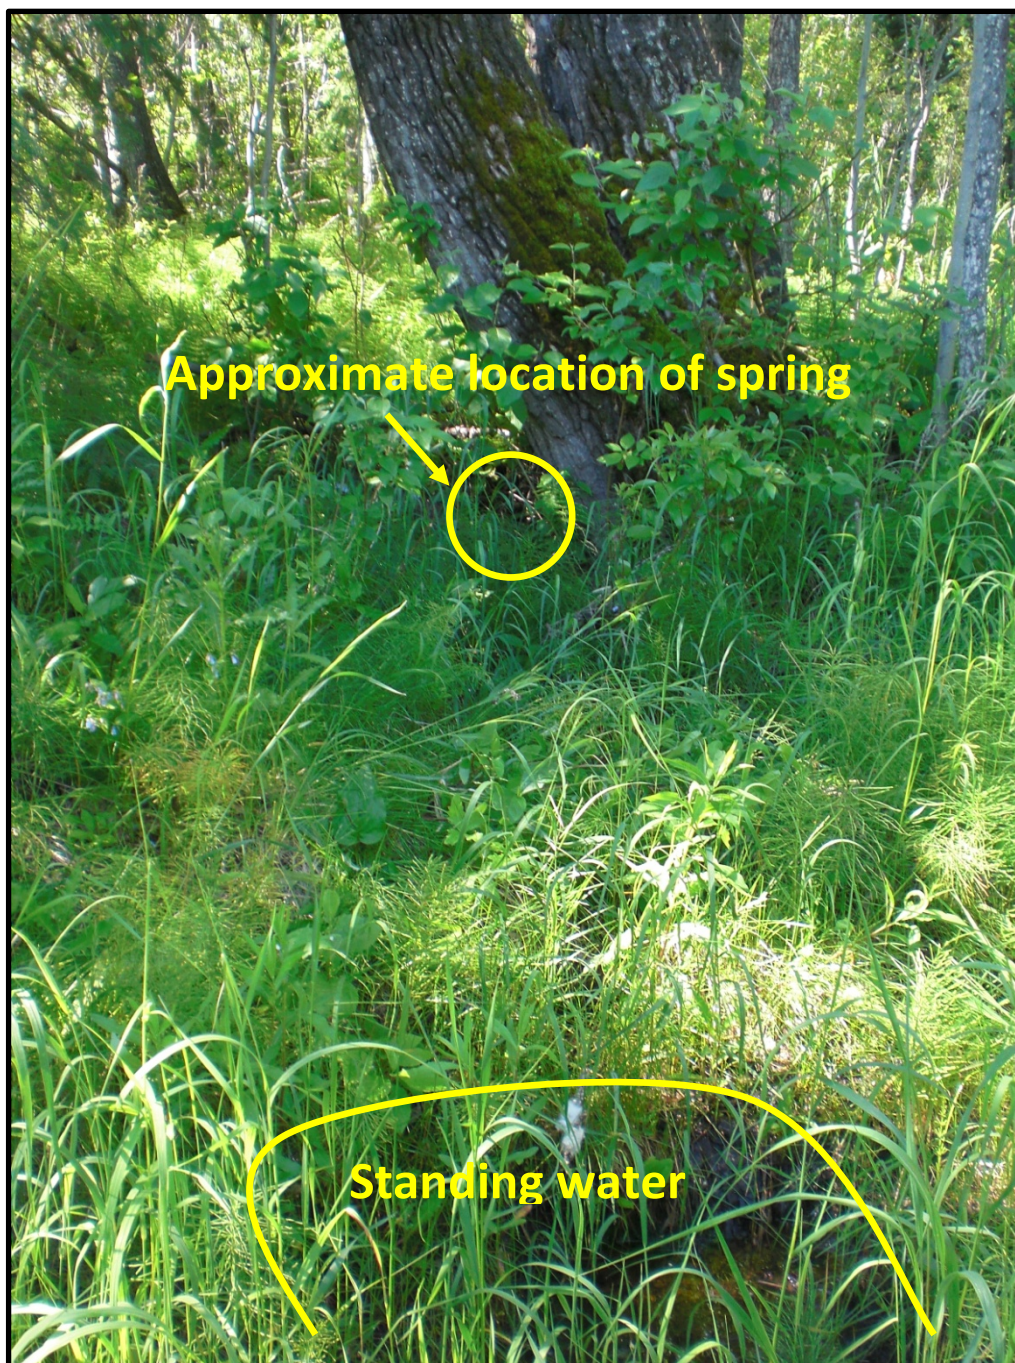
PHOTO 7: Spring observed at base of tree, standing water, facing upslope.

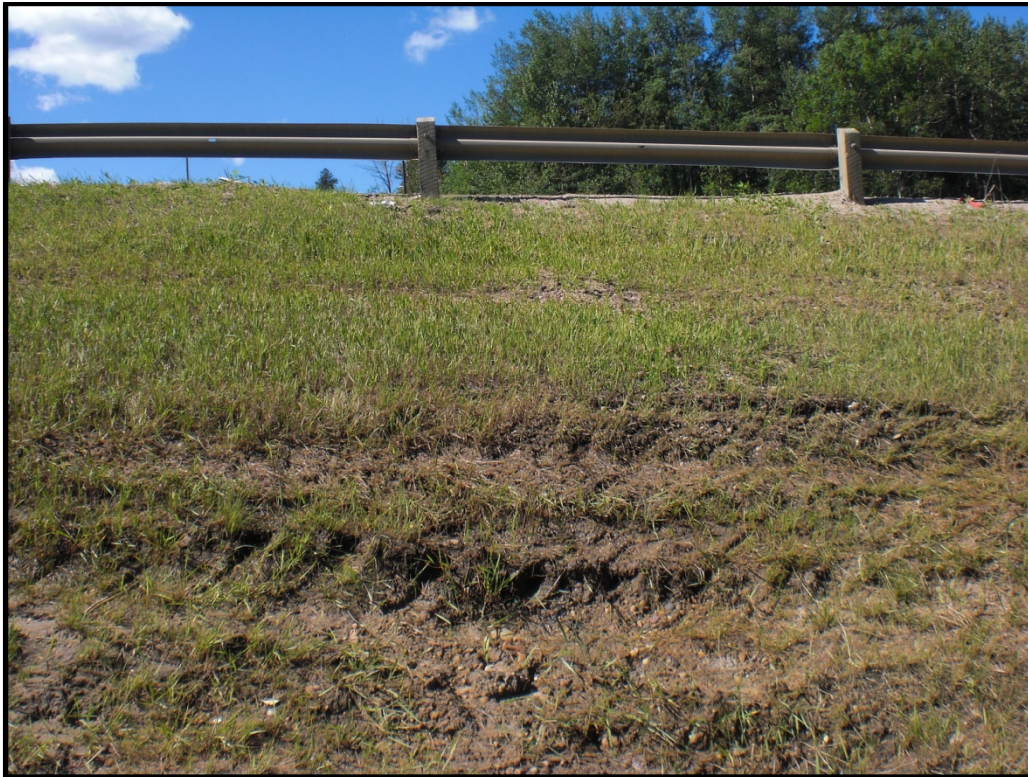
PHOTO 8: Seepage in North embankment slope at approximately Station 1+950.

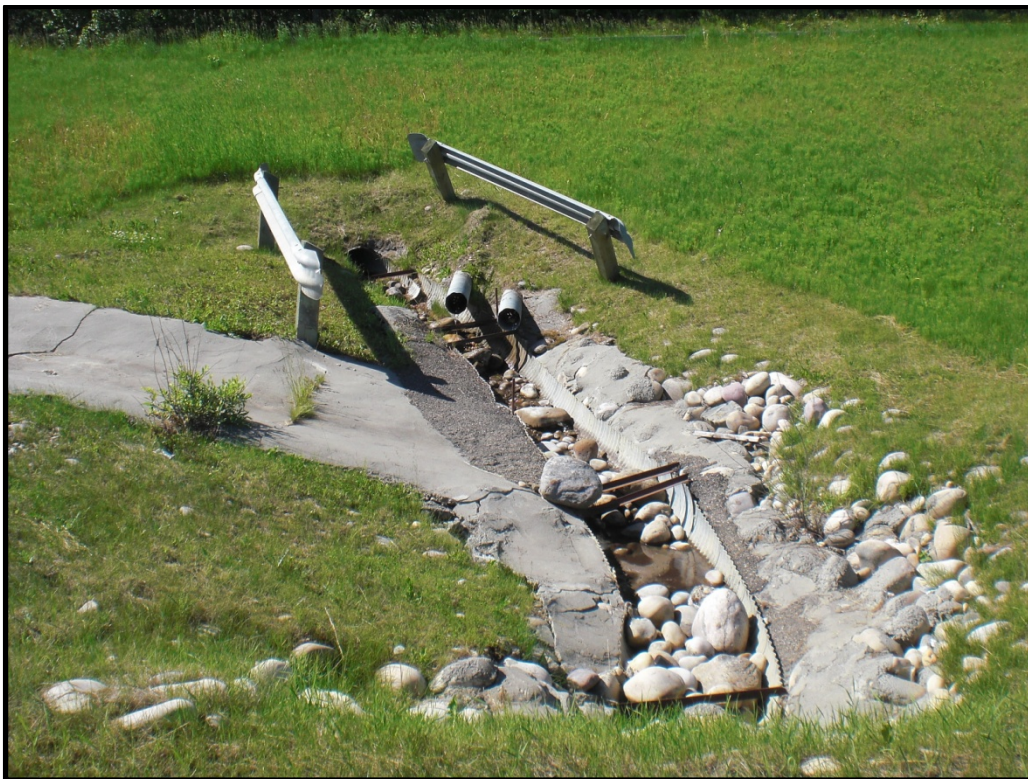
PHOTO 9: Concrete spillway and culvert at approximately Station 1+650.

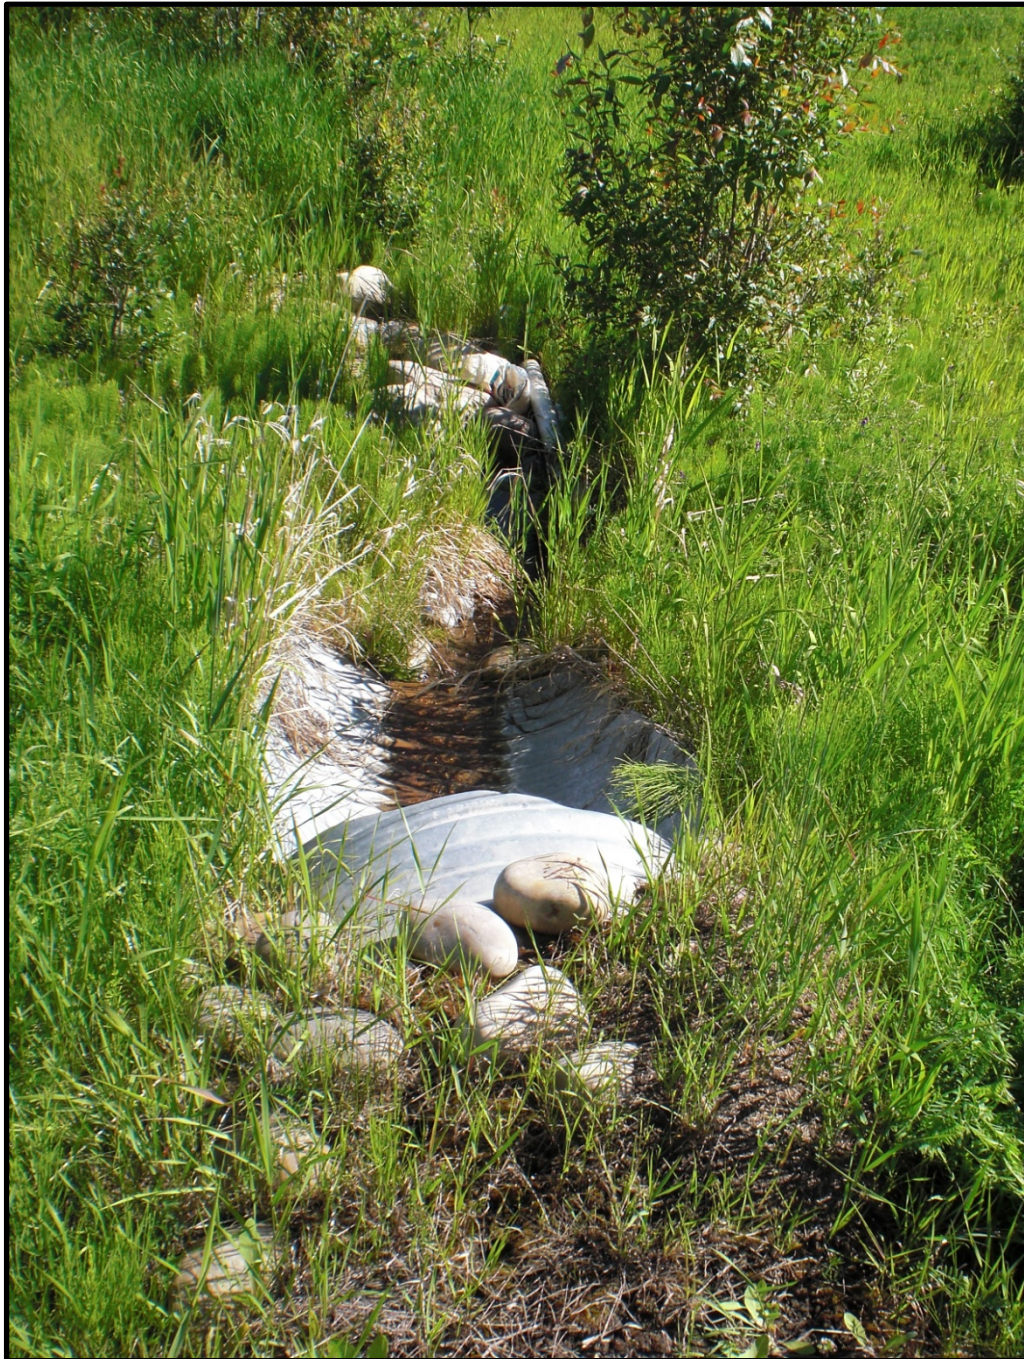
PHOTO 10: Culvert outlet at approximately 1+650.

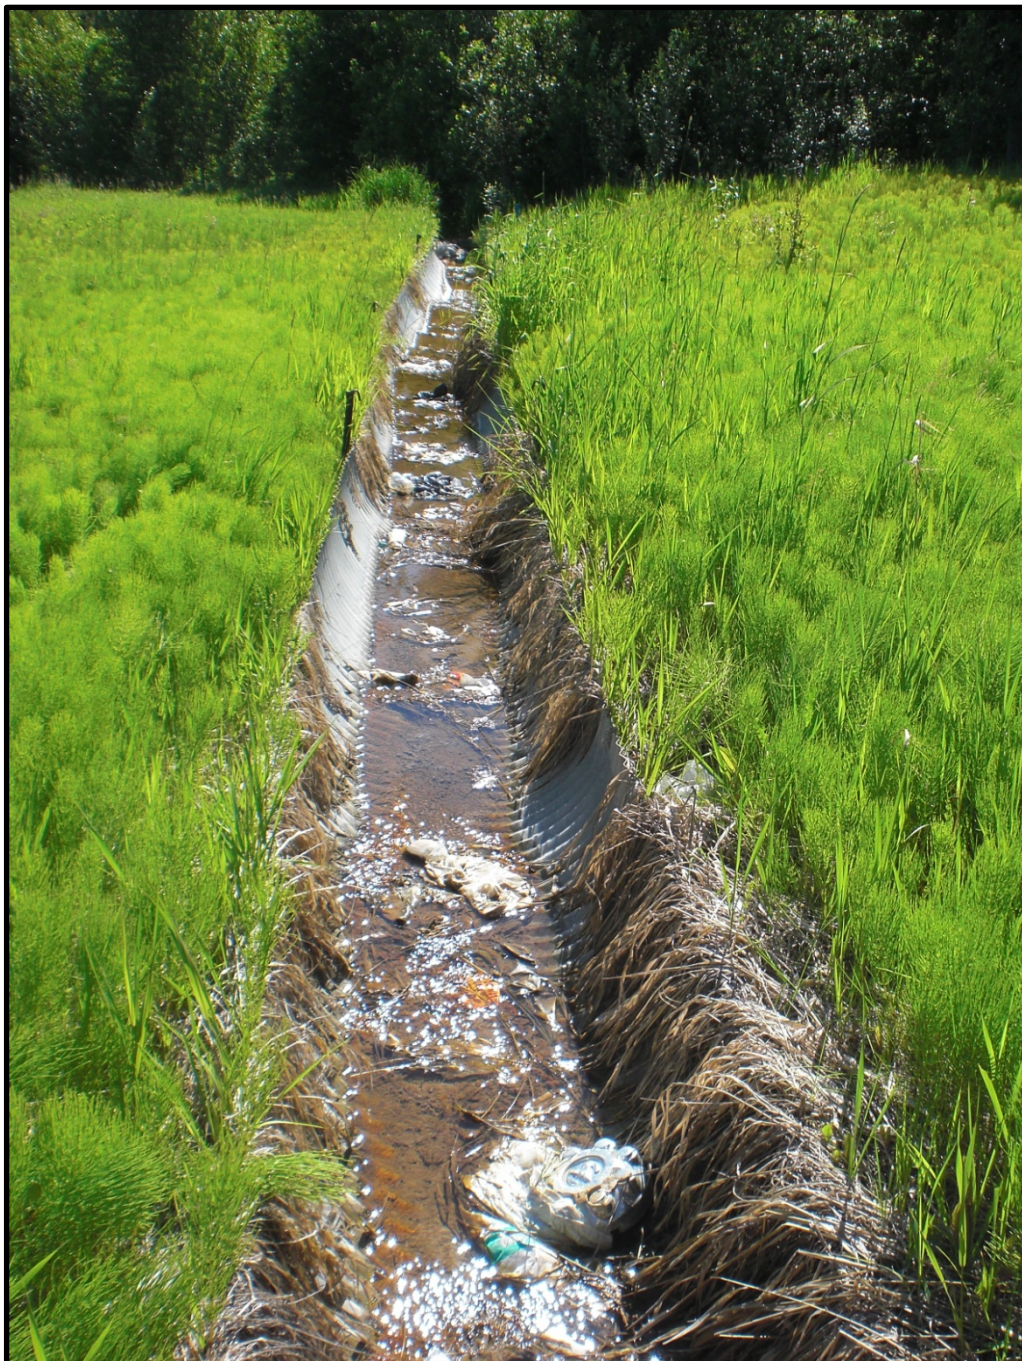
PHOTO 11: Half round surface culvert, North side of Hwy 43, facing East.
